Development and testing results of water-cooled divertor target concepts for EU DEMO reactor

Third Technical Meeting on Divertor Concepts
IAEA Headquarters, Vienna, 4-7 November 2019

Presenter: Visca Eliseo, ENEA
Contributors: J.-H. You, H. Greuner, A. v. Muller

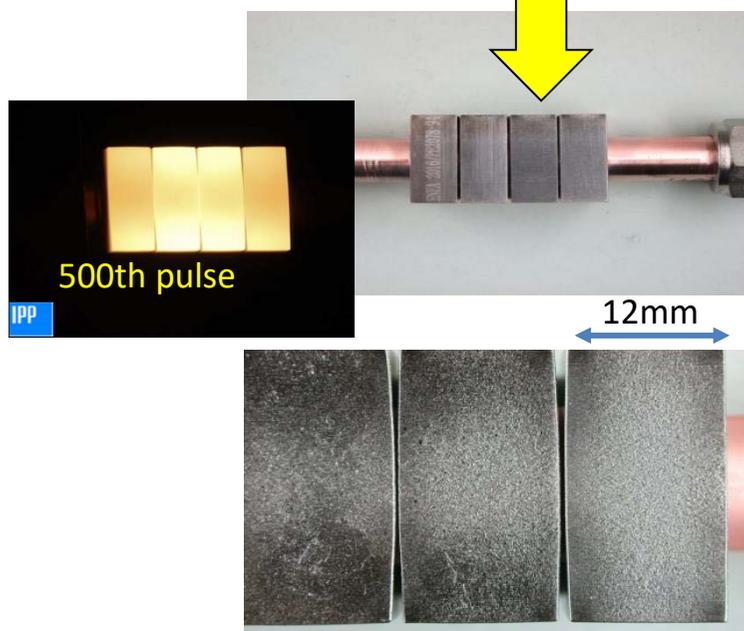
ITER-like ENEA #11

1st phase - HOT-WATER, 500 cycles @ 20 MW/m²

W-armor: 5 mm

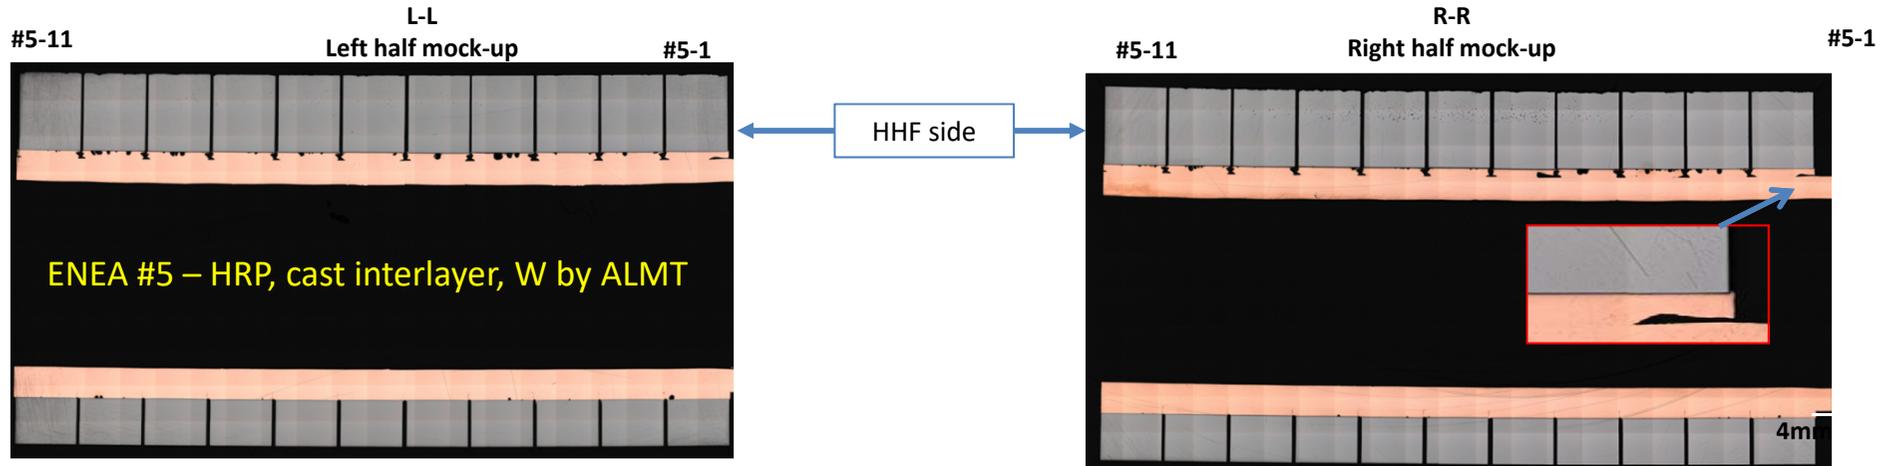
CCFE#6 ENE#5 CEA#4 IPP#1

Analyzed mock-ups which sustained
500c@20MW/m² :

- ➔ No modification and deep cracks in W HHF-surface
- ➔ Damages concentrated in the interlayer:
 - 1) voids in cast joints for 6 of 11 blocks
 - 2) increased number of voids due to HHF tests
- ➔ Good agreement with NDT (ENEА-ULTRAS)

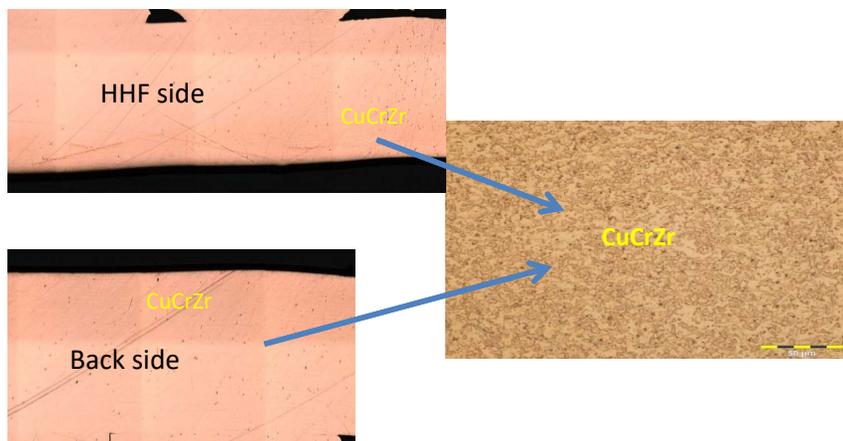
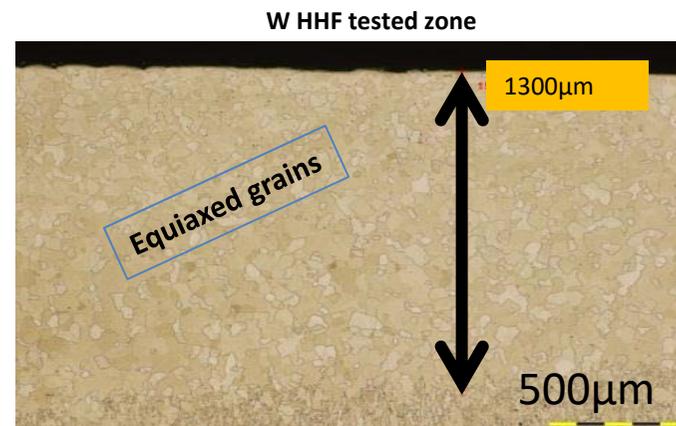
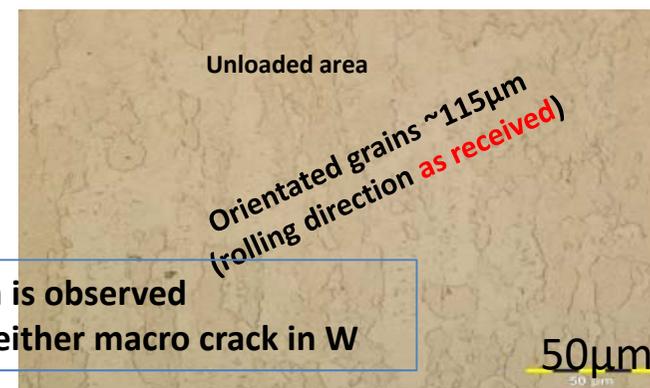
Micro-hardness 116 (HV 0.3)

- CuCrZr pipe keeps its fine grains aspect
- No softening of CuCrZr

- W recrystallization is observed
- No major defect neither macro crack in W

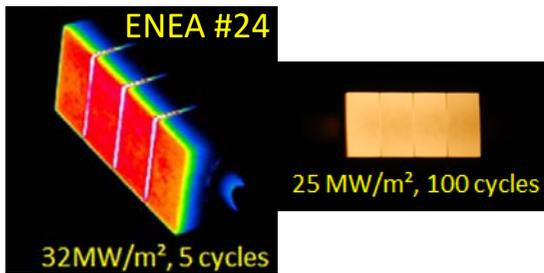
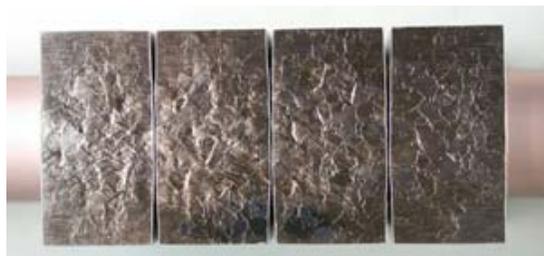
Cu interlayer: 0.1 mm

ITER-like (2nd phase, W: 8mm), W: AT&M -> 32 MW/m² (5 pulses) + 25 MW/m² (100 pulses)

No cracks, intact joint in all cases
