Damages on tungsten plasma facing components after experimental campaigns in WEST

Third IAEA Technical Meeting on Divertor Concept – 4th November 2019

M. Firdaouss, E. Tsitrone, M. Diez, A. Grosjean and the WEST team

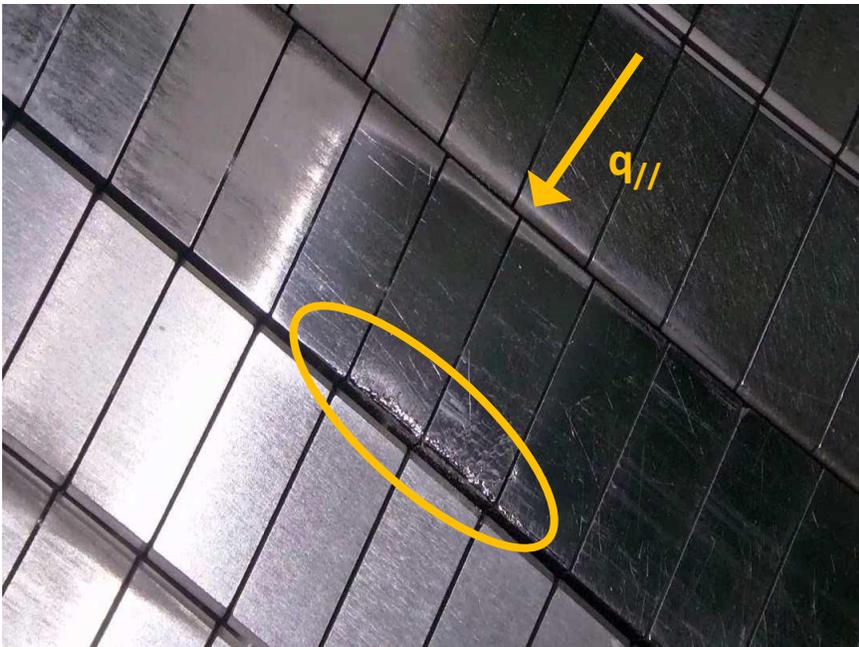
Articulated Inspection Arm inspection – in-situ view

- ▶ Damaged area identified after C3a using the robotic Articulated Inspection Arm during experimental campaign
- ▶ Localization on the **trailing sharp edge**
- ▶ Combination of single / few **powerful events** ($>200\text{MW/m}^2$ parallel during 10ms) with 0.8 mm misalignment
- ▶ **No evolution** during following operation C3b

Melted W across monoblock and **long crack**

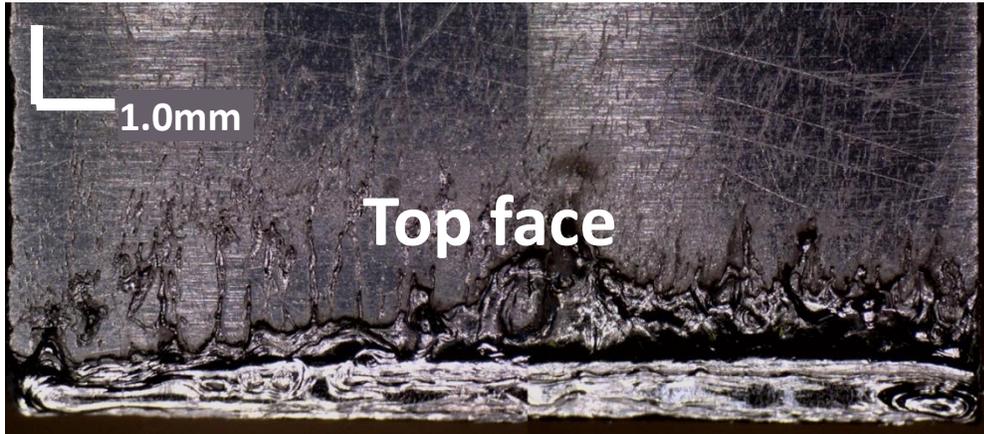
Monoblock 14 – Top and side views

- ▶ PFU #12 dismantled at the end of C3 -> large melted area (0.5mmx0.5mm) on 2 monoblocks and a half

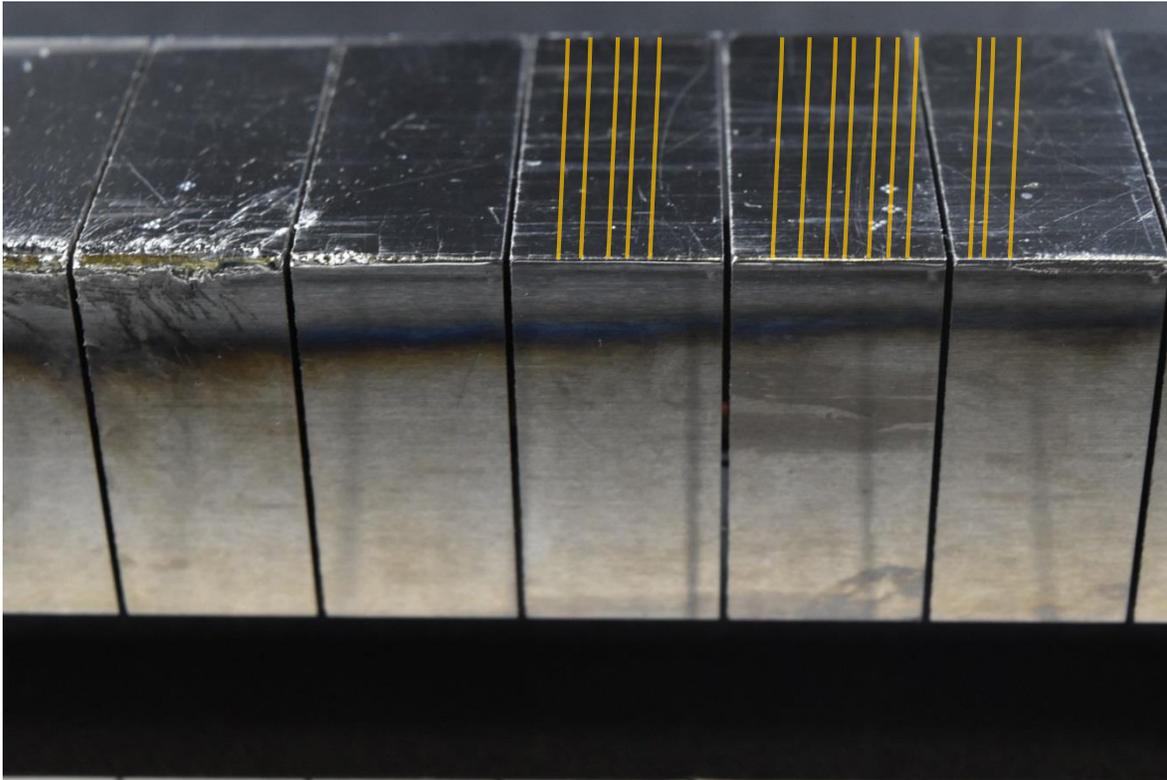
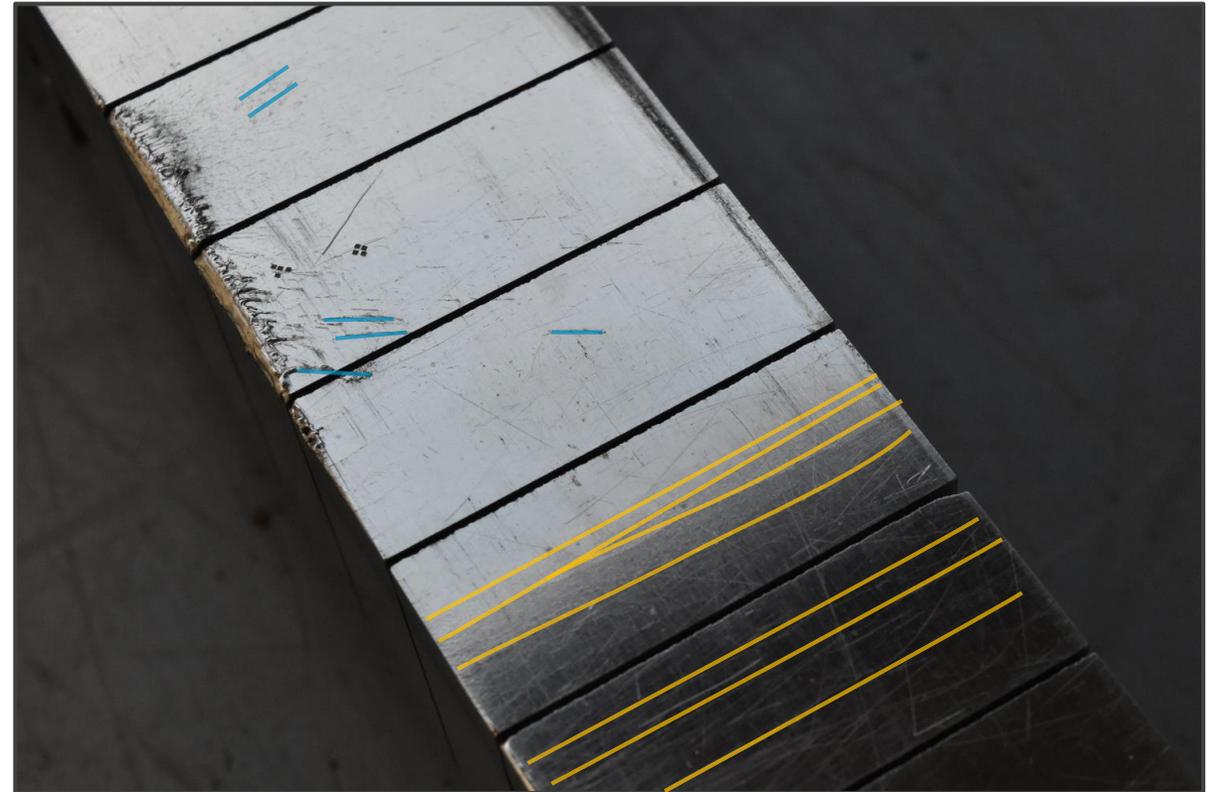
- ▶ Long cracks in yellow on monoblocks far from the melted area (and melted material in blue)
- ▶ Specific to this area, meaning that it is caused by a localized single / few transient event

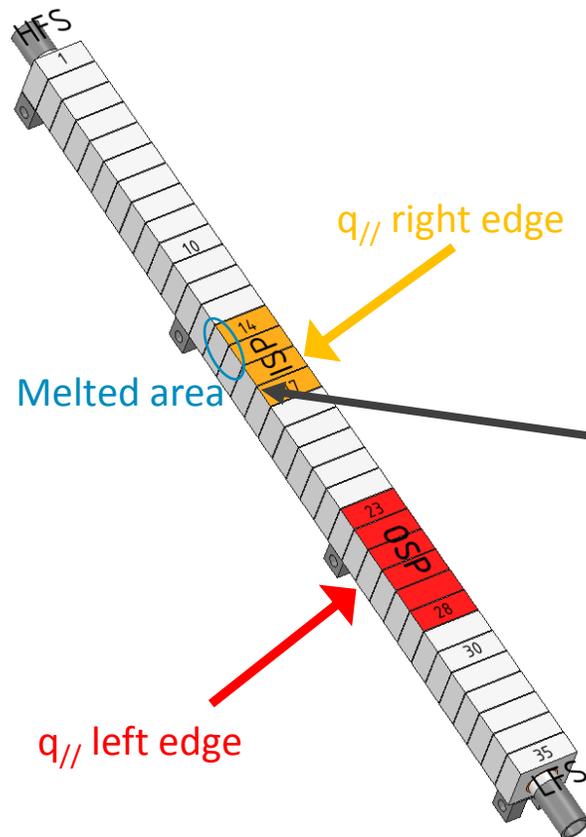
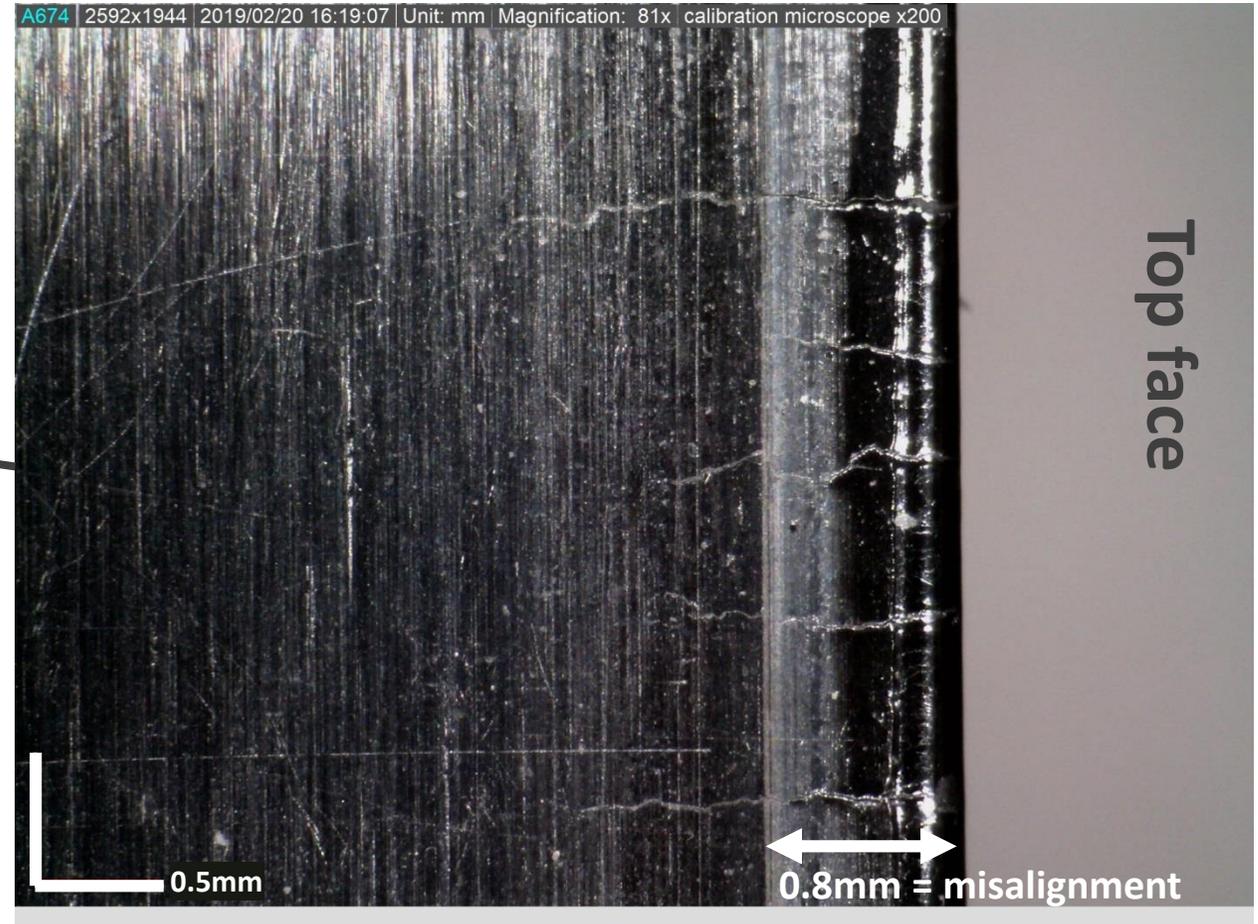
mb 17 – left edge - non exposed side close to the melted area

- ▶ 2mm deep vertical cracks – horizontal cracks
- ▶ Regular and numerous cracks

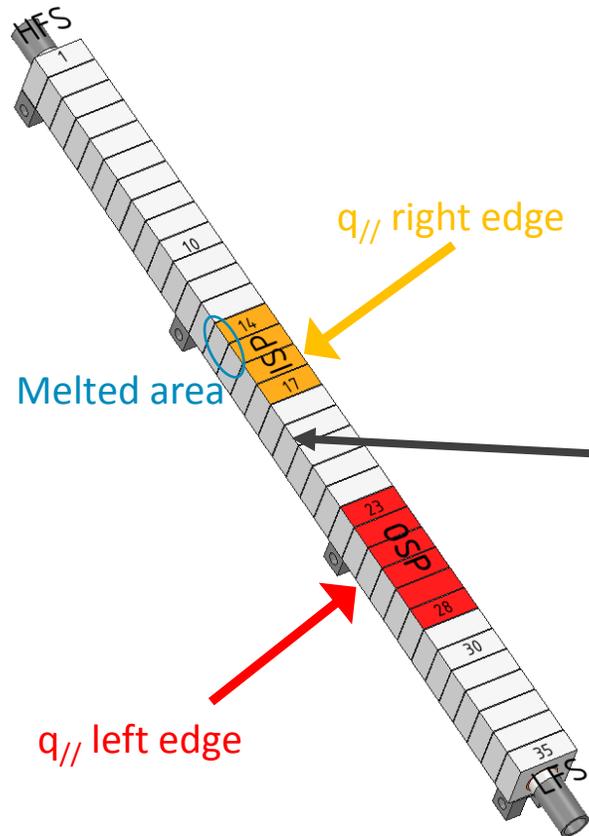
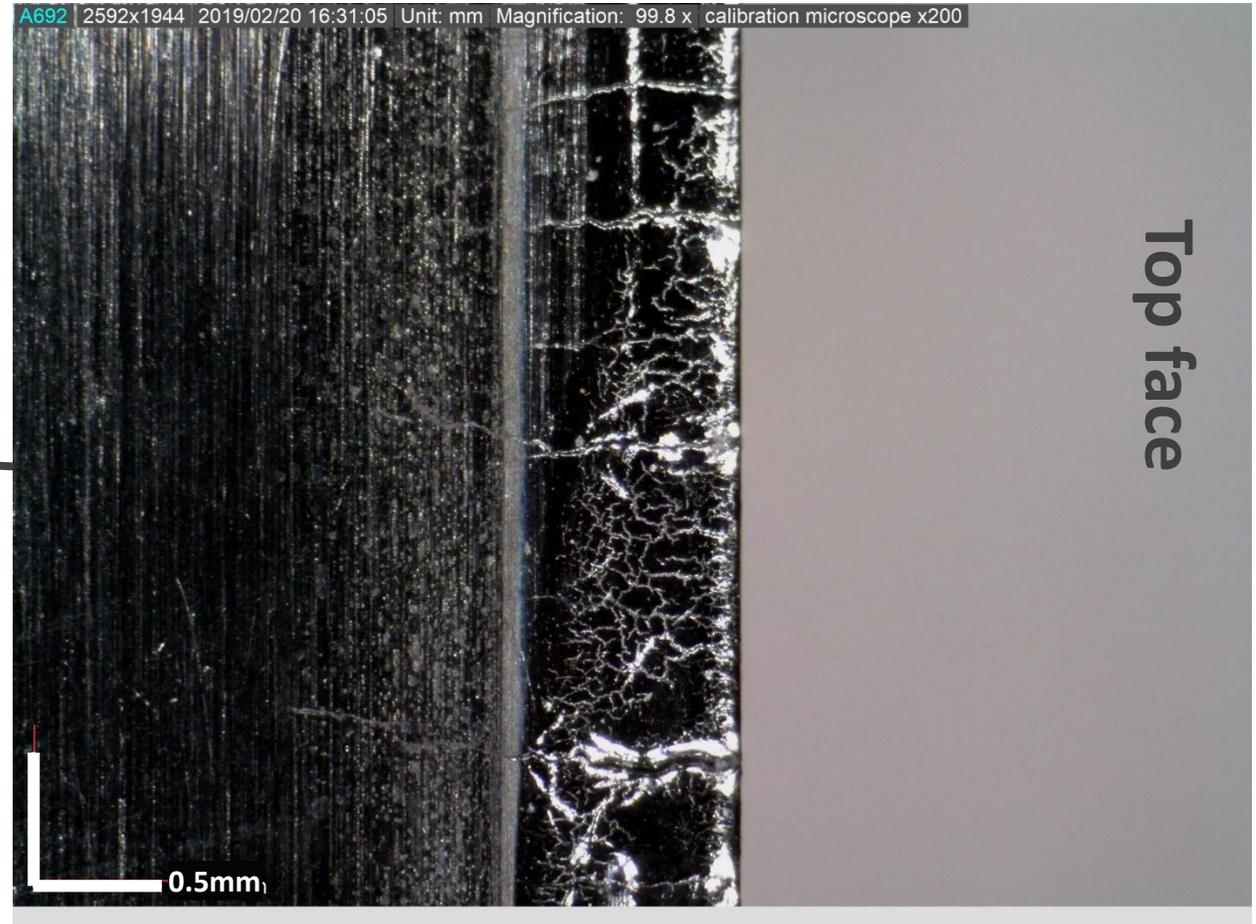
mb 19 – left edge - non exposed side

- ▶ Crack network well developed near the top surface
- ▶ Melting along the cracks

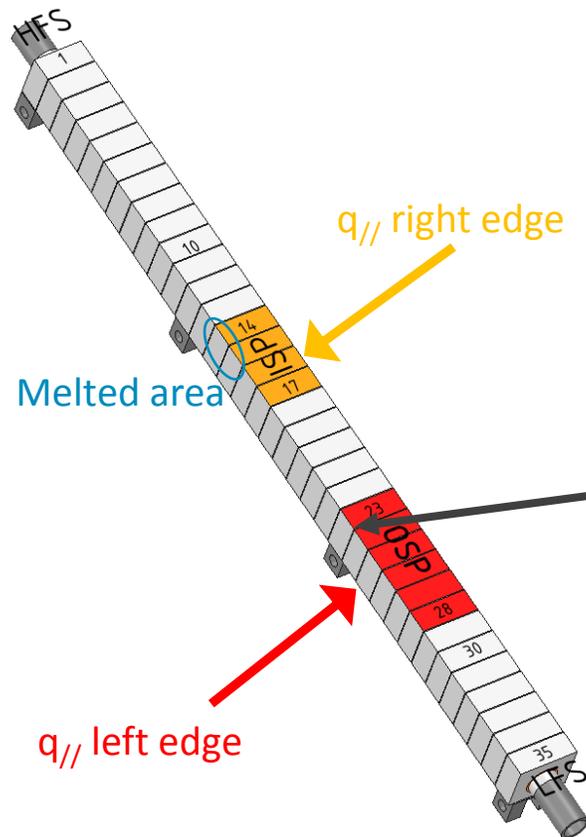
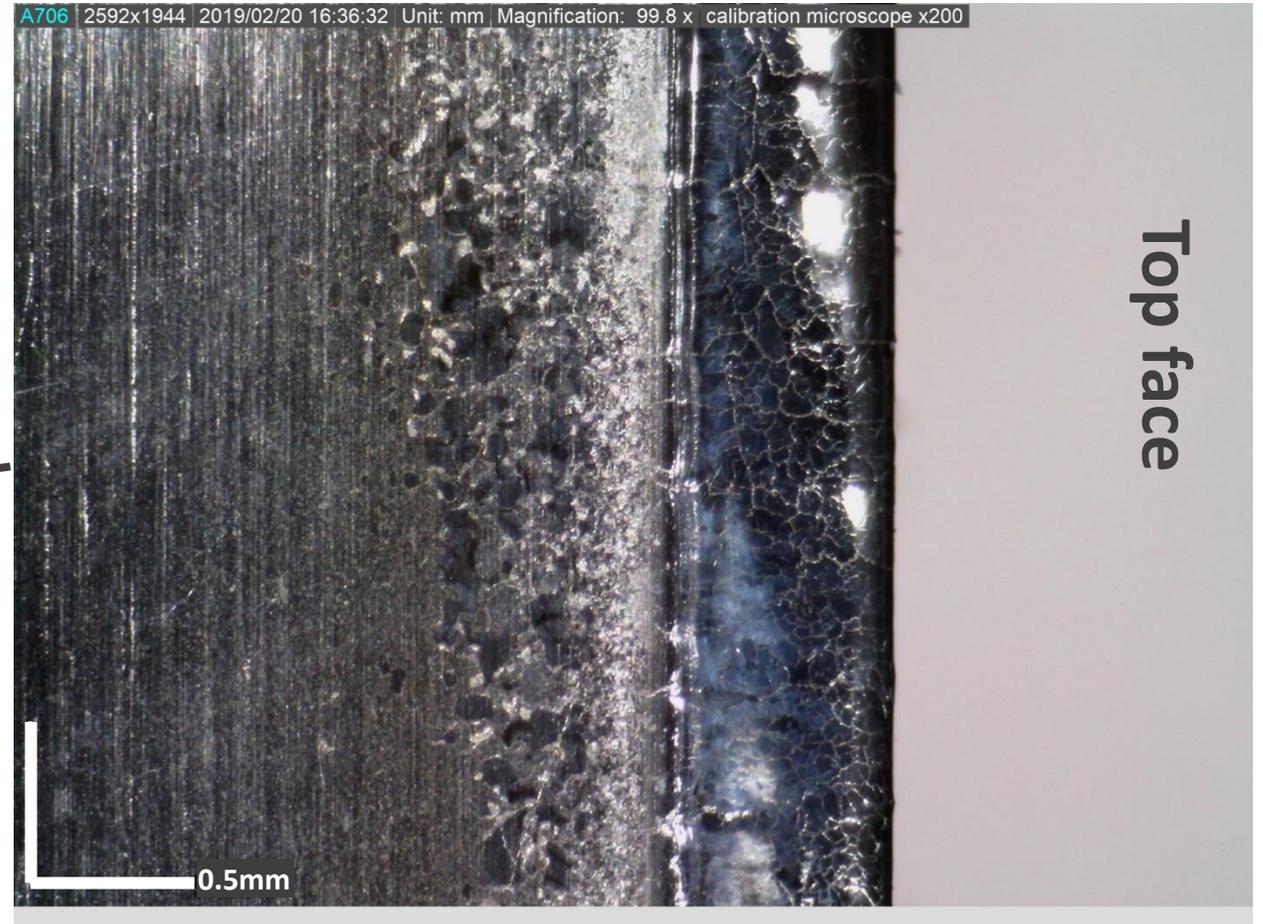
mb 23 – left edge - exposed side at the outer strike point

- ▶ Crack network well developed in the thickness
- ▶ Structural modification deeper than 2mm

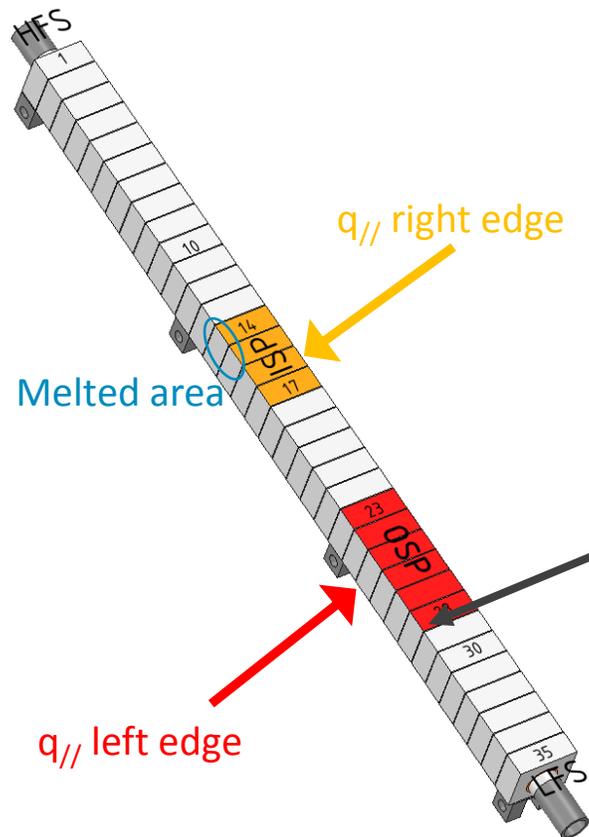
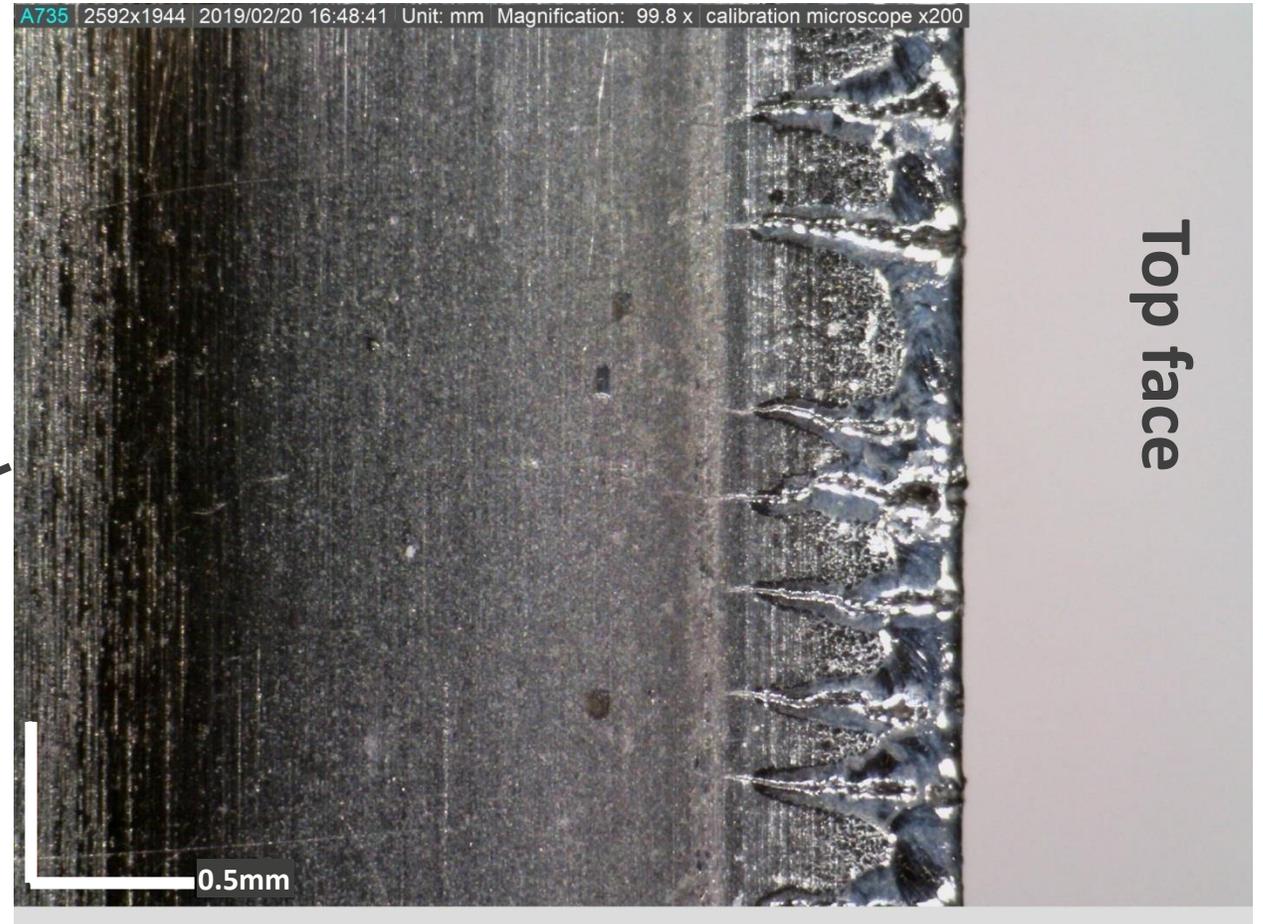
mb 28 – left edge - exposed side at the outer strike point

- ▶ Crack network well developed in the thickness
- ▶ Melting along large cracks

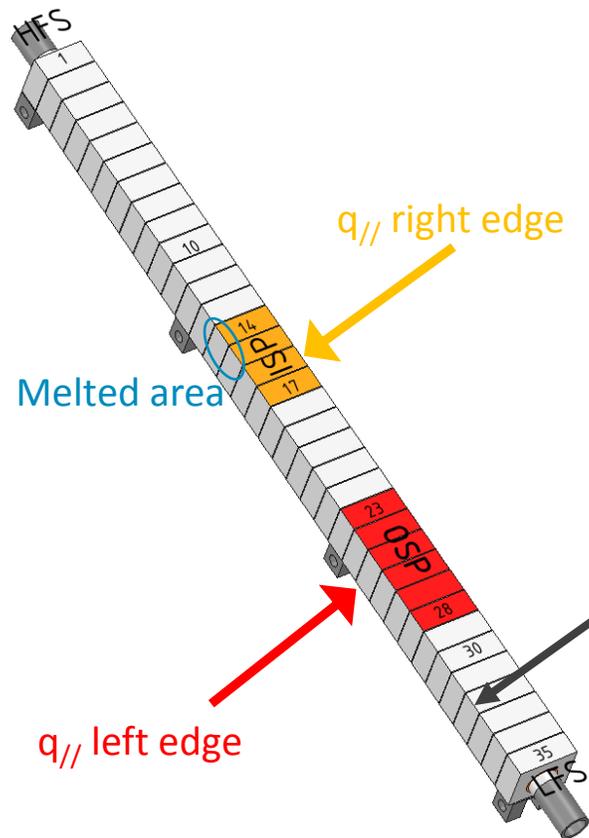
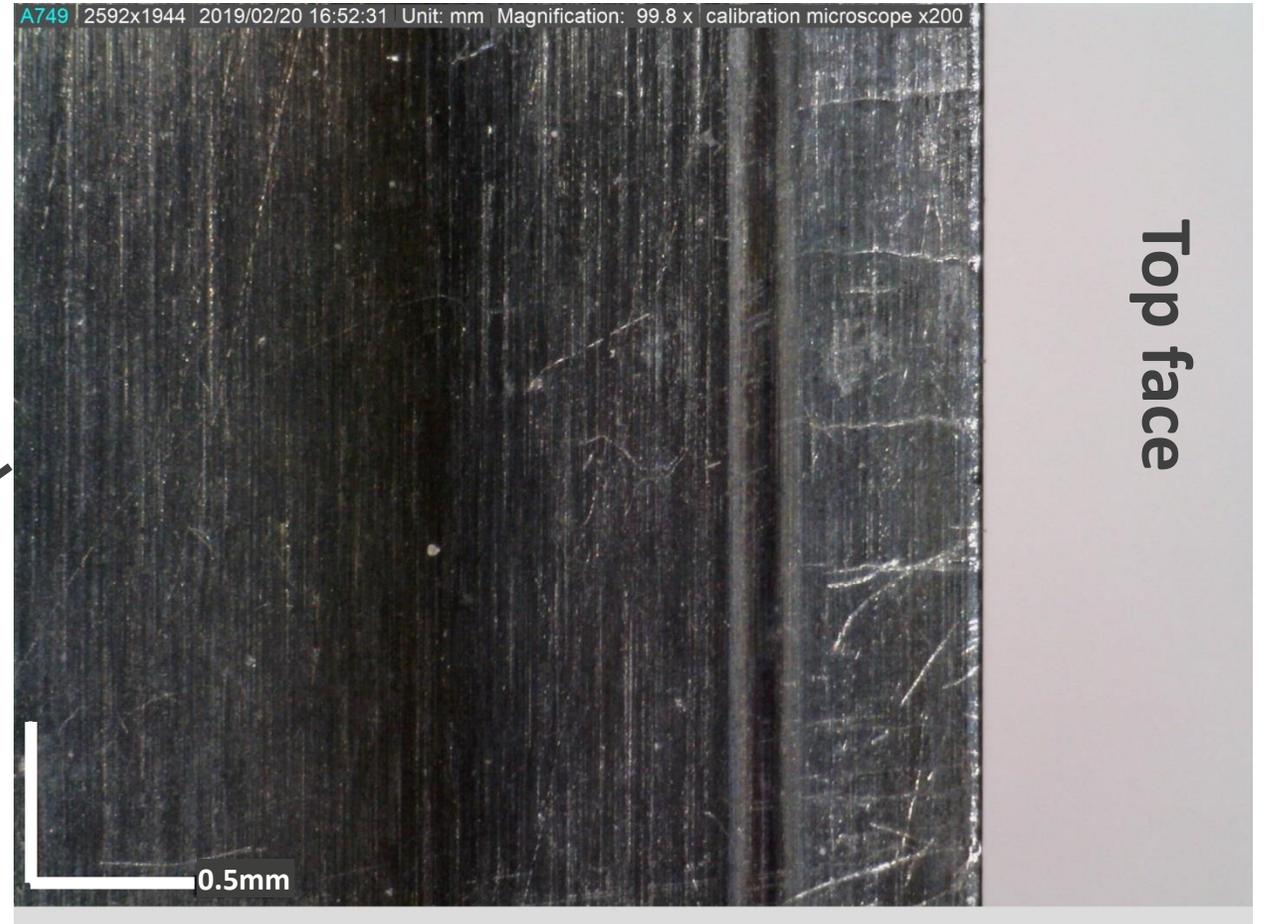
mb 32 – left edge - exposed side far from the outer strike point

► Regular thin cracks visible

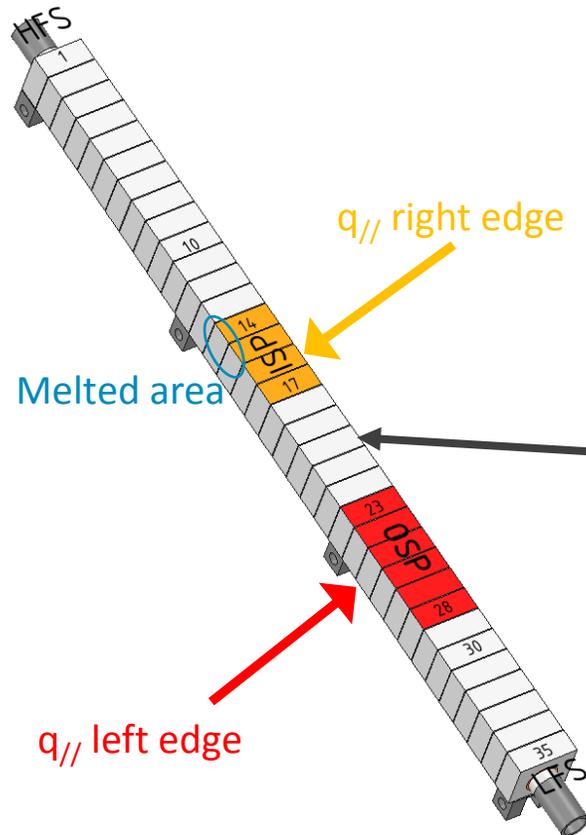
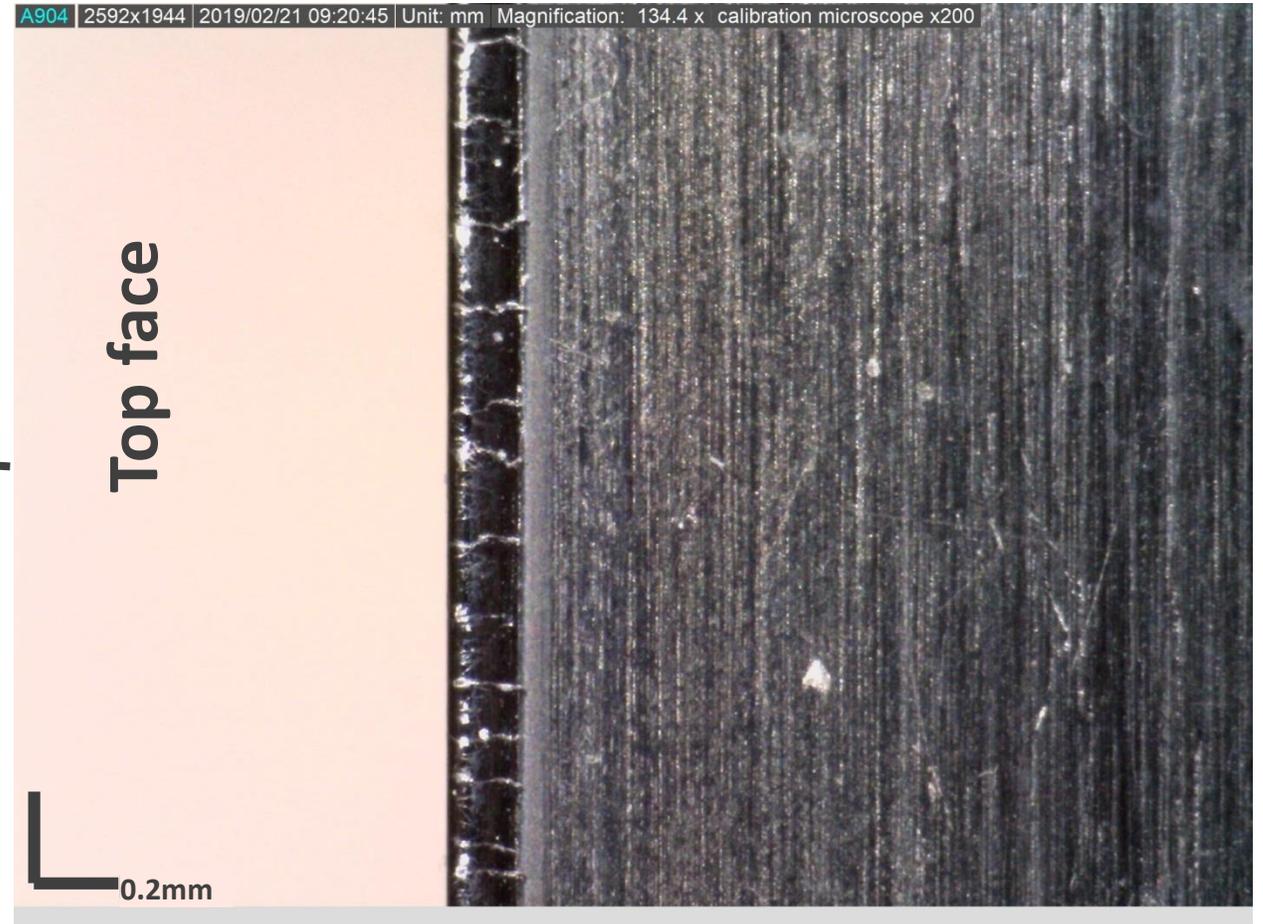
mb 20 – right edge – non exposed side

► Regular thin cracks visible with melting

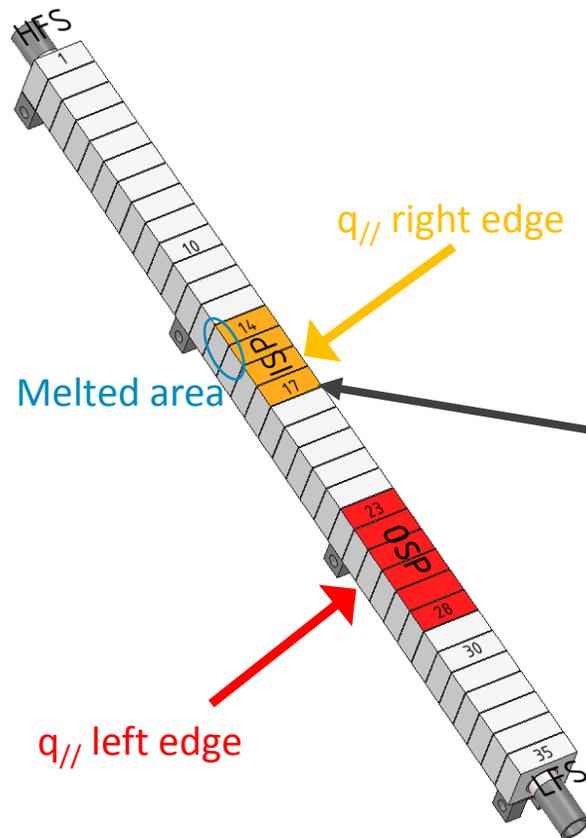
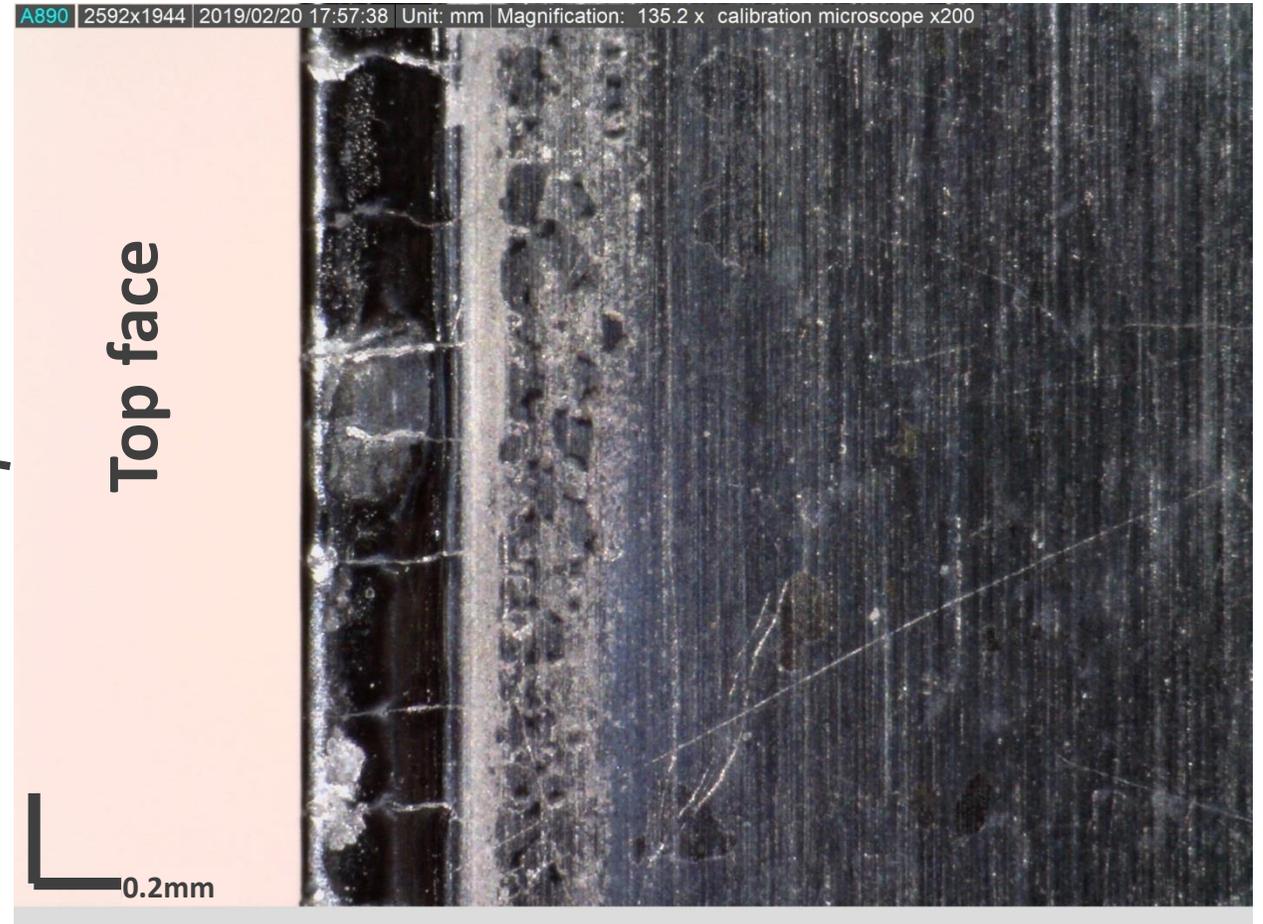
mb 17 – right edge – exposed side at the inner strike point near the melted area

- ▶ Regular thin cracks visible with melting
- ▶ Missing material

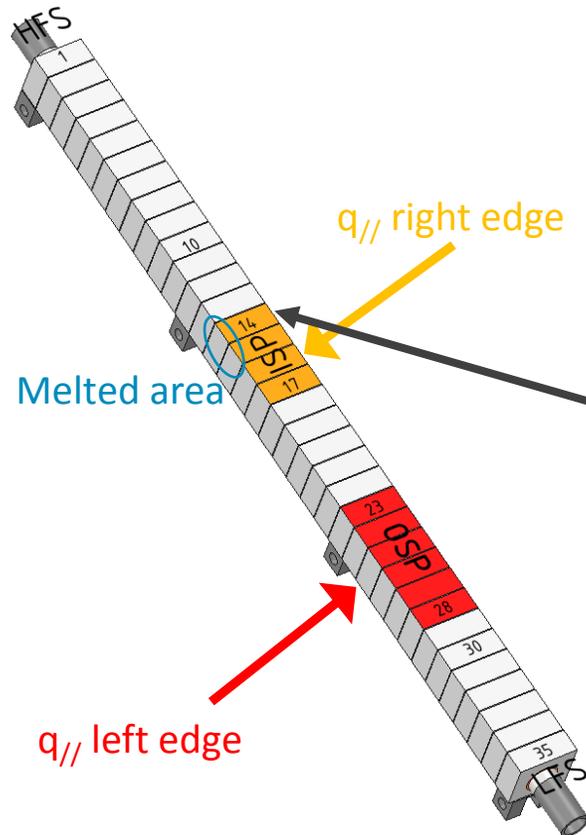
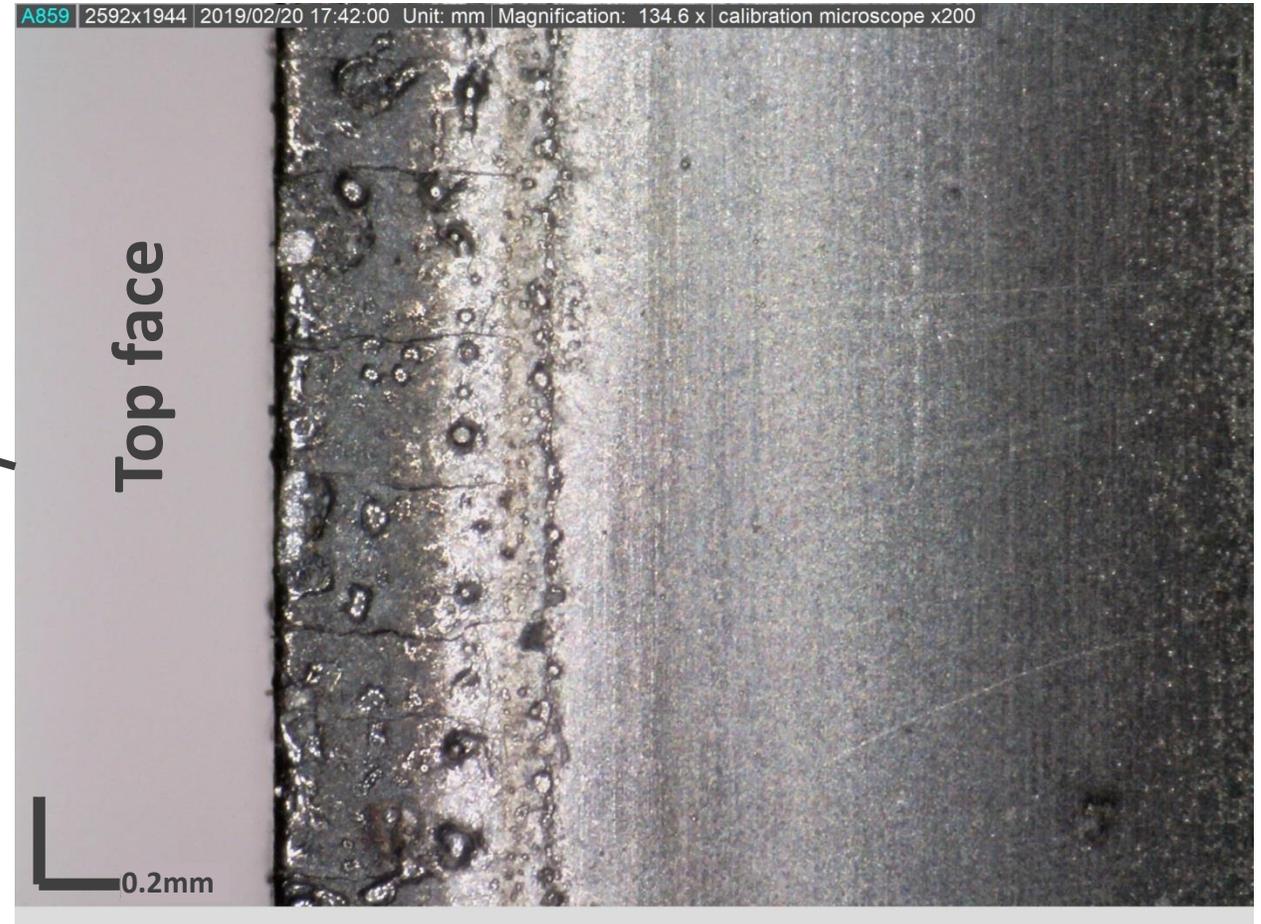
mb 14 – right edge – exposed side at the inner strike point near the melted area

- ▶ Regular thin cracks
- ▶ Many droplets

Misalignment responsible for cracks, melting and droplets

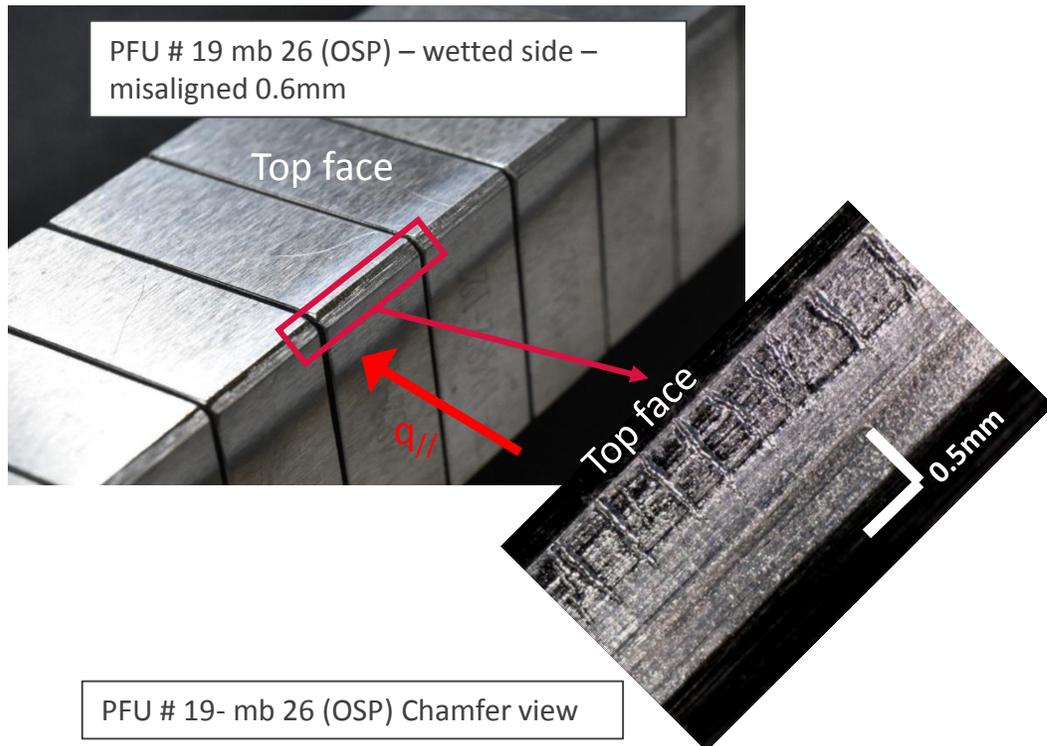
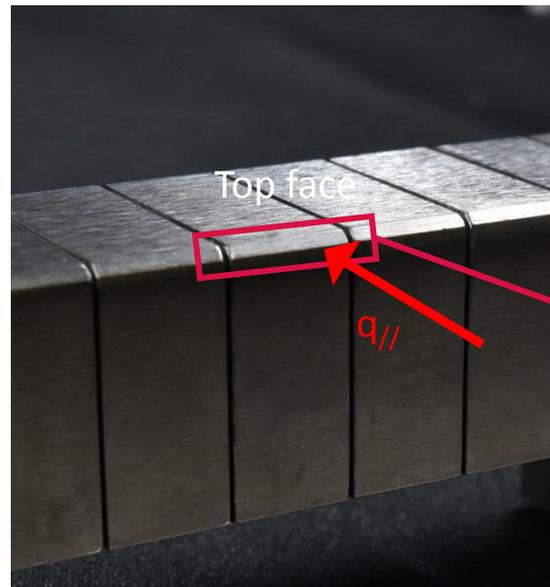
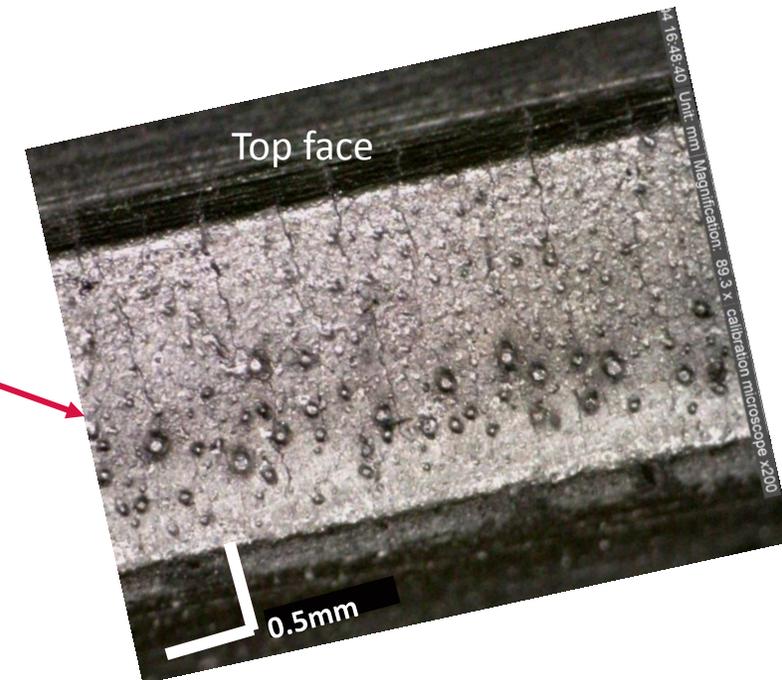
Cracks and melting are also observed on chamfered PFUs

- ▶ Same type of damages on different locations, on chamfered PFU
- ▶ Chamfer not sufficient to prevent damages for significant misalignment

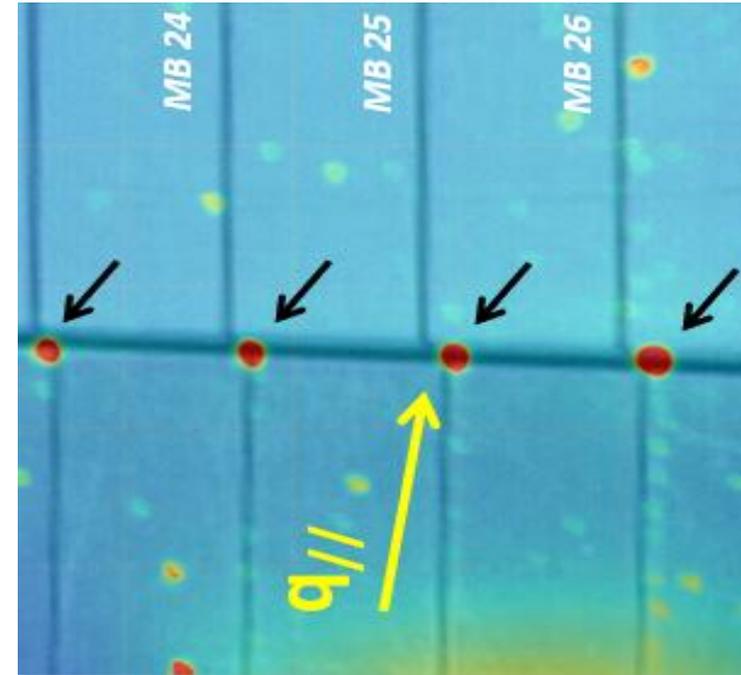
VHR Infrared image of OHS during a disruption (digital level) on PFU13 (aligned with PFU12)

- ▶ OHS has a deep triangular shape, depending of geometry and plasma equilibrium
- ▶ OHS observed for perfectly aligned PFU on the corner or on the face
- ▶ Simulations have shown that the thermal response of W monoblock to OHS can be an issue for ITER, during ELMs and transient (*Surface heat loads on the ITER divertor vertical targets*, J. P. Gunn et al., 2017, Nucl. Fusion)

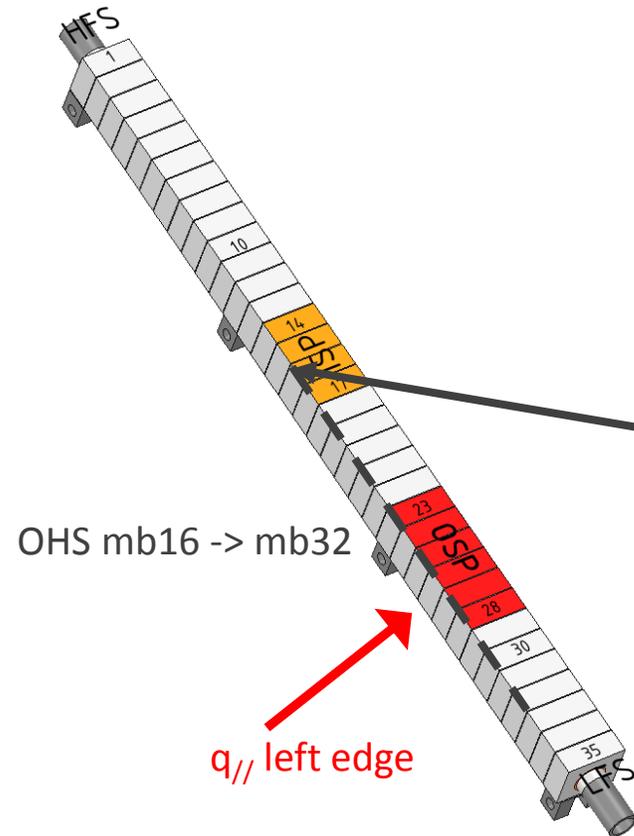
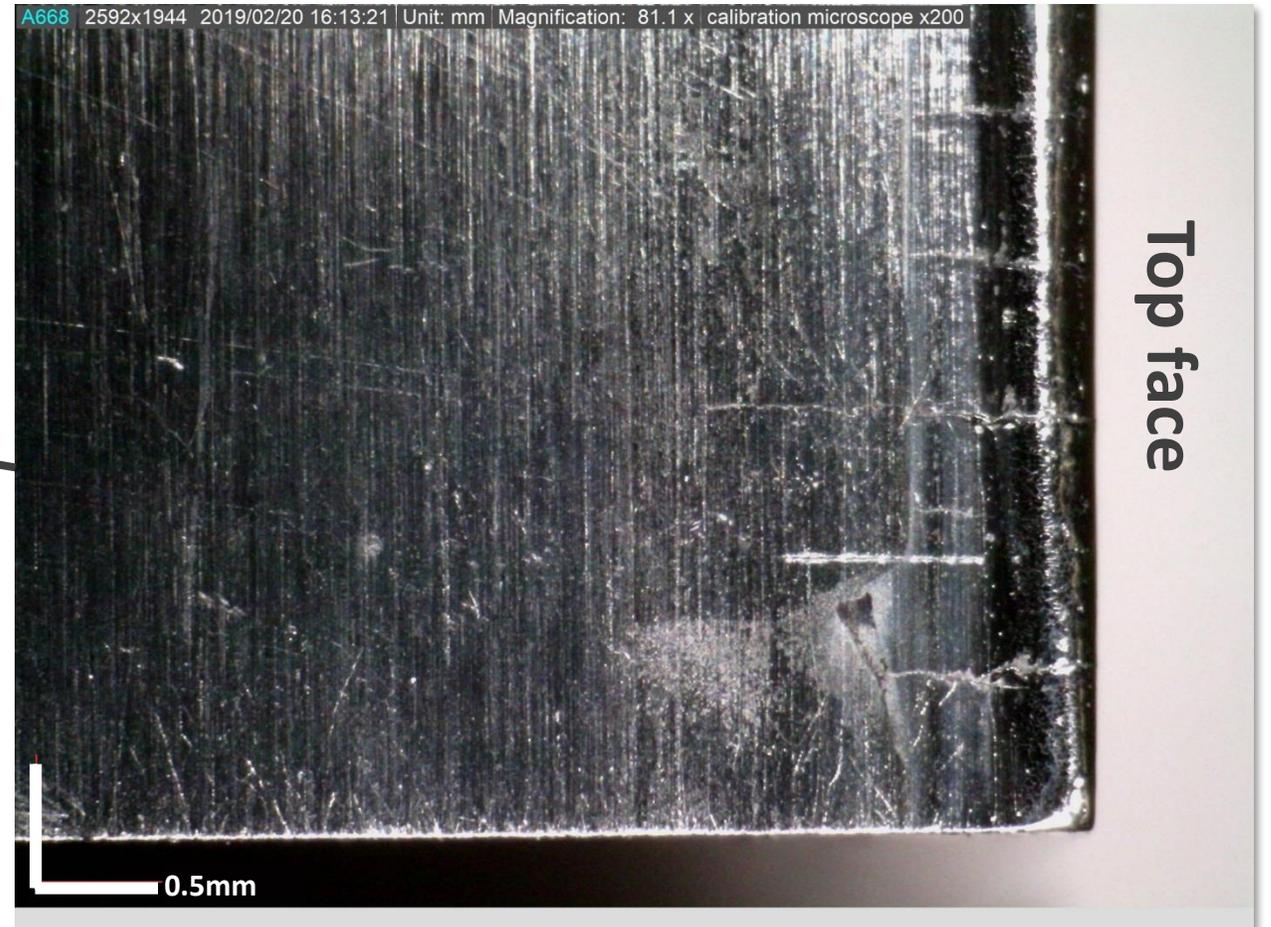
mb 16 – non exposed edge

OHS visible all along the plasma exposed edge, cracks near the strike points

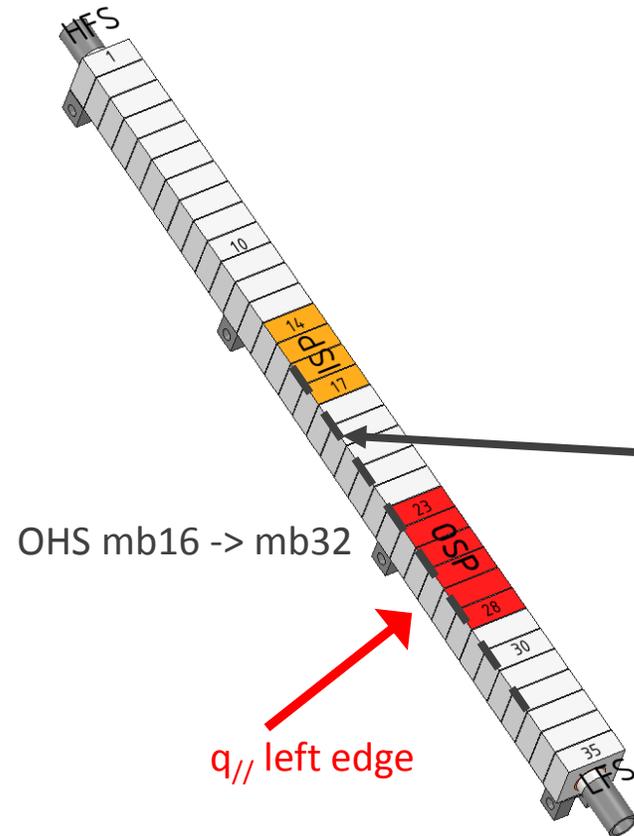
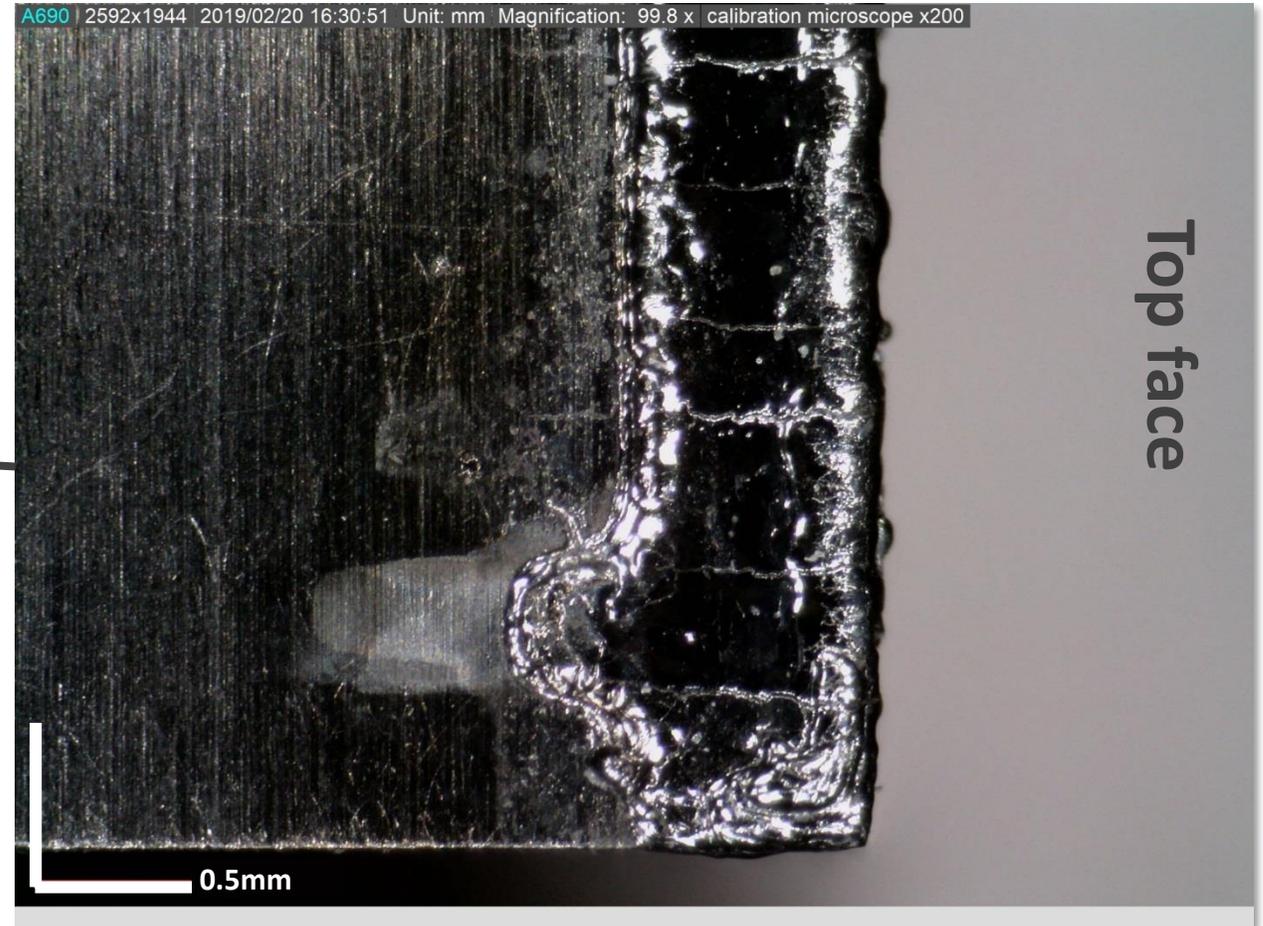
mb 19 – non exposed edge

- ▶ OHS deeper than misalignment -> exists even with perfect alignment
- ▶ Several OHS patterns:
 - Visual mark with no visible damage far from the strike points
 - Additional melting on non exposed edge (mb 19)
 - Melting and cracks up to the tip of the OHS at both strike points
