Damages on tungsten plasma facing components after experimental campaigns in WEST

Third IAEA Technical Meeting on Divertor Concept – 4th November 2019

M. Firdaouss, E. Tsitrone, M. Diez, A. Grosjean and the WEST team

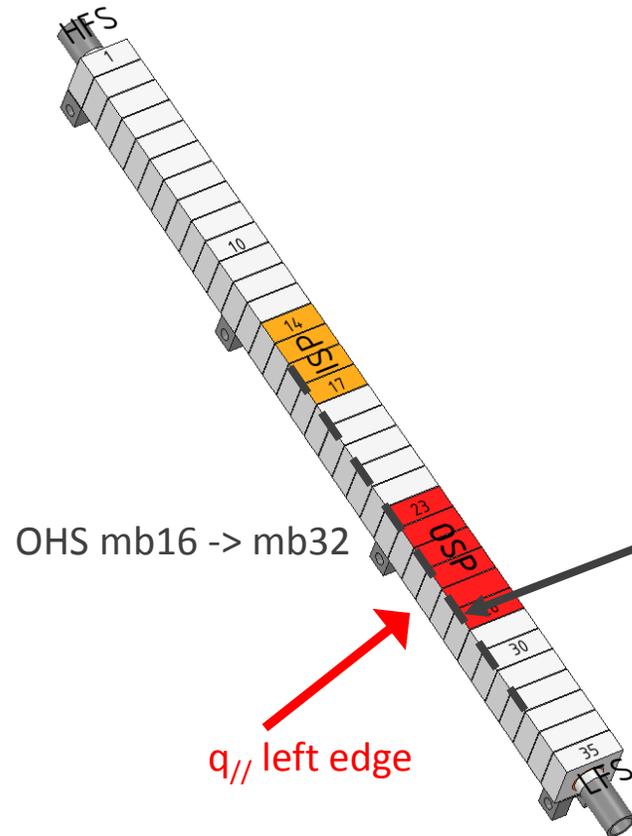
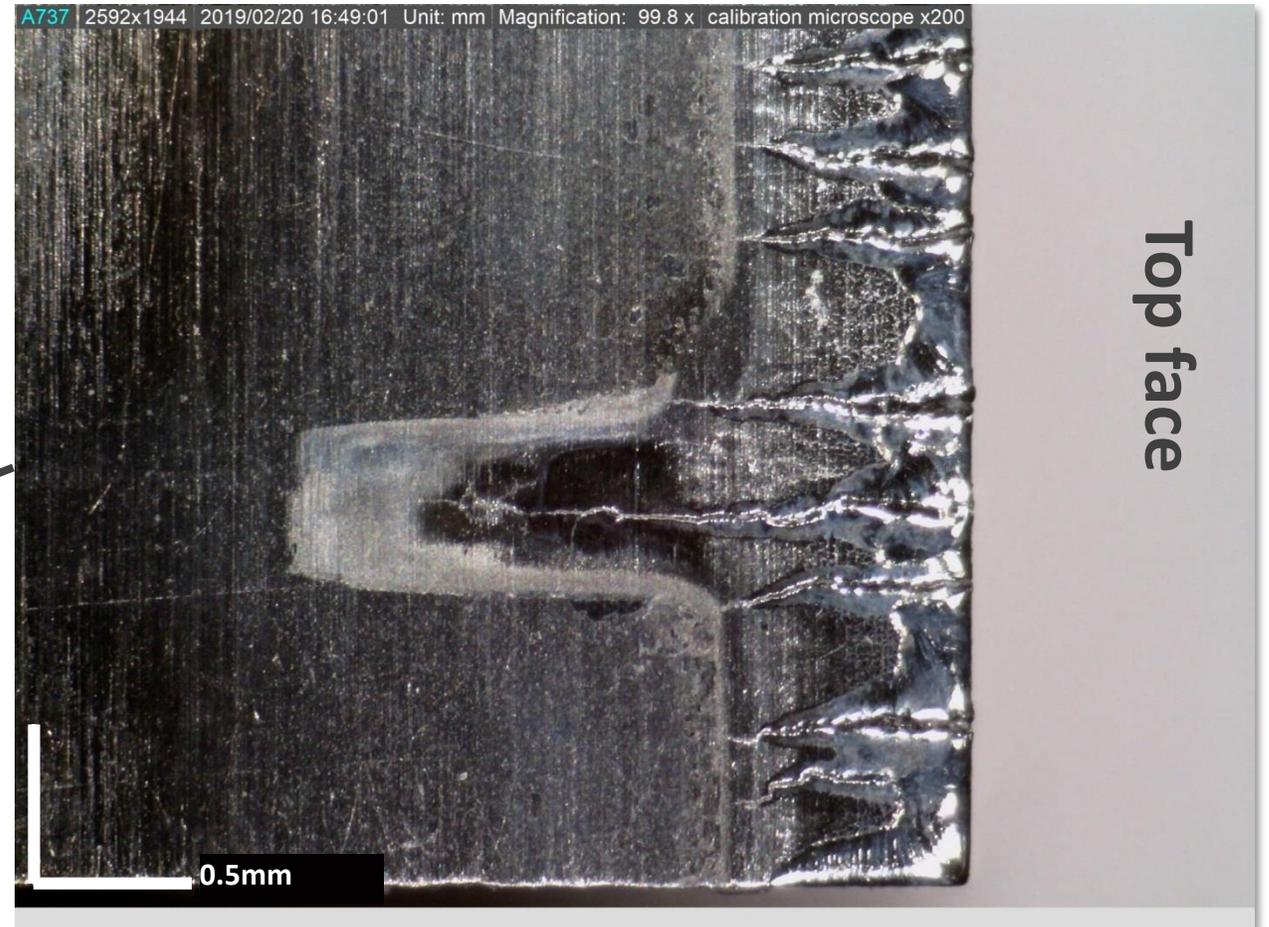
mb 28 - exposed edge at the outer strike point

OHS visible all along the plasma exposed edge, cracks near the strike points

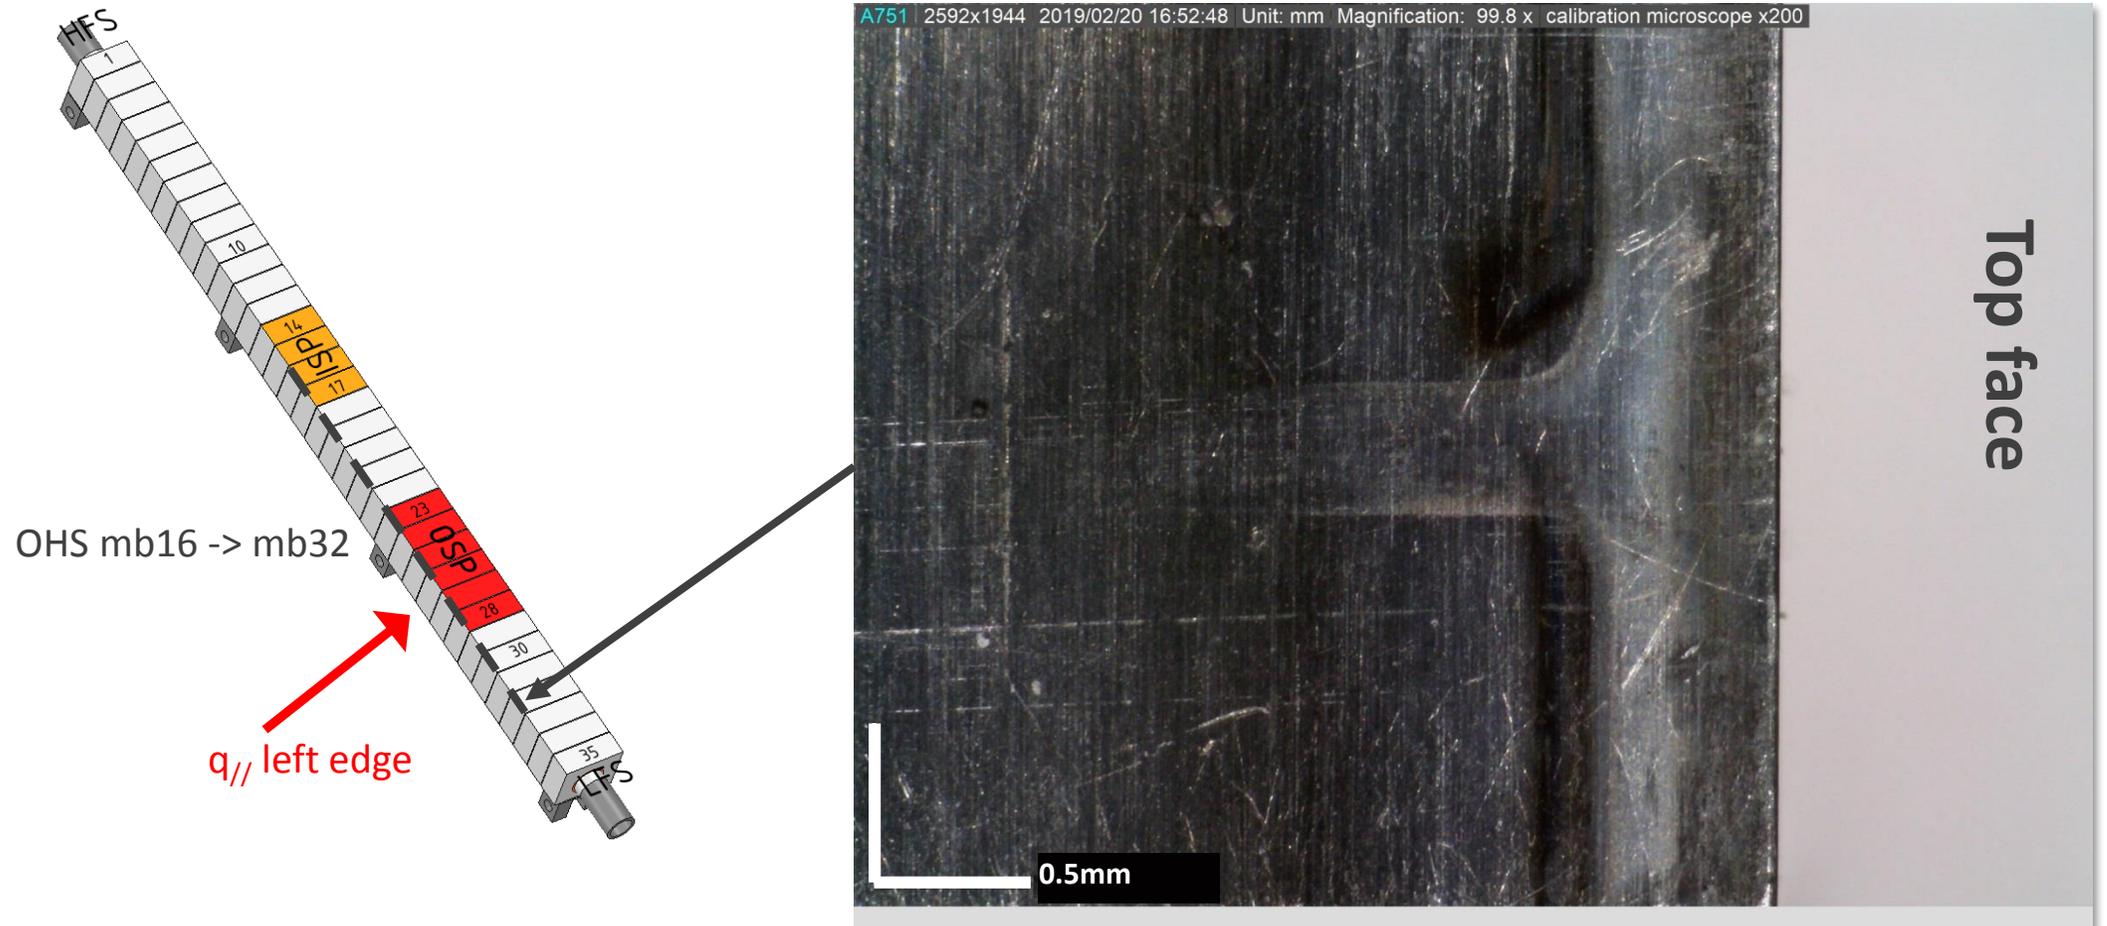
mb 32 - exposed edge far from the outer strike point

- ▶ OHS deeper than misalignment -> exists even with perfect alignment
- ▶ Several OHS patterns:
 - Visual mark with no visible damage far from the strike points
 - Additional melting on non exposed edge (mb 19)
 - Melting and cracks up to the tip of the OHS at both strike points

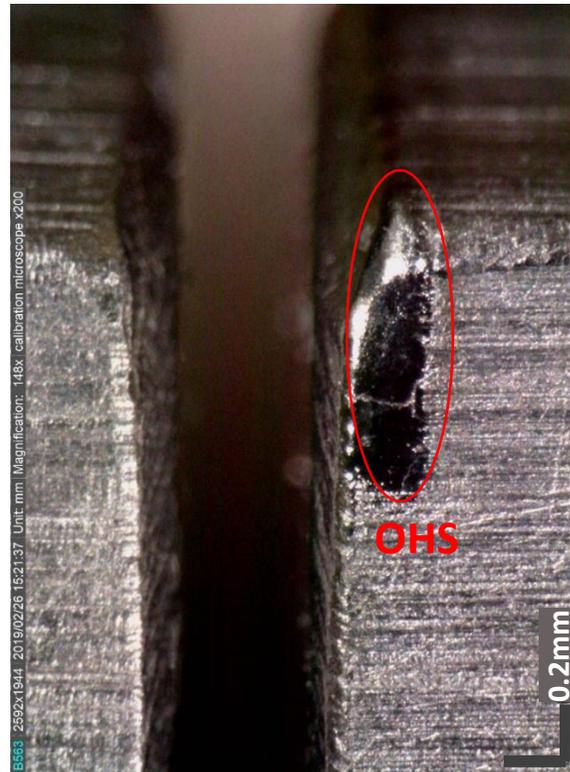
PFU # 8- MB 28 (OSP) - aligned

- ▶ PFU #8 within ITER tolerances and chamfered, but OHS with melting on a corner.
