In-situ leading edge induced thermal damages of melting and cracking on ITER-like W/Cu mono-blocks during long pulse operations in EAST

Tuesday, 11 May 2021 16:40 (20 minutes)

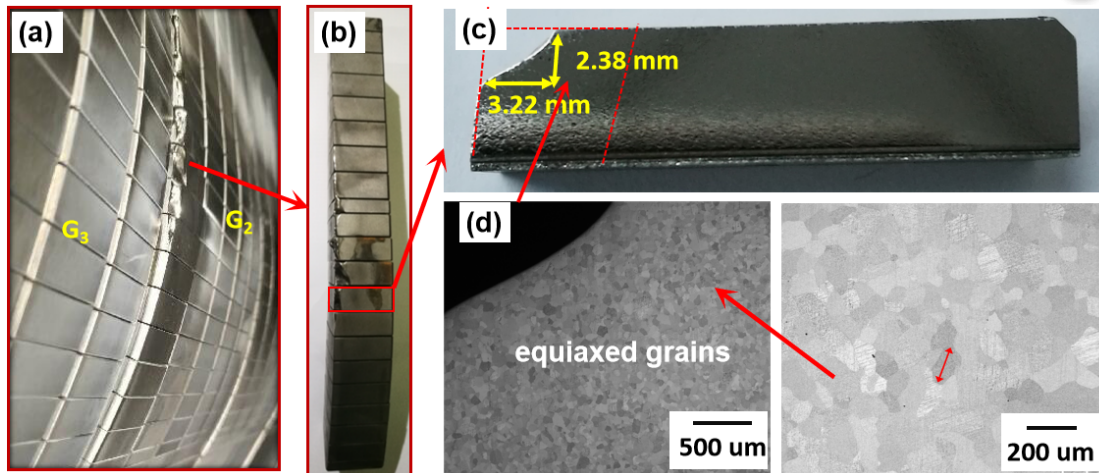
Figure 1: enter image description here

Many in-situ tungsten melting phenomenons were observed by means of distinguishing the droplets ejection from CCD video during plasma discharges. Correspondingly, the post mortem inspection also detected the melting vertical length up to 14 cm around strike point on both inner and outer targets [3]. It is found that all tungsten melting occurred only at the edges of cassette modules where larger misalignment up to 3 mm could be formed during assembly process. Due to low misalignment below 0.3 mm between neighboring monoblocks within each cassette module, no any damage was occurred on the edges of monoblocks within cassette module. The melted layer which was mainly driven by the electromagnetic force was moved either up or down in different conditions, and induced only a few bridge connections along poloidal direction. Such tungsten melting ejected a large number of droplets into the core plasma, and resulted in a sharp increasing of tungsten impurity and power radiation and could eventually lead to disruptions. With droplets ejection and melted layer removal, the melted corner was leaved with a moderate chamfer structure as depicted in Fig.1. From thermal simulation predictions [3], such beveled structures may mitigate the temperature rise in the following shots. Indeed, no evidence showed that the melted monoblock could be melted again in the following plasma discharges. Such melting does not have a big impact on the EAST operations.

Fig.1. Morphology of a typical leading edge induced melting at G2 cassette module in EAST. (a) the in-situ picture of melting in vacuum vessel; (b) the removed melted monoblocks; (c) the beveled leading edges after melted layer movement and droplets ejection; and (d) the metallic inspection on the near surface.

Currently, such leading edge induced damages in EAST may be acceptable to some extent. However, with gradually increasing of auxiliary heating power, such leading edge induced damages are foreseen to become more seriously, will be likely to restrict the long pulse and high performance operations in future. Thus, further efforts should be performed to mitigate such damages, such as optimization of the chamfering structure to protect the leading edges.

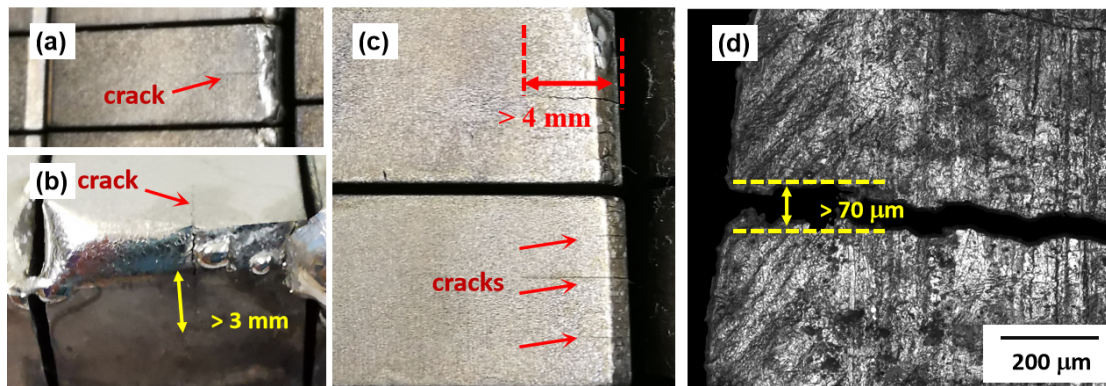
Figure 2: enter image description here

Meanwhile, many new kinds of macro cracks were also found universally on the edges of cassette modules. They were generally horizontal and along toroidal and radial direction. The cracks were initially generated at the edge corners by leading edge thermal loading, and then propagated into deeper and central areas. Fig. 2 is the typical morphology of cracks generated from leading edges on W/Cu monoblocks. The width of such cracks was about 70 μm, while the depth of cracks can reach up to 4 mm. Since the melting occurs, the temperature can reach up to thousands of oC at leading edges. Accordingly, the thermal stress and strain are

in a high level with such high temperature gradient, which could induce such macro cracks. It is noted that such new kinds of cracks were different from the macro cracks along radial direction and poloidal directions during high heat load tests especially under multiple cycles of 20 MW/m² only on surface of such kinds of W/Cu monoblocks [4]. Such cracks seemed to divide W surface at leading edges equally to similar lamellar structures. Because such cracks were parallel to the heat propagation direction and the elongated grains, they probably have little effect on heat transfer. So far, no clear influence on plasma discharges by such kinds of cracks was found in EAST.

Fig.2. Morphology of cracks at the leading edge of W/Cu monoblocks. (a) the top view of a crack; (b) the side view of a crack; (c) the typical multiple cracks; and (d) the micromorphology of a crack.
