# In-situ leading edge induced thermal damages of melting and cracking on ITER-like W/Cu mono-blocks during long pulse operations in EAST

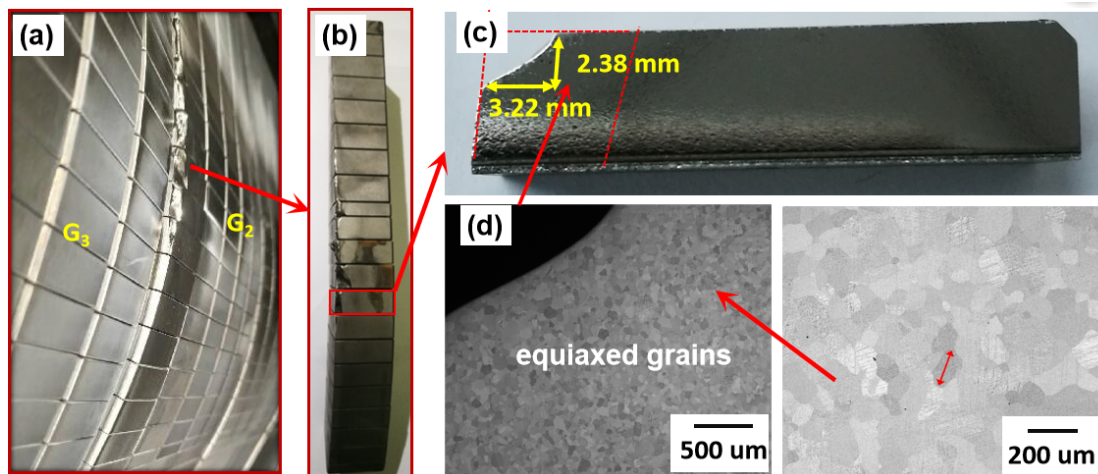
Figure 1: enter image description here

Many in-situ tungsten melting phenomena were observed by means of distinguishing the droplets ejection from CCD video during plasma discharges. Correspondingly, the post mortem inspection also detected the melting vertical length up to 14 cm around strike point on both inner and outer targets [3]. It is found that all tungsten melting occurred only at the edges of cassette modules where larger misalignment up to 3 mm could be formed during assembly process. Due to low misalignment below 0.3 mm between neighboring monoblocks within each cassette module, no any damage was occurred on the edges of monoblocks within cassette module. The melted layer which was mainly driven by the electromagnetic force was moved either up or down in different conditions, and induced only a few bridge connections along poloidal direction. Such tungsten melting ejected a large number of droplets into the core plasma, and resulted in a sharp increasing of tungsten impurity and power radiation and could eventually lead to disruptions. With droplets ejection and melted layer removal, the melted corner was leaved with a moderate chamfer structure as depicted in Fig.1. From thermal simulation predictions [3], such beveled structures may mitigate the temperature rise in the following shots. Indeed, no evidence showed that the melted monoblock could be melted again in the following plasma discharges. Such melting does not have a big impact on the EAST operations.

Fig.1. Morphology of a typical leading edge induced melting at G2 cassette module in EAST. (a) the in-situ picture of melting in vacuum vessel; (b) the removed melted monoblocks; (c) the beveled leading edges after melted layer movement and droplets ejection; and (d) the metallic inspection on the near surface.

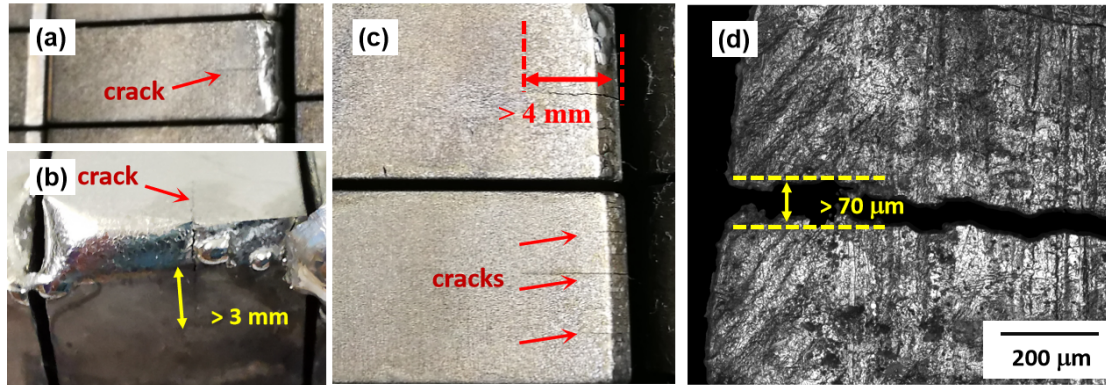
Figure 2: enter image description here

Meanwhile, many new kinds of macro cracks were also found universally on the edges of cassette modules. They were generally horizontal and along toroidal and radial direction. The cracks were initially generated at the edge corners by leading edge thermal loading, and then propagated into deeper and central areas. Fig. 2 is the typical morphology of cracks generated from leading edges on W/Cu monoblocks. The width of such cracks was about  $70 \mu\text{m}$ , while the depth of cracks can reach up to 4 mm. Since the melting occurs, the temperature can reach up to thousands of  $^{\circ}\text{C}$  at leading edges. Accordingly, the thermal stress and strain are

in a high level with such high temperature gradient, which could induce such macro cracks. It is noted that such new kinds of cracks were different from the macro cracks along radial direction and poloidal directions during high heat load tests especially under multiple cycles of 20 MW/m<sup>2</sup> only on surface of such kinds of W/Cu monoblocks [4]. Such cracks seemed to divide W surface at leading edges equally to similar lamellar structures. Because such cracks were parallel to the heat propagation direction and the elongated grains, they probably have little effect on heat transfer. So far, no clear influence on plasma discharges by such kinds of cracks was found in EAST.

Fig.2. Morphology of cracks at the leading edge of W/Cu monoblocks. (a) the top view of a crack; (b) the side view of a crack; (c) the typical multiple cracks; and (d) the micromorphology of a crack.

Currently, such leading edge induced damages in EAST may be acceptable to some extent. However, with gradually increasing of auxiliary heating power, such leading edge induced damages are foreseen to become more seriously, will be likely to restrict the long pulse and high performance operations in future. Thus, further efforts should be performed to mitigate such damages, such as optimization of the chamfering structure to protect the leading edges.
