First observations of tungsten PFCs after the first phase of operation of the WEST tokamak

M. Diez, Y. Corre, E. Delmas, N. Fedorzack, M. Firdaouss, A. Grosjean, J.P. Gunn, M. Missirlian, M. Richou, E. Tsitrone
CEA, IRFM, France

INSPECTION OF THE W-COATED PFCs

INSPECTION OF BULK W ITER-LIKE PFUs

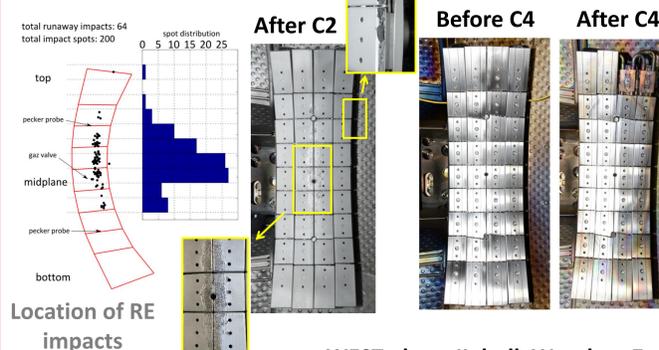
► **Outer limiter (W/Mo coated CFC then bulk W)**

W coating delamination and W melting were observed after C2 and C3 due to impacts of runaway electrons in the absence of a control scheme (C2, C3). For C4, bulk W tiles were developed and proved to be a robust solution.

WEST phase II: bulk W or low-Z BN tiles. Under discussion

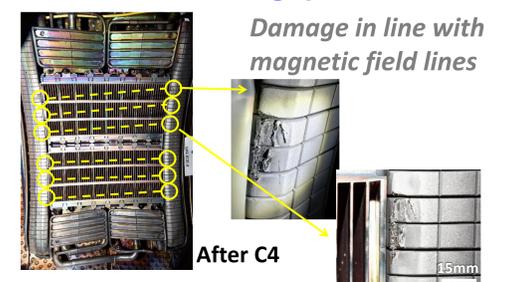
► **Antenna protections (W/Mo coated CFC)**

Damage observed on the antenna protections due to arcing after C4.

WEST phase II: new design under investigation

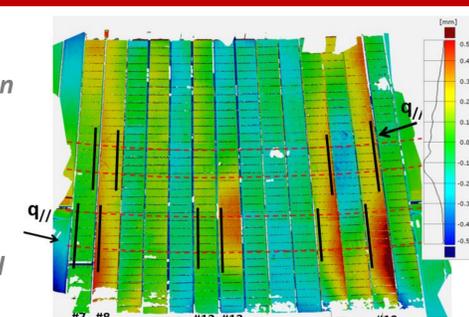
Change of surface morphology

- Erosion/deposition pattern clearly identified
- Cracks observed on every misaligned PFU with ISP/OSP exposed leading edge. Some cracks formed during C3, some others during C4
- A change of surface morphology appeared near the exposed leading edge (OSP only). This was also detected by IR camera during operation [A. Grosjean et al., Nuc. Mat. And Energy 27, 2021]

Metrology map obtained by laser scanning showing the relative misalignments of the PFUs with their theoretical position (CAO model) during C4. The black lines indicate the cracks location
