Italian National Agency for New Technologies,  
Energy and Sustainable Economic Development

# RADIATION TESTS ON COMPONENTS FOR THE ITER PROJECT AT THE CALLIOPE FACILITY

J. SCIFO<sup>1</sup>

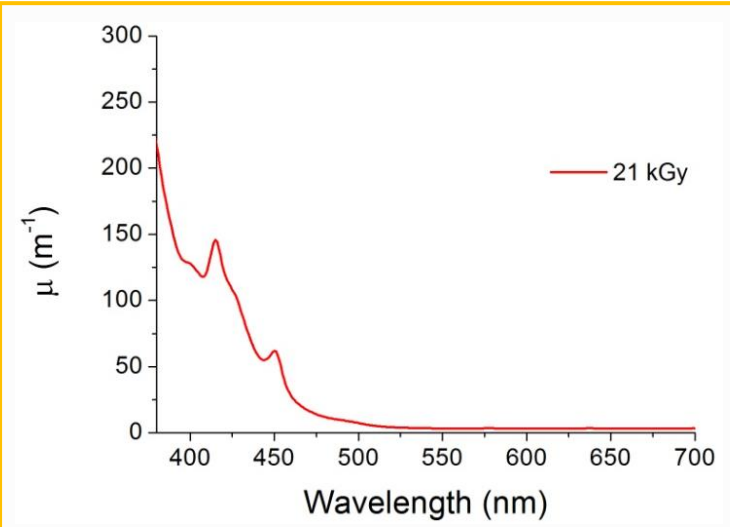
Stilbene crystal:  
 ✓ heavy damaged also at low doses (21 kGy)

**Not suitable for ITER environment**

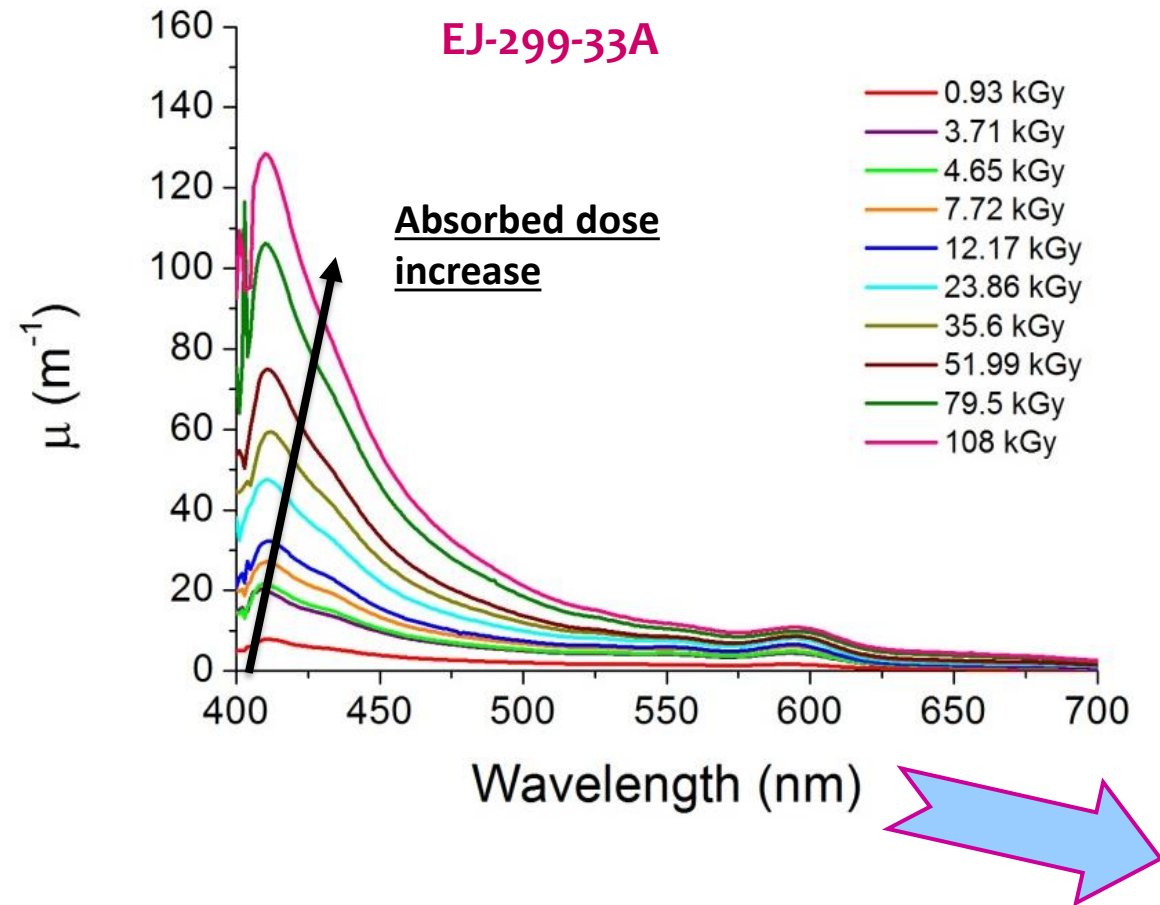
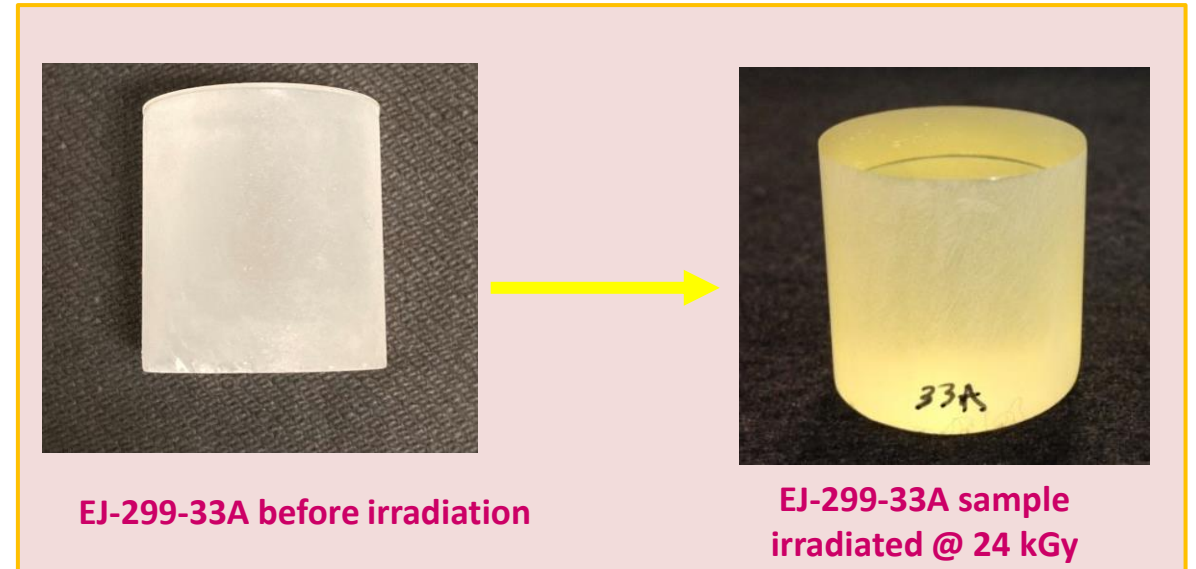
- ✓ radiation damage @ 420nm (emission wavelength peak) linearly increases with the absorbed dose
- ✓ no saturation is reached

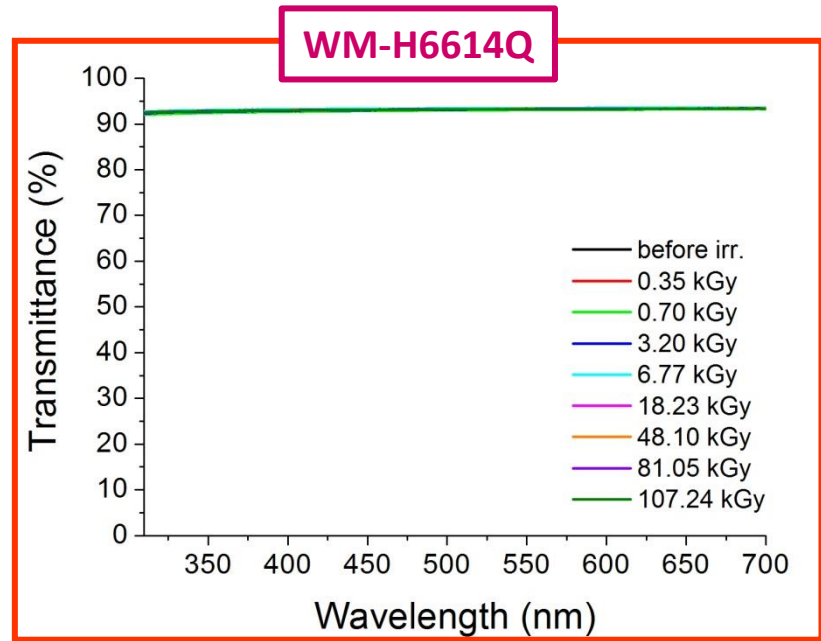
**Synthetic silica:  
no modification  
up to 107 kGy!**

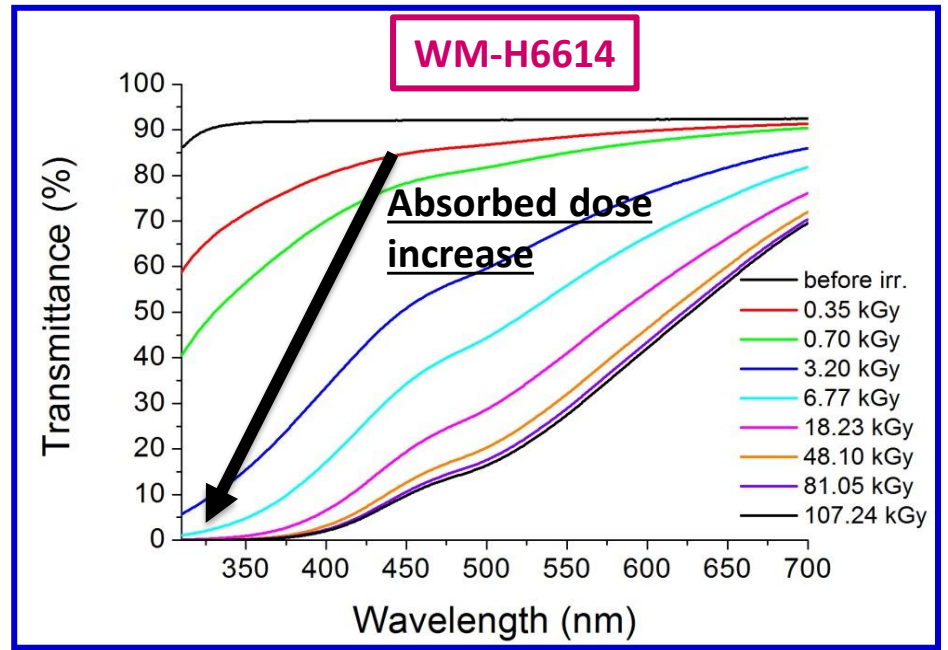
**Borosilicate glass:  
seriously damaged**

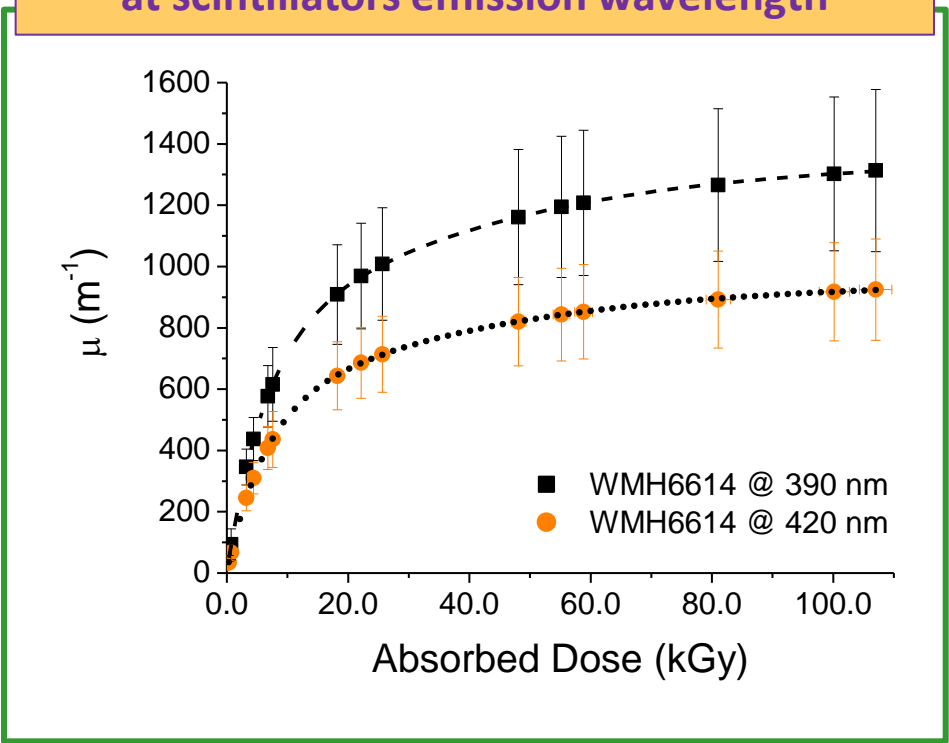
- ✓ Saturation above 50 kGy
- ✓ heavier damage at 390 nm  
(Stilbene emission peak wavelength)

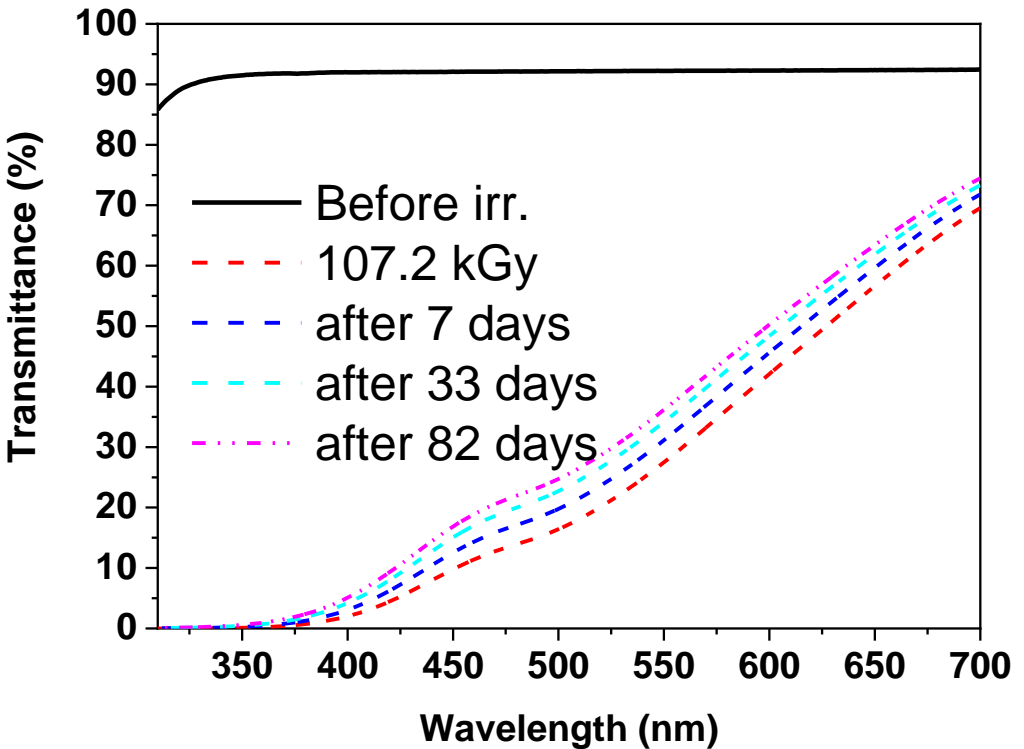
- ✓ No significant improvement in the range of interest after 3 months

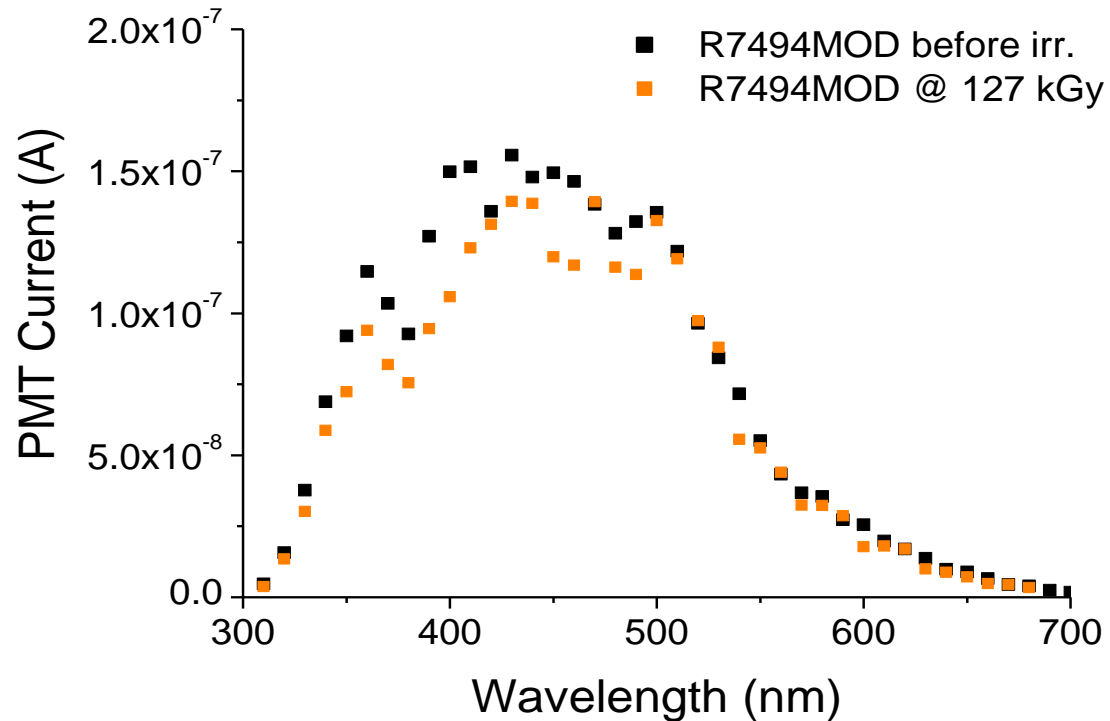
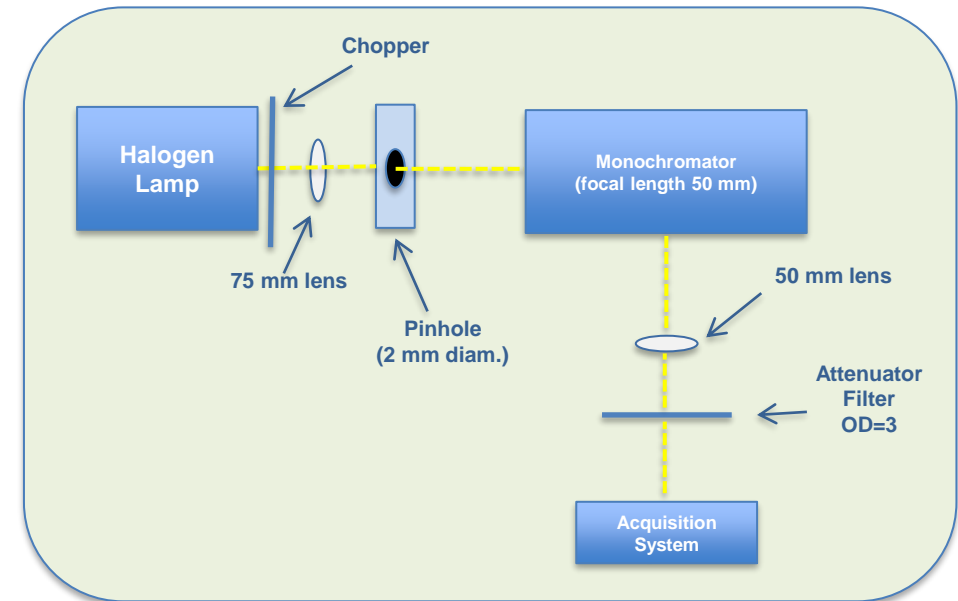
- ✓ Slight PMT current decrease up to 127 kGy absorbed dose (same results for all PMTs)
- ✓ Hamamatsu PMT current around 10 times higher than ET PMTs

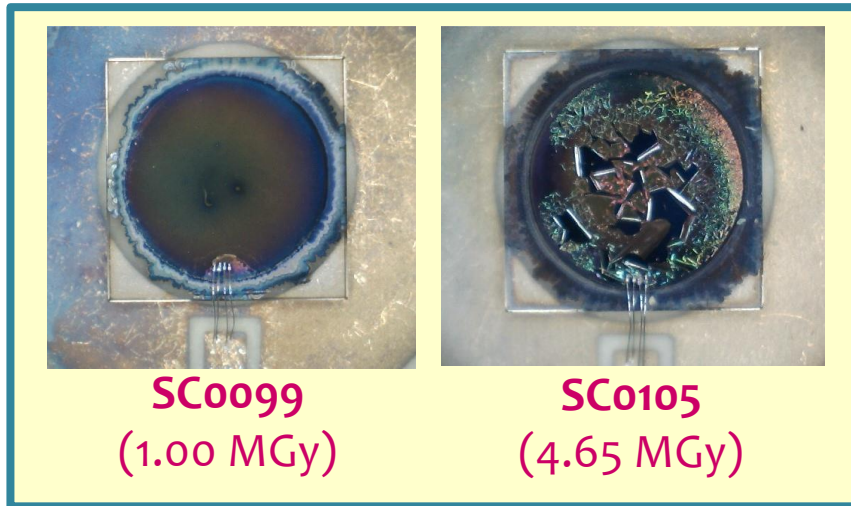
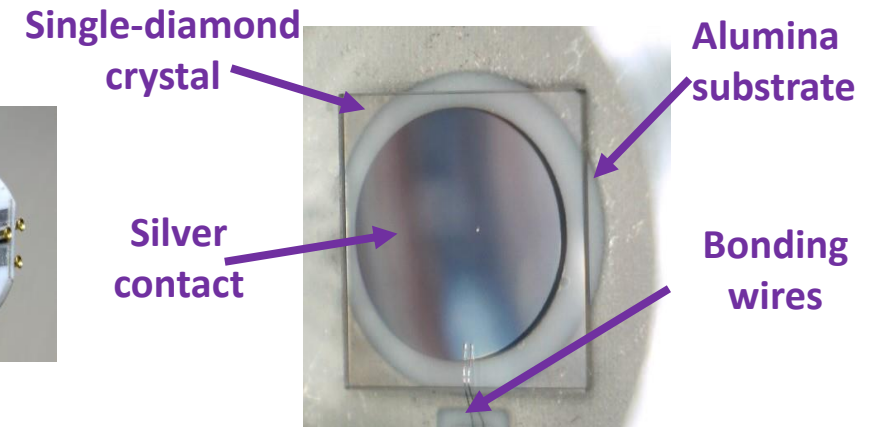
*Silver layer seriously peeled and detached at the highest absorbed dose and almost intact up to 1 MGy*

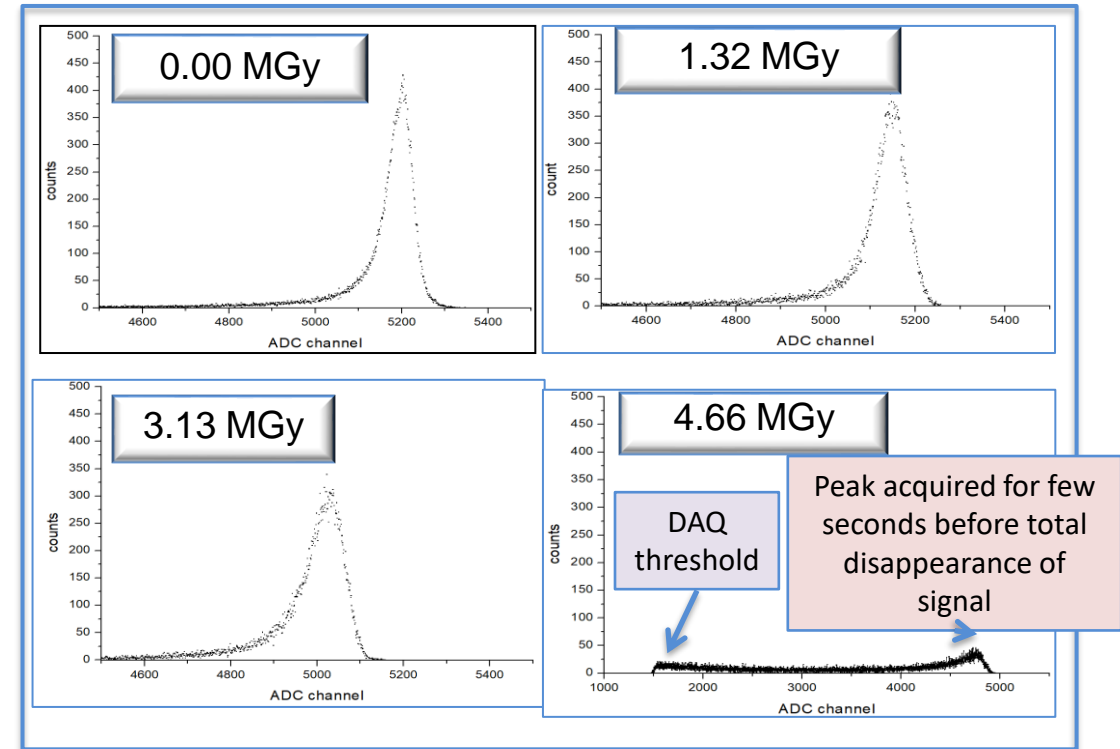
- Single-crystal diamond detectors have an acceptable behaviour up to 3.13 MGy but with a partial damaging induced by gamma radiation.
- At 4.66 MGy detectors were broken.

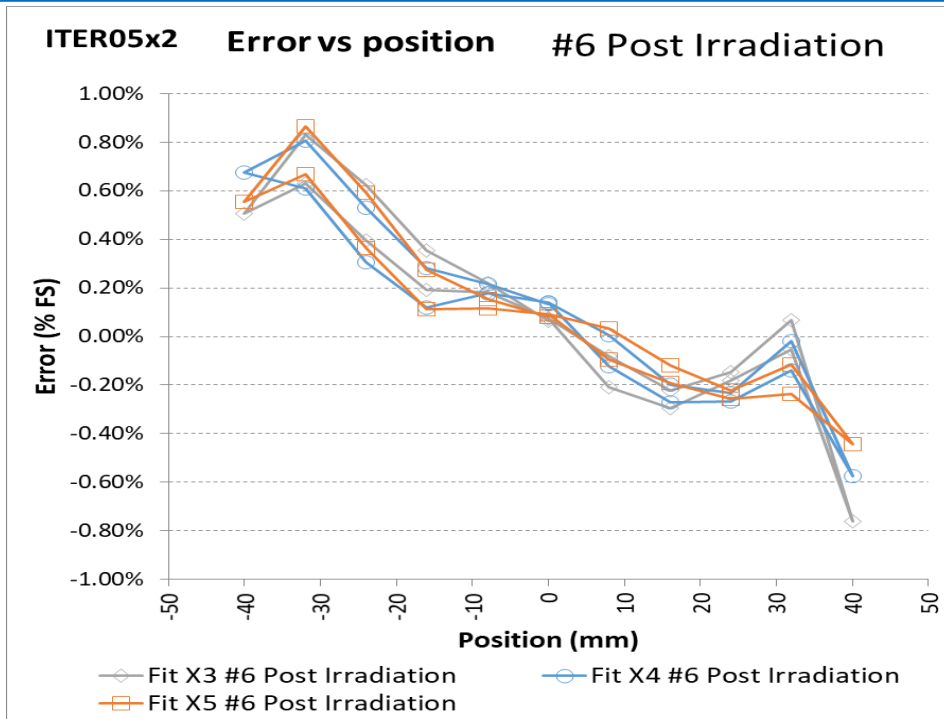
Calibration curve variation after irradiation

- No significant damage or degradation have been detected.
- Some darkening appeared on the metallic surfaces, but the sensors have passed the accuracy verification.
- **Maximum deviation lower than 1% of the Full Scale (FS)**
- **Minimum modulation value of 8.7% higher than 6%**

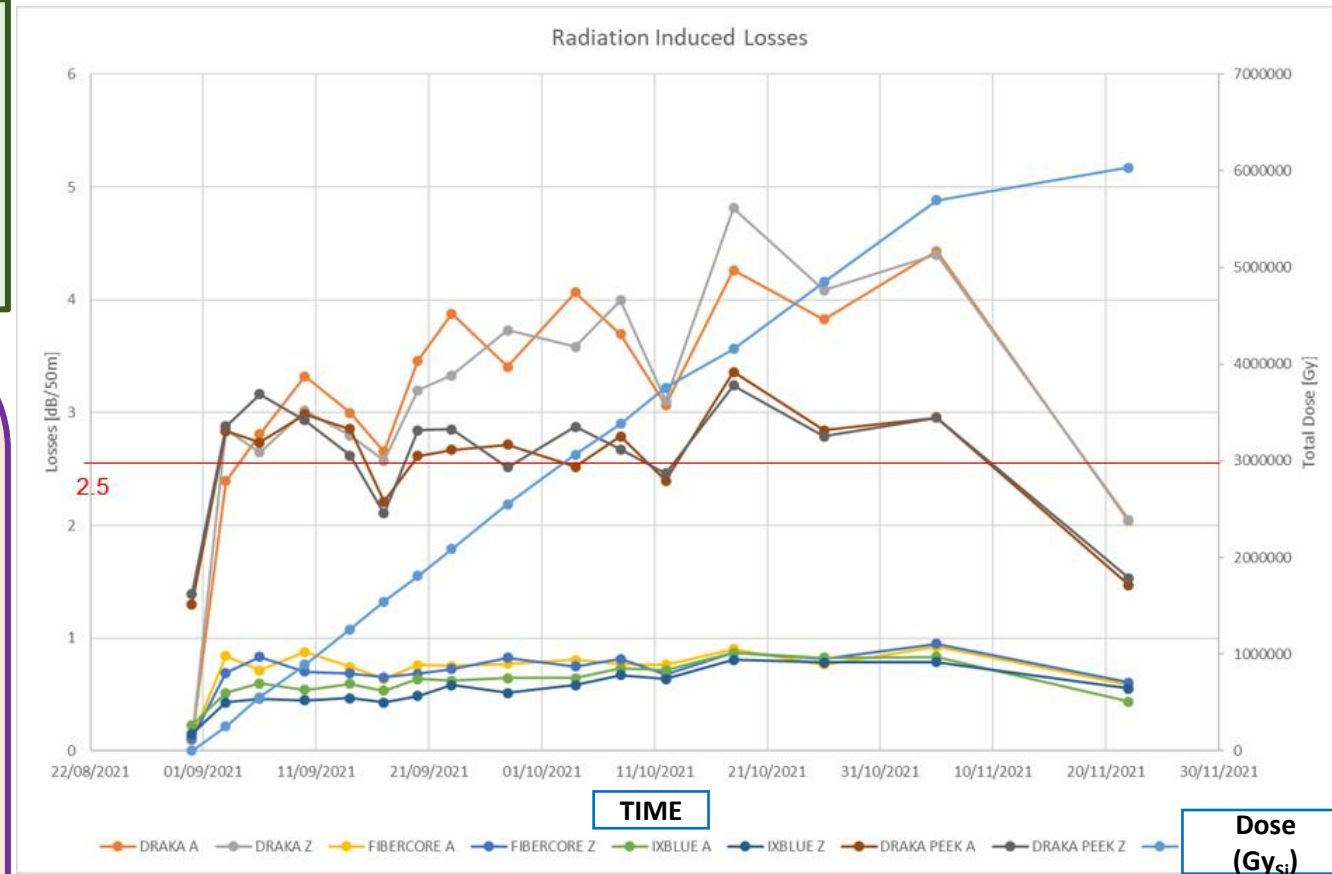
- To measure the fibre performances, an Optical Time Domain Reflectometer has been used.
- The performances of tested optical fibre spools have been measured at regular intervals during irradiation and at the end of the irradiation test
- No significant damage or degradation have been detected. The insertion losses are below the fixed limit.
