Characterization of transient heat flux induced damages of tungsten PFCs during plasma disruption in EAST

Institute of Plasma Physics, Chinese Academy of Sciences

3-6 Sept 2024, IO Headquarters

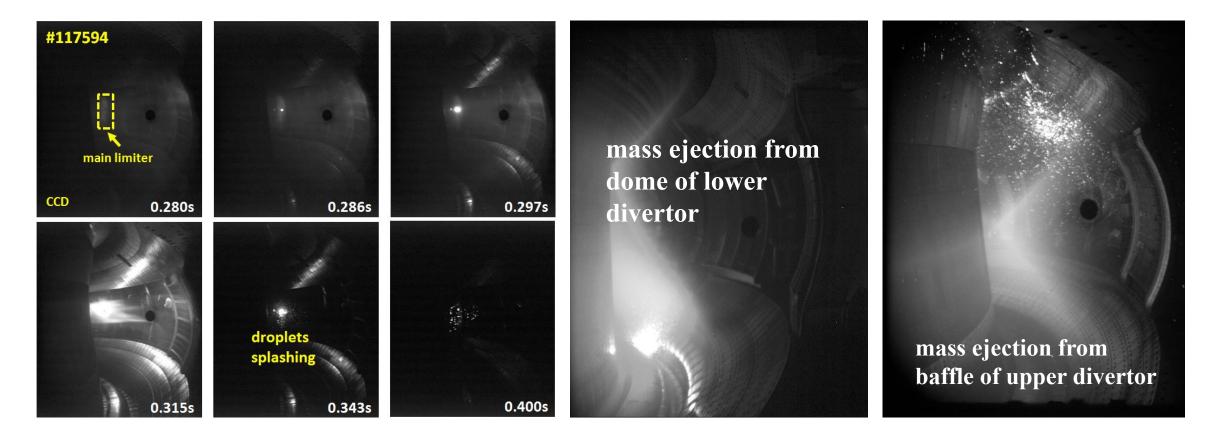
Observation of disruption induced splashing of PFC

- Mass ejection/Splashing from main limiter when disruption events occurred was repeatedly monitored by CCD camera during plasma startup phase in each plasma campaign
- Same phenomena were also found on the dome and baffle of divertor, and the first wall

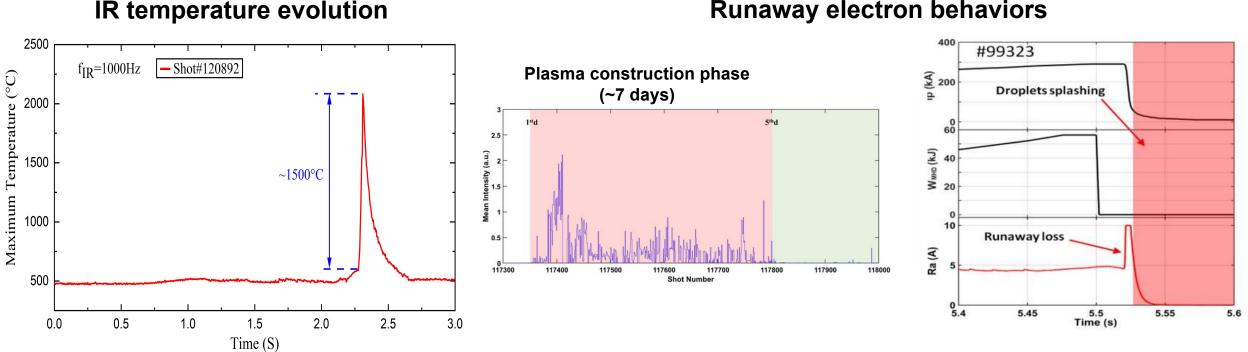
Analysis and confirmation of such transient events

- IR temperature evoluation confirmed it was a transient heat loading effect
- The time of runaway electron loss mathchs well with the time when the splashing occured
- Multiple runaway electron loss events often occurred at the initial phase with plasma construction

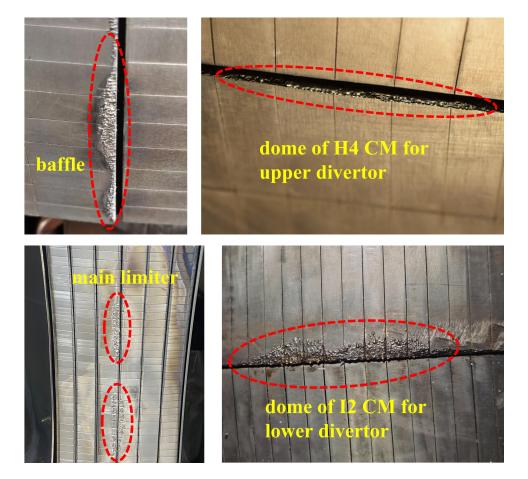
Post mortem inspection of transient heat flux induced damages

Η р Melted PFCs with macrocracks

Multiple PFCs transient heat flux induced damage, including melting and cracking were found universally

Damages often occur on the leading edge area, and the protruded part

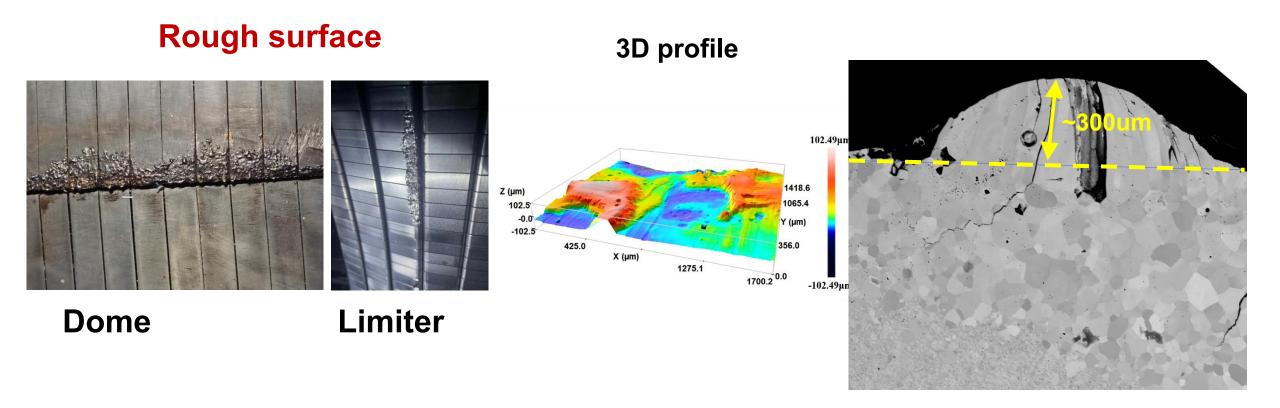
4.1 Rough surface morphology

■ Transient heat flux induced melting often leaves a rough (wave) surface

■ Typical particles were protruded with a height 0.2 mm~0.5 mm

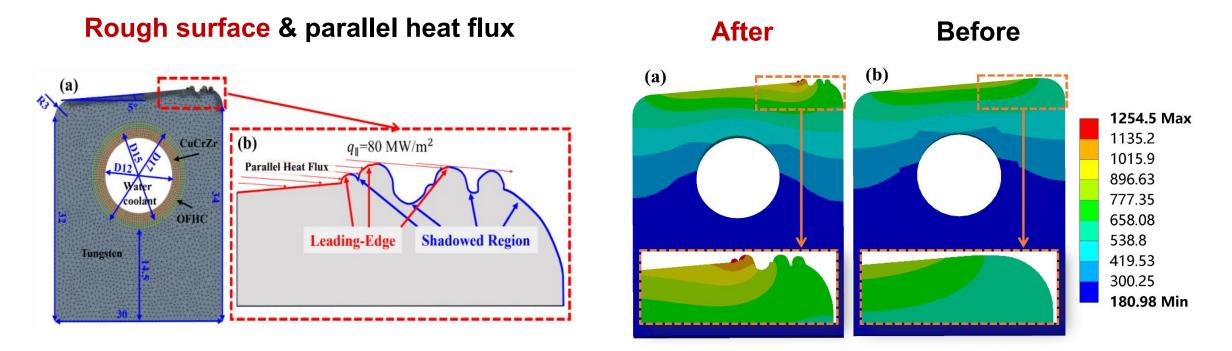
Rough morphology imposed leading edge issue

- Rough (wave, ±0.5 mm) surface forms new leading edge induced thermal effect in tokamak conditons
- Thermal analysis shows that such wave surface seems to have neighble influence on lower area, but leads to obvious temperature increasing on the near melting area, decreasing the heat exhaust capacity of steady state heat load

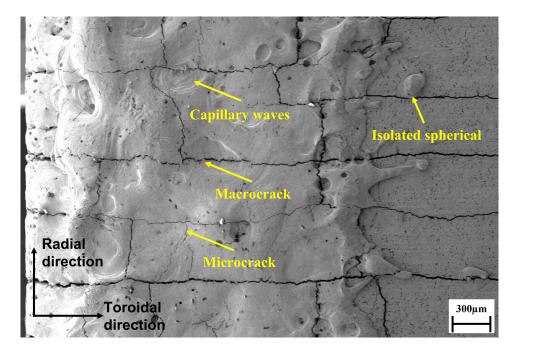
Melting zone

Net-like (~0.3mm*~1mm) cracks are observed on melting region on tungsten surface and can extend along toroidal direction up to 1~2 cm

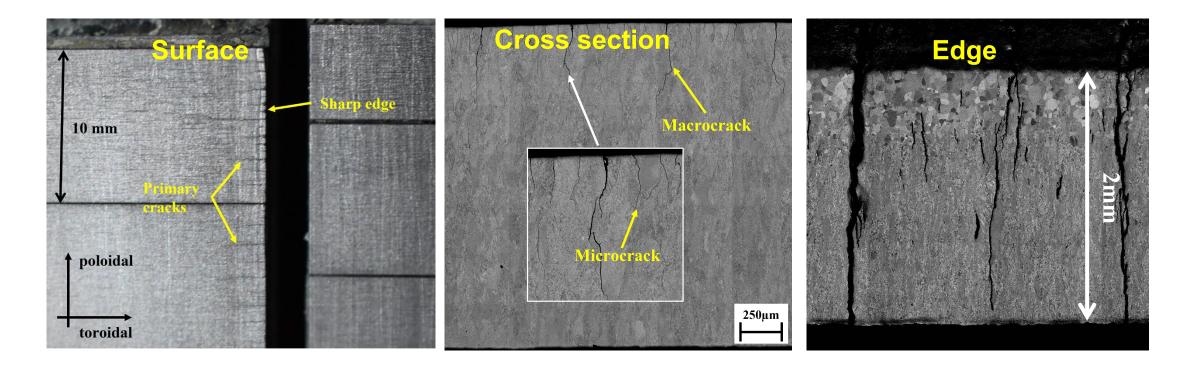
4.3 Dense cracks at leading edges

- Macrocracks and microcracks are observed on melting region and macrocracks can extend along toroidal direction up to 1~2 mm
- Macrocracks at leading edges on melting regin can extend to the W/Cu joint (W thickness ~2mm)
- Microcracks can be observed on cross-section inside W plate

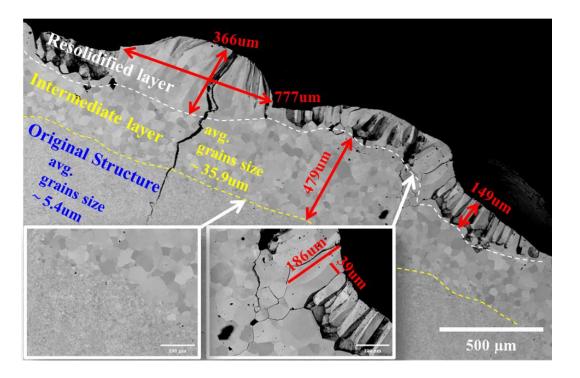
Cross-section of melted area

■ Three layers of grain crystal:

(1) Columnar grain (100-300 µm, recrystallization → brittle),
(2) Equiaxed grain (300-500µm, recrystallization → brittle)
(3) Original grain (deeper zone, large temperature gradient from 3410°C to ~1200°C further confirm transient event)
