**30<sup>th</sup> IAEA Fusion Energy Conference**

# **Recovery of ITER Sector Modules from Critical Issues**

**Chang Hyun NOH, A. Bonito Oliva, N. Koizumi, and E. Rodilla Hoyo**

15 Oct. 2025

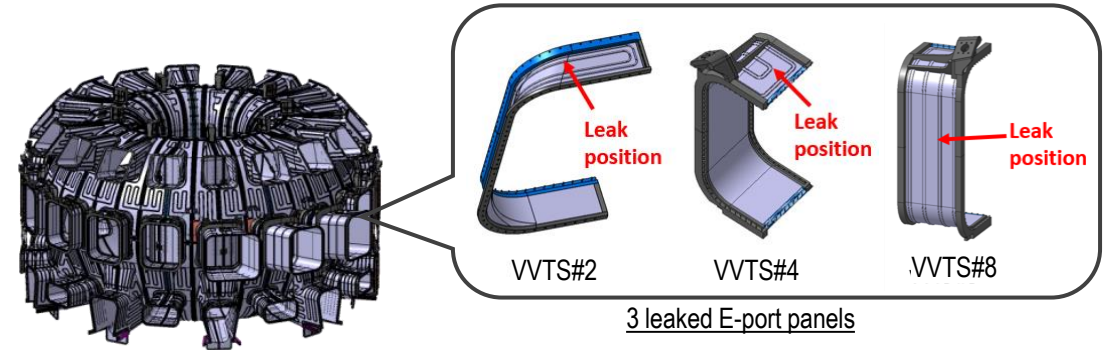
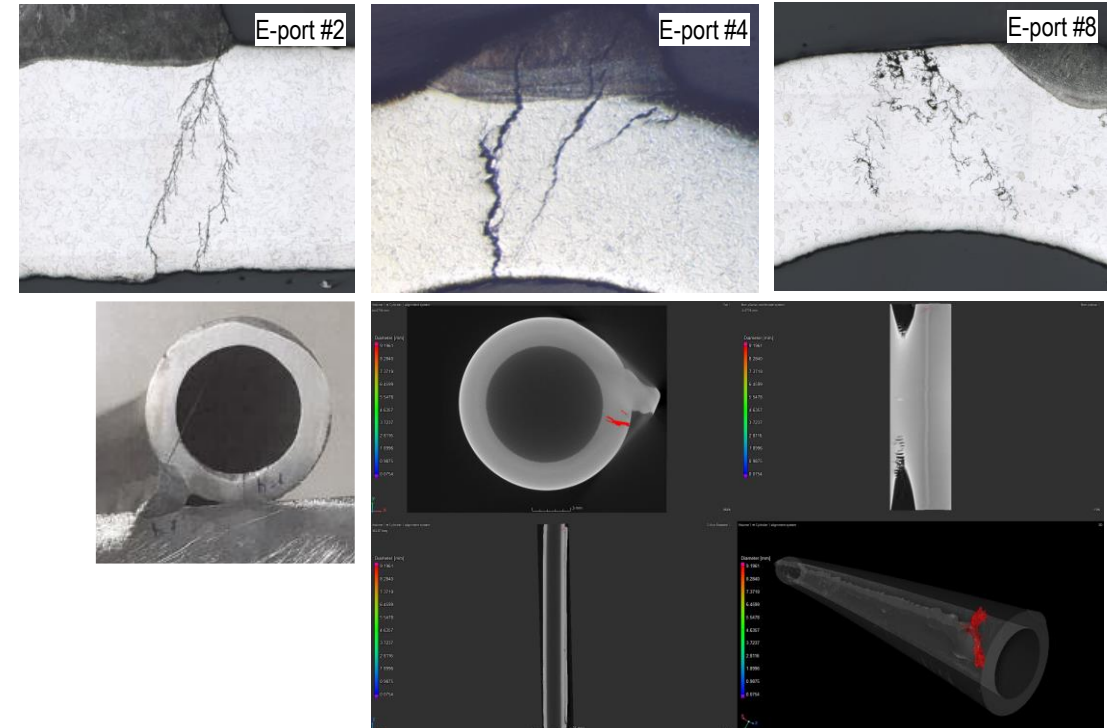
- ✓ Leak detected on the three EQ shroud panels during site acceptance test
- Total number of TS panels : VVTS 200 pcs, CTS 320 pcs

- ✓ Intergranular crack observed by metallographic examination
- ✓ High contents of chloride detected on the pipe surface (chemicals from **Ag coating\*** process became trapped underneath of the pipe weld)
- ✓ Residual stress due to pipe bending and pipe welding

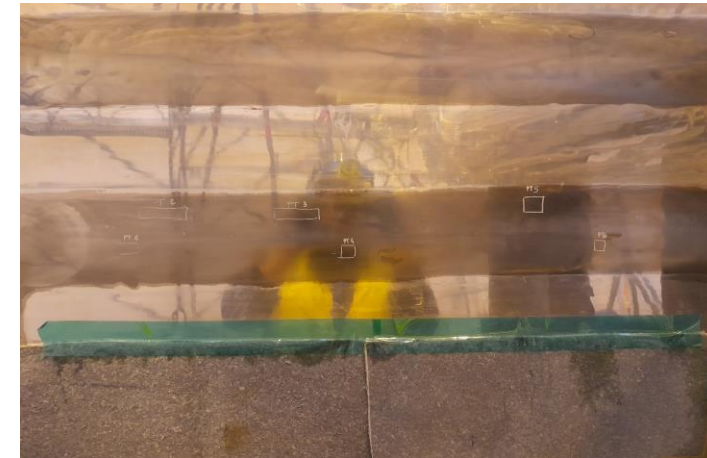
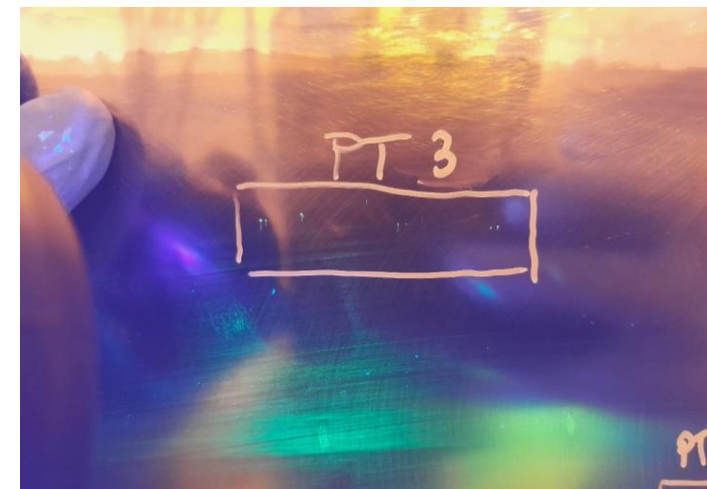
**Panel** : SCC propagation was detected only in the leaking panel.

Luminescent PT and Metallographic test on the panel-to-panel weld joint (considered susceptible to SCC) : no crack observed.

→ Replacement of pipes in all thermal shield panels

→ Remanufacturing of EQ shroud and repair of other panels.

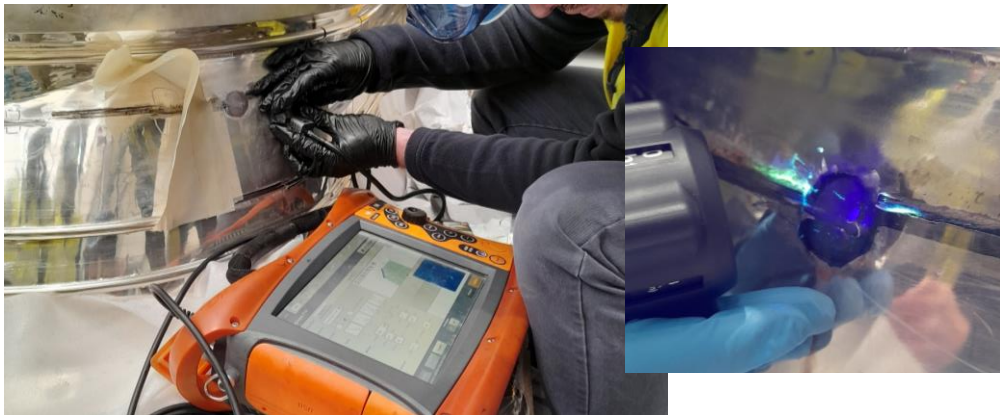
Systematic visual inspection & FPT

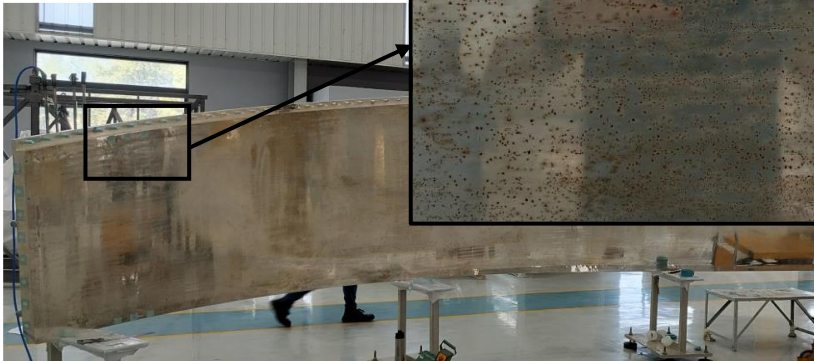
- ✓ Numerous corrosion spots were observed in two VVTS panels that had been shipped to the supplier for repair.
- ✓ Upon investigation, TS panel working group confirmed that galvanic corrosion happened due to
  - presence of Chloride under Ag coating,
  - defects of Ag coating (pin-hole, scratch, etc.) resulting from thin Ag coating (3mm thickness instead of 5-10mm), and
  - high humidity during shipping and/or by opening package at Indian custom at port.

Galvanic corrosion in two panels

→ Ag coating removal and surface buffing with  $R_a < 0.1 \mu\text{m}$

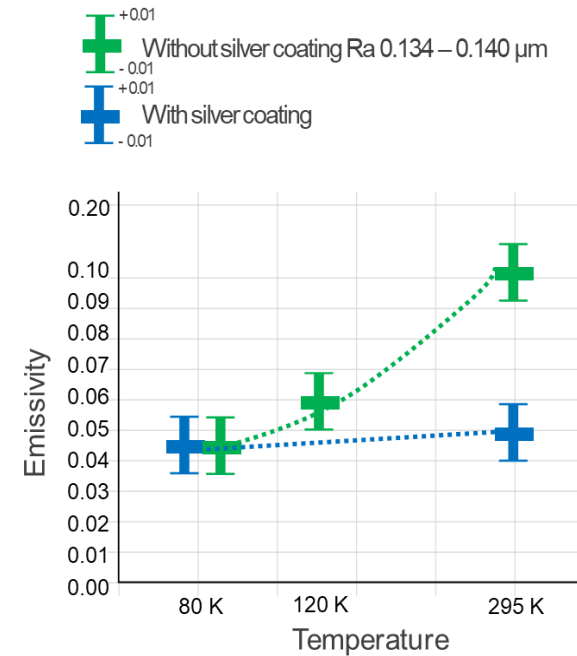
Polished stainless steel with a surface roughness of less than  $0.2 \mu\text{m}$  can exhibit emissivity comparable to that of a previously silver-coated surface

Emissivity test result

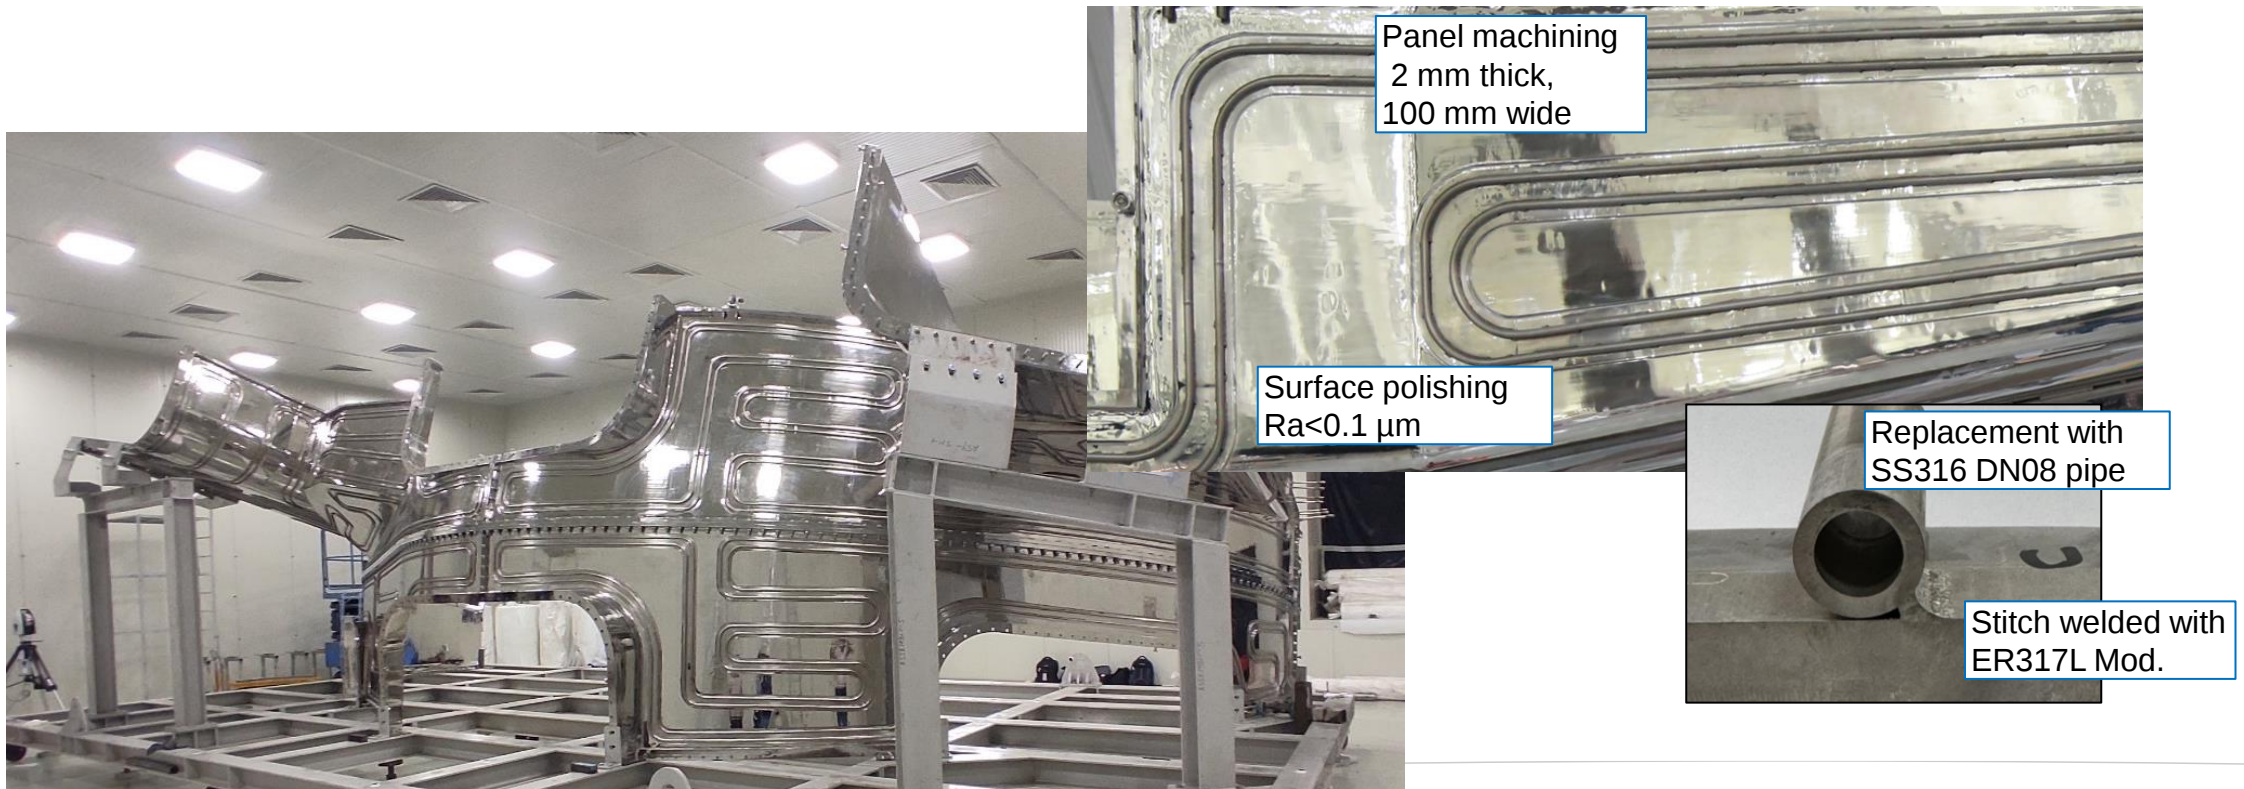
- The success of repair was confirmed geometrically by the pre-assembly test and survey.
- Thermal shield repair approach shortened the time of recovery from the critical issue of thermal shield as mentioned previously.

VVTS Outboard right-hand segment repair completion and key element of repair

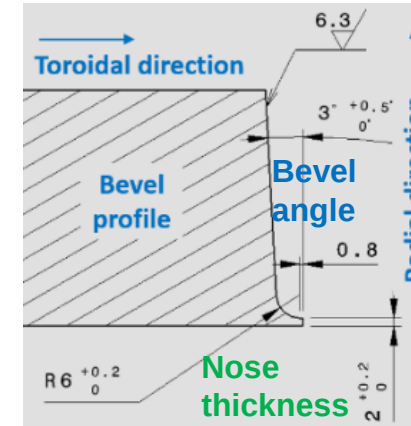
- ✓ Deformations on the VV Sector field joint bevels during sector manufacturing not compatible with the VV Sector welding requirements.

VV Field Joints bevel tolerances accuracy (especially for automatic system)

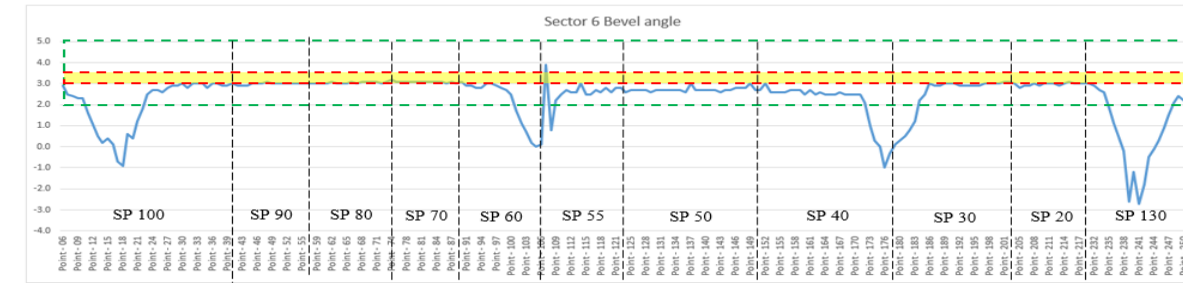
### Bevel angle

- ✓ Toroidal welding shrinkage from manufacturing process\* in consequence, radial/toroidal waviness, slope in bevel profile

- ✓ Final machining at Segment level
- ✓ Segment installed on Assembly Jig and Welded together
- ✓ Welding shrinkage not compensated.
