# Recovery of ITER Sector Modules from Critical Issues

Chang Hyun NOH, A. Bonito Oliva, N. Koizumi and E. Rodilla Hoyo  
ITER Organization  
changhyun.noh@iter.org

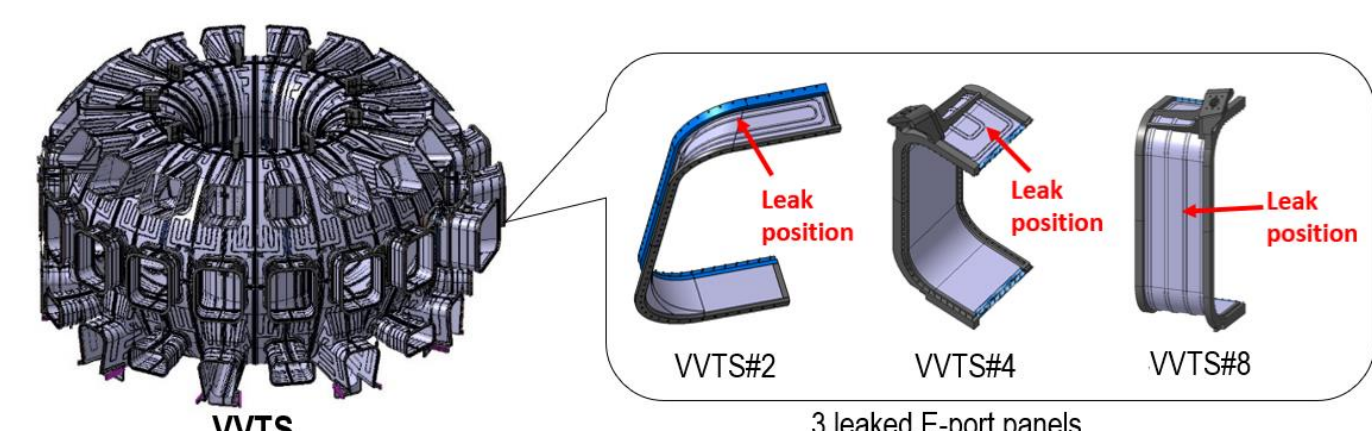
- Intergranular crack observed by metallographic examination
- High contents of chloride detected on the pipe surface (chemicals from Ag coating process became trapped underneath of the pipe weld)
- Residual stress due to pipe bending and pipe welding

3 leaked panels out of 500 TS panels

- Presence of chloride and SCC crack  
→ Systematic visual inspection / FPT, Targeted the pipe welded area
- Grinding can't guarantee perfect removal of chloride  
→ Panel 2 mm thick layer in the vicinity of the pipes
- Potential risk of SCC and corrosion from long-term storage  
→ Use of 316L grade pipe and ER317L Mn Mod filler
- Defects on Ag coating layer caused by exposure to high humidity conditions  
→ Ag coating removal and surface buffing with  $Ra < 0.1 \mu m$   
\*Polished stainless steel ( $Ra < 0.2 \mu m$ ) exhibit emissivity comparable to a silver-coated surface

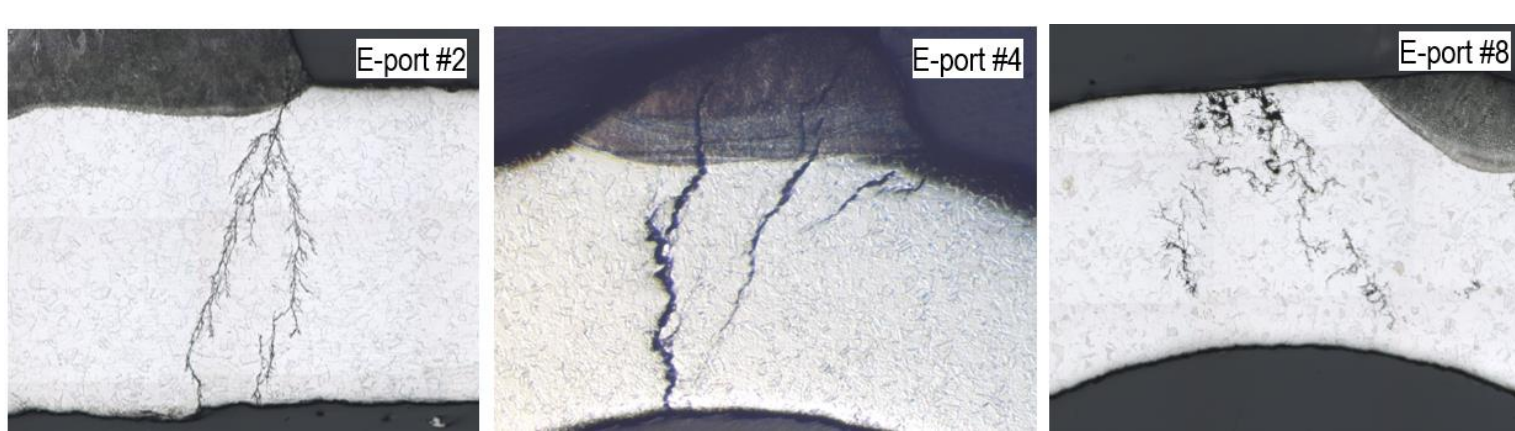
Pipe crack from leaked panels

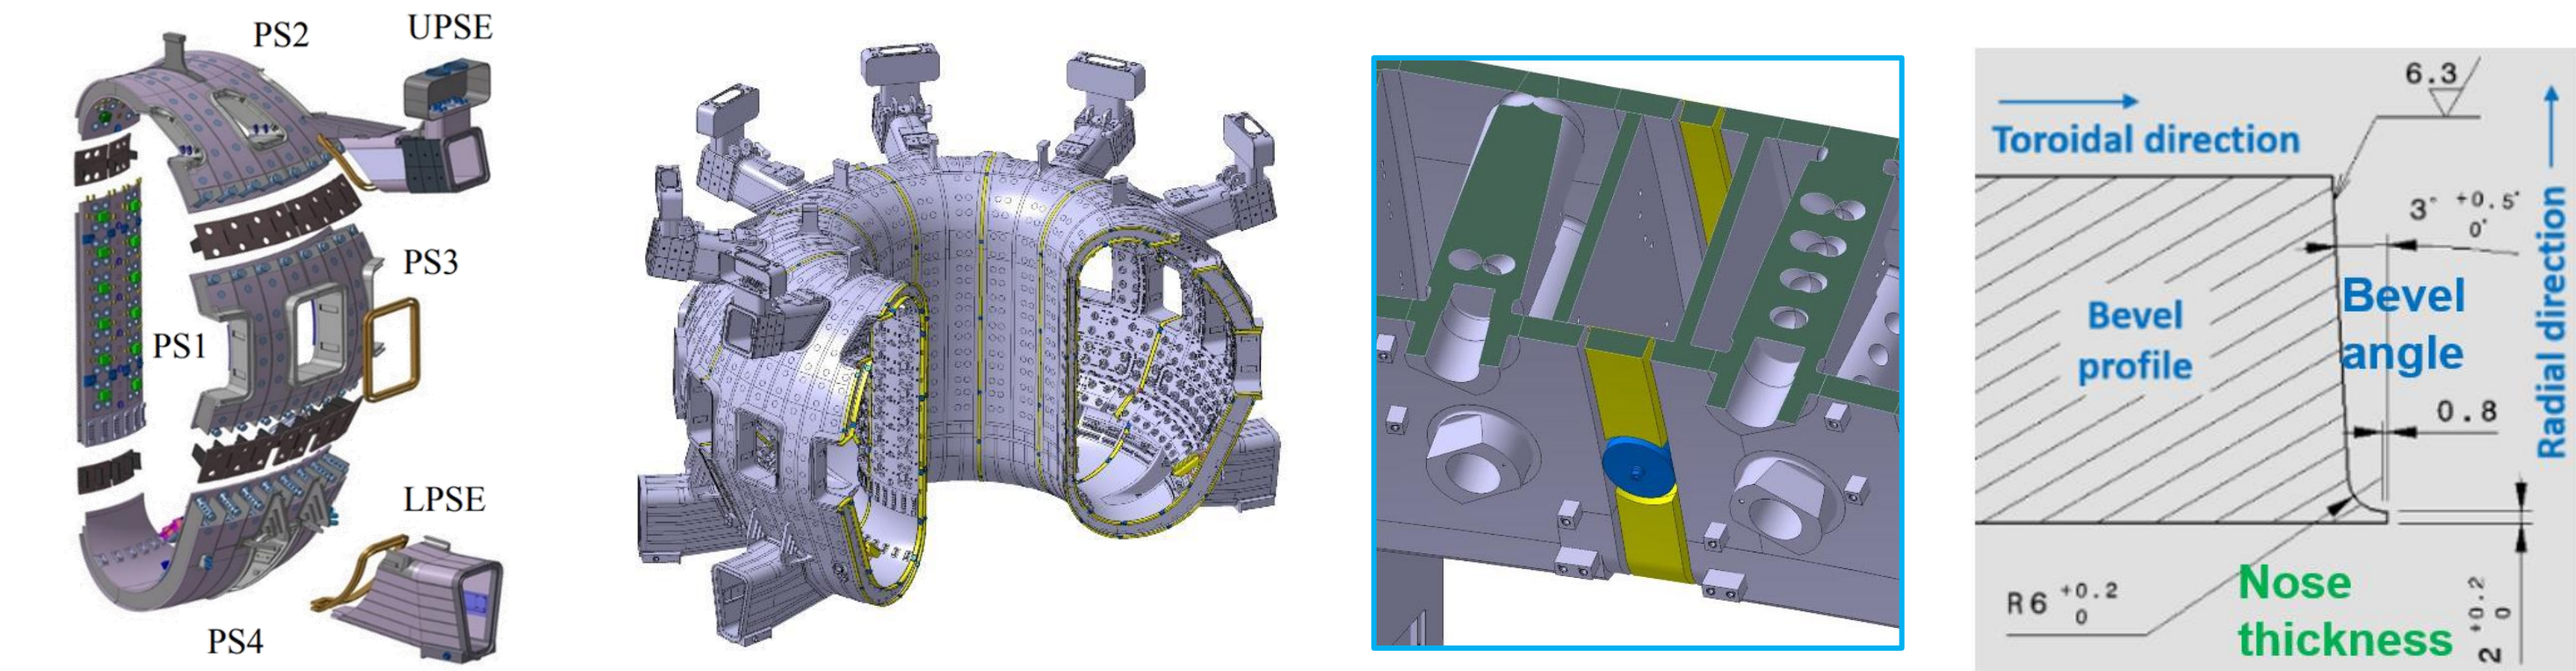
Toroidal welding shrinkage from manufacturing process causes radial/toroidal waviness, slope in bevel profile.

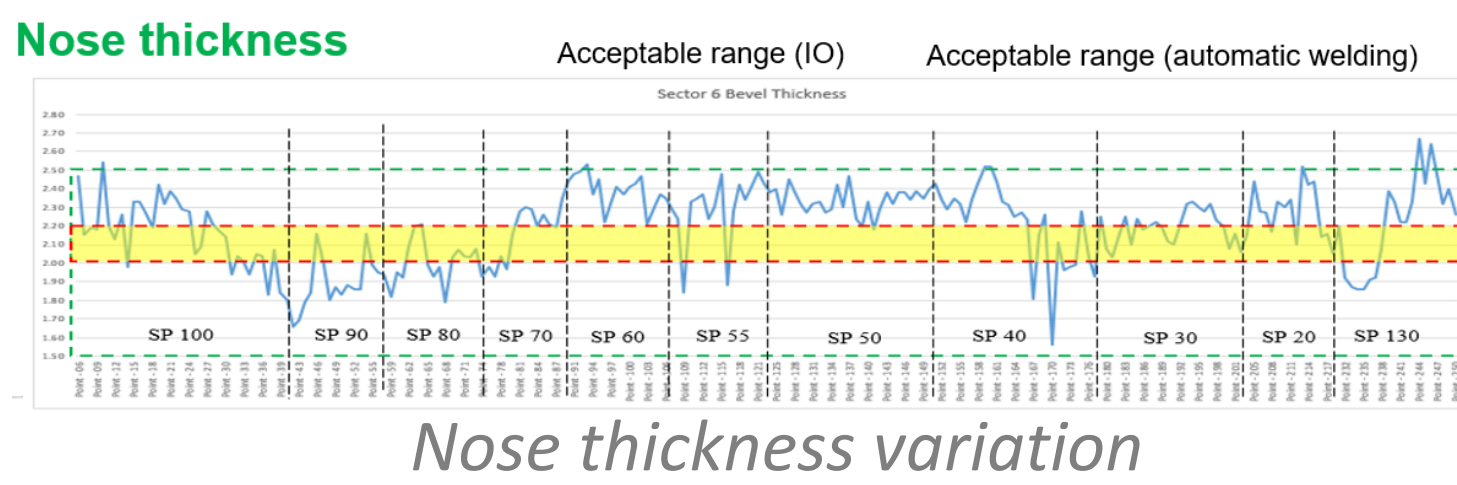
- Difficulties to adapt the welding machine to trajectory changes / splice plate customization and alignment / welding machine operation
- Potential clash with welding machining and NDE tooling.

Nose thickness variation
