# RECOVERY OF ITER SECTOR MODULES FROM CRITICAL ISSUES

C.H. NOH, E. Rodilla Hoyo, N. Koizumi and A. Bonito Oliva

ITER Organization

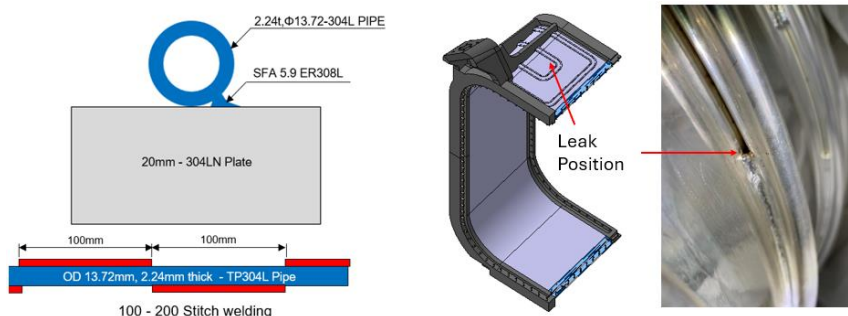
In December 2021, during acceptance tests of the VVTS panels, three leaks were found in the DN8 2 mm thick cooling tube on the three Equatorial Ports (E-ports) of VVTS#2, #4 and #8 (Fig. 2). In May 2022, a preliminary

FIG. 2. Pipe stitch welding and leak position on the VVTS E-port shroud

root cause analysis (RCA) indicates that these leaks were caused by stress corrosion cracking (SCC) in the cooling pipes, which had been welded onto the VVTS panels for cooling purposes. Further detailed RCA was required because an impact to the project is significant if SCC happens.

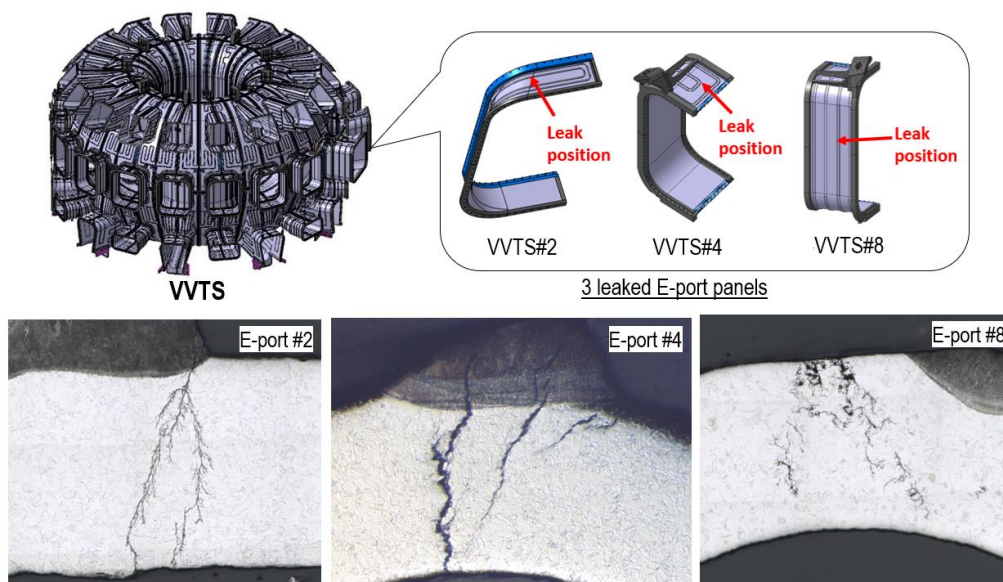
Detailed metallographic examination of pipe specimen from leak panel was carried out. Computed Tomography (CT), Scanning Electron Microscopy (SEM) confirmed SCC on pipe crack in July 2022 [4-5]. In the cooling piping of the E-port, SCC with a depth exceeding the 2.2 mm pipe wall thickness was observed (Fig. 3). In addition, high contents of chloride were detected on surface of pipe. On the other side, considering that the leaks occurred exclusively in the E-port pipes, which have a total length of 1 km, while no leaks were observed in other components despite their total pipe length of approximately 23 km, SCC was suspected to be a phenomenon specific to the E-ports.

Therefore, further detailed studies were performed on the cooling piping of other components. SCC was detected on these pipes in September 2022, however its depth was generally below 0.3 mm. Meanwhile, in the TS panels, only one location at the E-port exhibited propagated SCC with a depth of 2.4 mm. These facts indicate that the E-port provides the necessary conditions for SCC, namely residual stress and the presence of chlorides. Consequently, it is anticipated that SCC progresses more rapidly and penetrates more deeply at the E-port.

FIG. 3. Leaked E-port panels and crack cross-section by CT scan

Once SCC has propagated, its removal becomes practically impossible. In the cooling pipes on thermal shield and panel surfaces on E-port, SCC progression was observed, therefore it was decided to replace all the cooling pipes

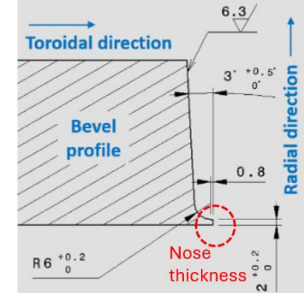
- Difficulties to adapt welding parameters to irregular bevel profile, particularly when the nose thickness shows large variation outside the specified tolerance. Example of high variations on bevel nose thickness (Fig. 4) is represented in Fig. 5a.

FIG. 4. VV welding bevel: profile dimensions

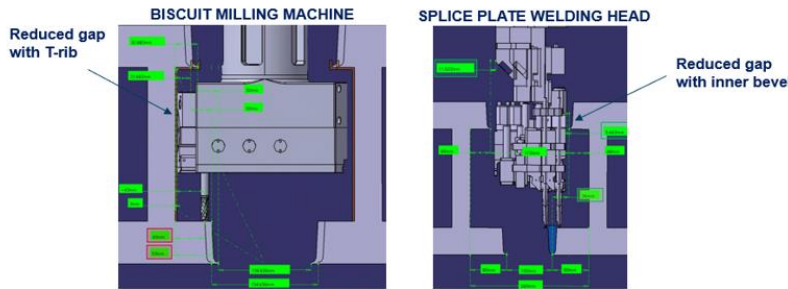
- Difficulties for splice plate customization and onsite alignment to the field joint bevels in Fig. 5b.
- Potential clashes with welding tools, biscuit<sup>1</sup> hole machining tools and NDE tooling. In Fig. 5c : in left figure, biscuit hole milling machine is clashing with T-rib due to reduced distance from outer bevel to T-rib; in right figure: Splice plate welding head clash with inner bevel due to reduced distance between inner and outer bevel.

Fig. 5c. Potential clashes with bevels and T-rib

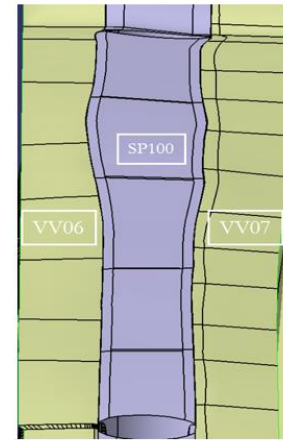
- Difficulties to adapt the welding machine to significant trajectory changes. Representation of VV sector field joint with splice plate with high deviations in toroidal direction is shown in Fig. 5b.

Fig. 5b. Toroidal deviations at the bevel nose

From these difficulties, it was concluded that repair of field joint bevels was necessary to have VV sector bevels at acceptable dimensional conditions (in terms of bevel dimensions, and toroidal & radial position) compatible with VV sectors welding process and tools.

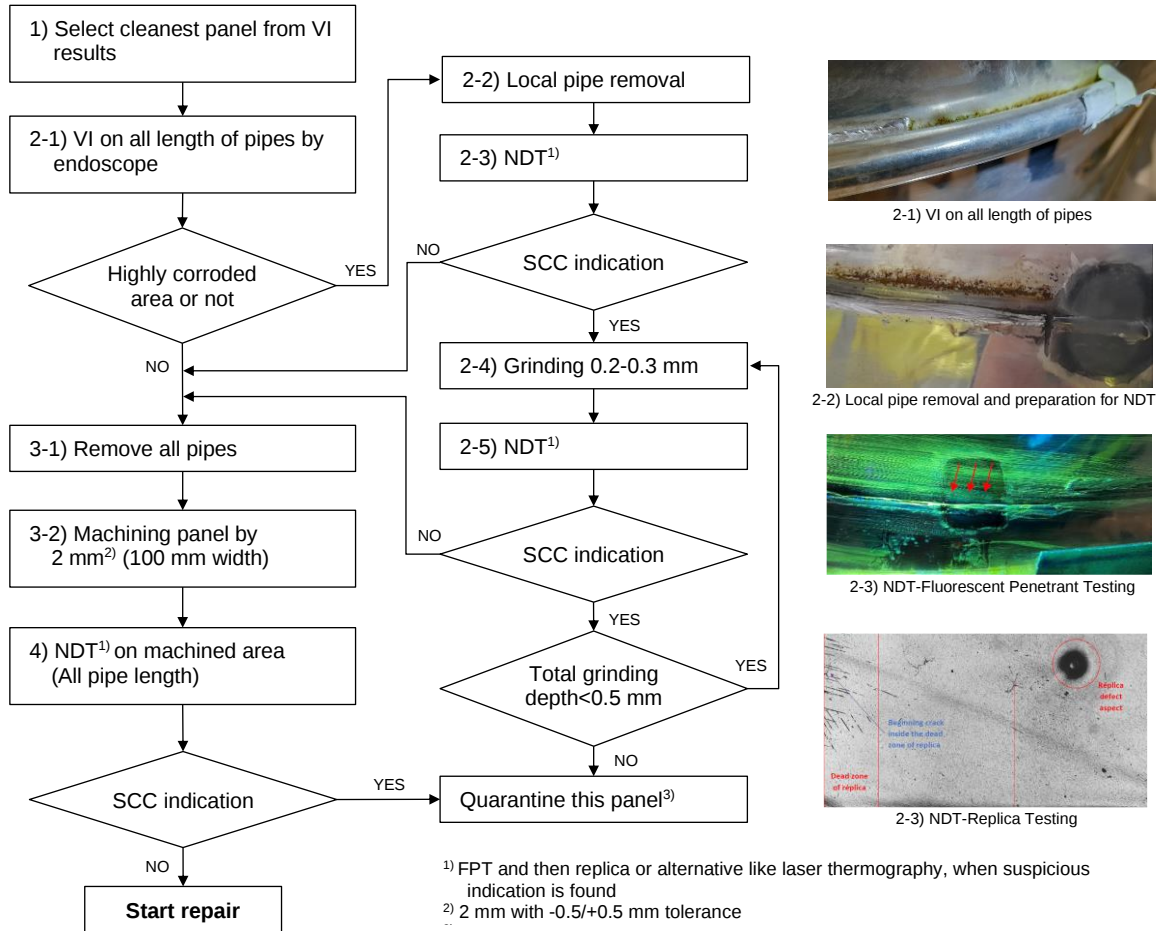
FIG. 6. Panel examination to delete SCC risk before starting of repair

For the repair of VVTS, a clean panel was selected based on the systematic visual inspection. Subsequently, NDE was performed to verify the panel condition in the areas showing suspicious indications of severe corrosion. Fig. 6 describes the work process to repair the panel checking the soundness of the panel from risk of SCC. Visual inspection for all pipe stitch welded regions had been carried out. The inspection focused on the pipe attachment area, where the risk of SCC propagation was considered higher due to the presence of residual chlorine. Locally highly corroded area was examined precisely by Fluorescent Penetrant Testing (FPT) on the panel surface after partial removal of cooling pipe. The inspection particularly targeted the pipe welded area and welding joint between panels, since at room temperature (non-operational condition) there is almost no stress on the panel, and residual chloride does not cause an issue on the unwelded panel surface.

When there is no indication on the test part, all pipe removal and panel 2 mm thick layer in the vicinity of the pipes was performed. Since complete removal of existing chloride to deactivate crack propagation is difficult by grinding, panel were machined to ensure the complete removal of the chloride where high chloride contents were detected. And then the panel surface was polished to achieve lower thermal radiation emissivity. After panel machining and polishing, FPT was performed to confirm the absence of SCC on the panel before new pipe attachment.

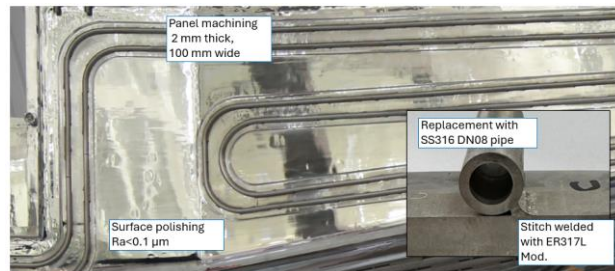
Numerous corrosion spots were observed on some panels that had been shipped to the supplier for repair. Upon investigation, it was determined that these panels were exposed to high humidity conditions at the port after being inspected by customs. The Ag coating layer thickness was examined and found to be only a few micro-meters, whereas the required thickness is greater than 5  $\mu\text{m}$ . Such a thin Ag coating leads to discontinuities in the protective layer and defects such as pinholes and scratches. These weaknesses, combined with high humidity conditions during shipping and at repair sites, facilitated corrosion. Furthermore, chlorides trapped beneath the Ag coating contributed to galvanic corrosion under conditions of high humidity and elevated temperatures during transportation and repair work at the supplier's premises.

FIG. 7. Repaired thermal shield panel

To mitigate further corrosion risk, it was decided to remove the Ag coating from the VVTS panel surfaces. The panel surfaces were then buffed ( $R_a < 0.1 \mu\text{m}$ ) to ensure adequate emissivity. From tests on different surface roughness conditions, it was found that polished stainless steel with a surface roughness of less than  $0.2 \mu\text{m}$  can exhibit emissivity similar to that of a previously silver-coated surface at cryogenic temperatures. The emissivity of a well-polished VVTS surface is expected to be 0.05–0.06, compared to 0.03–0.05 for a silver-coated surface at 80 K [6]. Fig 7 presents the repaired thermal shield surface.

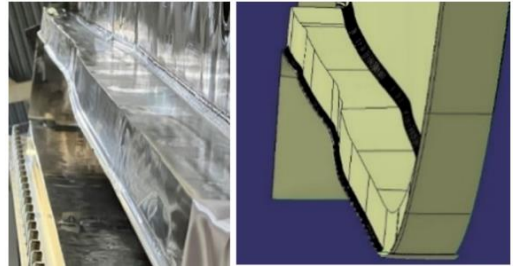
Analysis of as-built deviations and potential repair solutions begun with full and precise 3D scan of the field joint bevels all along the VV sector. The raw scan data are used to create accurate reconstructed surfaces of the as-built bevels with an accuracy of  $< 0.1$  mm (Fig. 8). The analysis of potential repair solutions starts with the 3D CAD model of the as-built bevels reconstructed surfaces. Specific dedicated software and high level of expertise are required for the postprocessing of the 3D scan captured raw data and modelling of 3D reconstructed surfaces.

FIG. 8. From VV sector as-built bevel (left) to CAD Model of reconstructed surfaces (right)

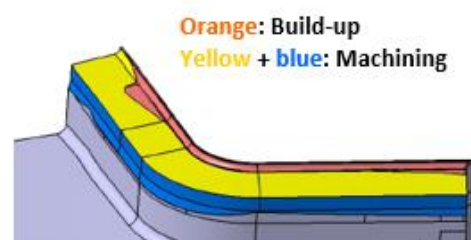
FIG. 10. Illustration of “optimized” repair solution combining build-up and machining

- To limit the distortions induced by the deposited weld build-up material: an “optimized” repair solution<sup>2</sup> combining local build-up (only at some locations) and machining of bevels (all around the Sector) was selected (Fig. 10).

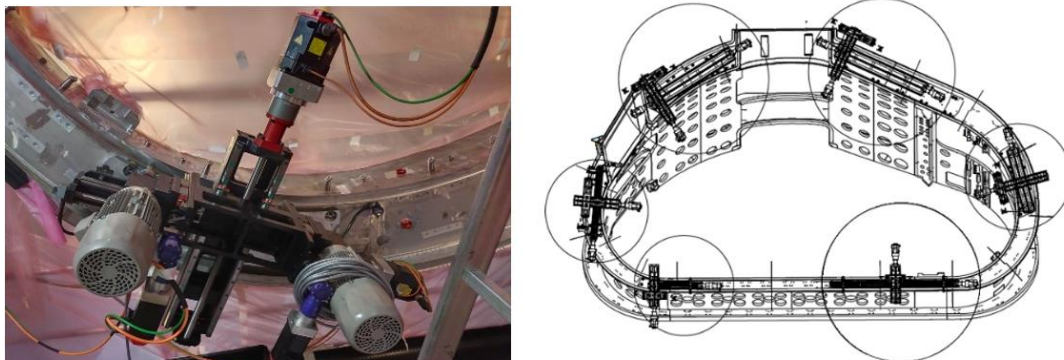
FIG. 12. Portable milling machine installed in the VV sector and illustration of different milling machines on the VV Sector

For the final machining, customized portable milling machines have been developed to work in any required position. Five different models of milling machines are used, depending on the area of the VV sector to be machined (Fig. 12).

The portable machines are clamped to the VV sector using threaded holes drilled on the plate (T-rib) located between inner and outer bevels all around the VV sector. The milling machines are precisely aligned with the VV sector permanent metrology network using a temporary metrology network, which is referenced to the VV sector network. This precise alignment ensures that bevels are machined at required global position within the VV sector. The temporary metrology network is defined by target nests tack welded close to the field joint bevels all around the VV sector. After completion of bevel machining and final validation, target nests are removed.

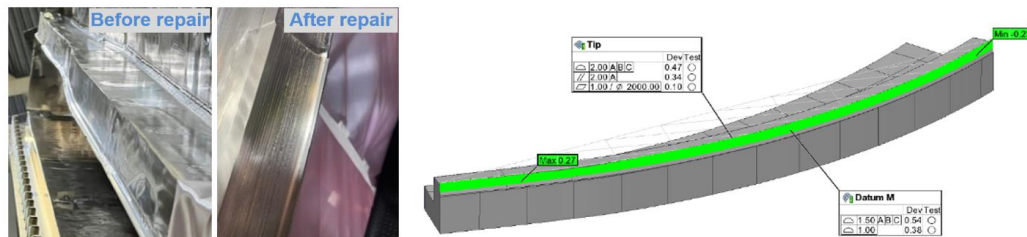
FIG. 13. Repaired VV bevel: Bevel shape before and after repair (left); achieved tolerances after bevel machining (right)

Validation of achieved bevel tolerances after final machining is performed by 3D scanning. Fig. 13 illustrates an example before and after bevel repair, and some results of scanned machined bevel.
