# THE HUMAN ASPECT OF THE FUKUSHIMA DAIICHI ACCIDENT

**Takafumi ANEGAWA**

**Tokyo Electric Power Company**

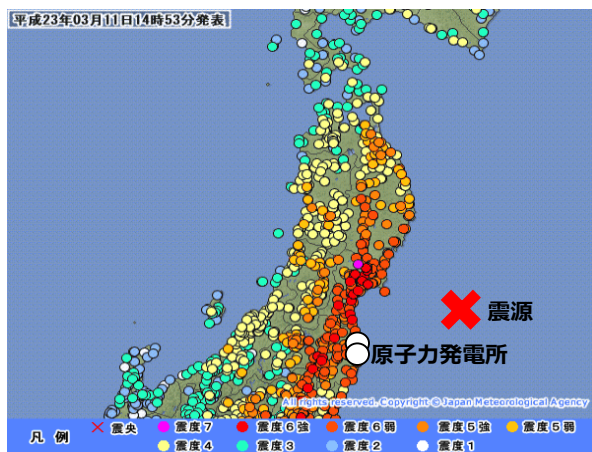
Seismic intensity distribution of present earthquake

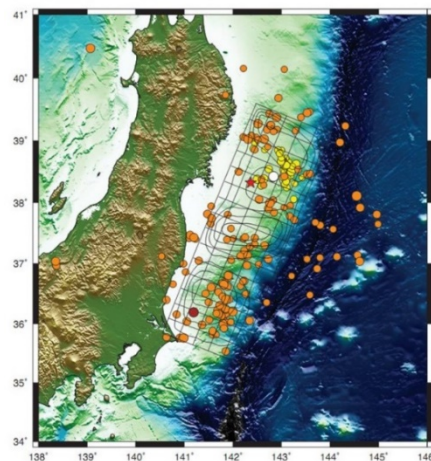
Source area of present earthquake  
(Created by Earthquake Research Institute, University of Tokyo)

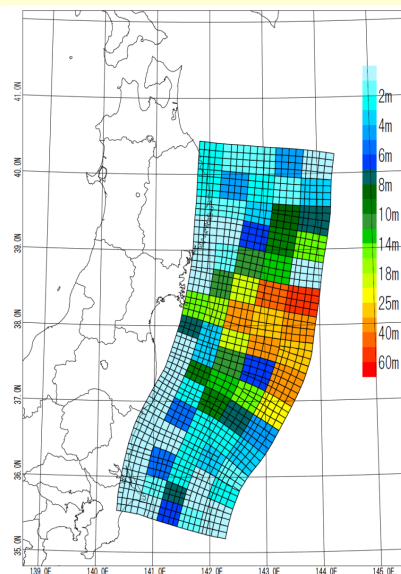
Source of present tsunami  
(Created by TEPCO)

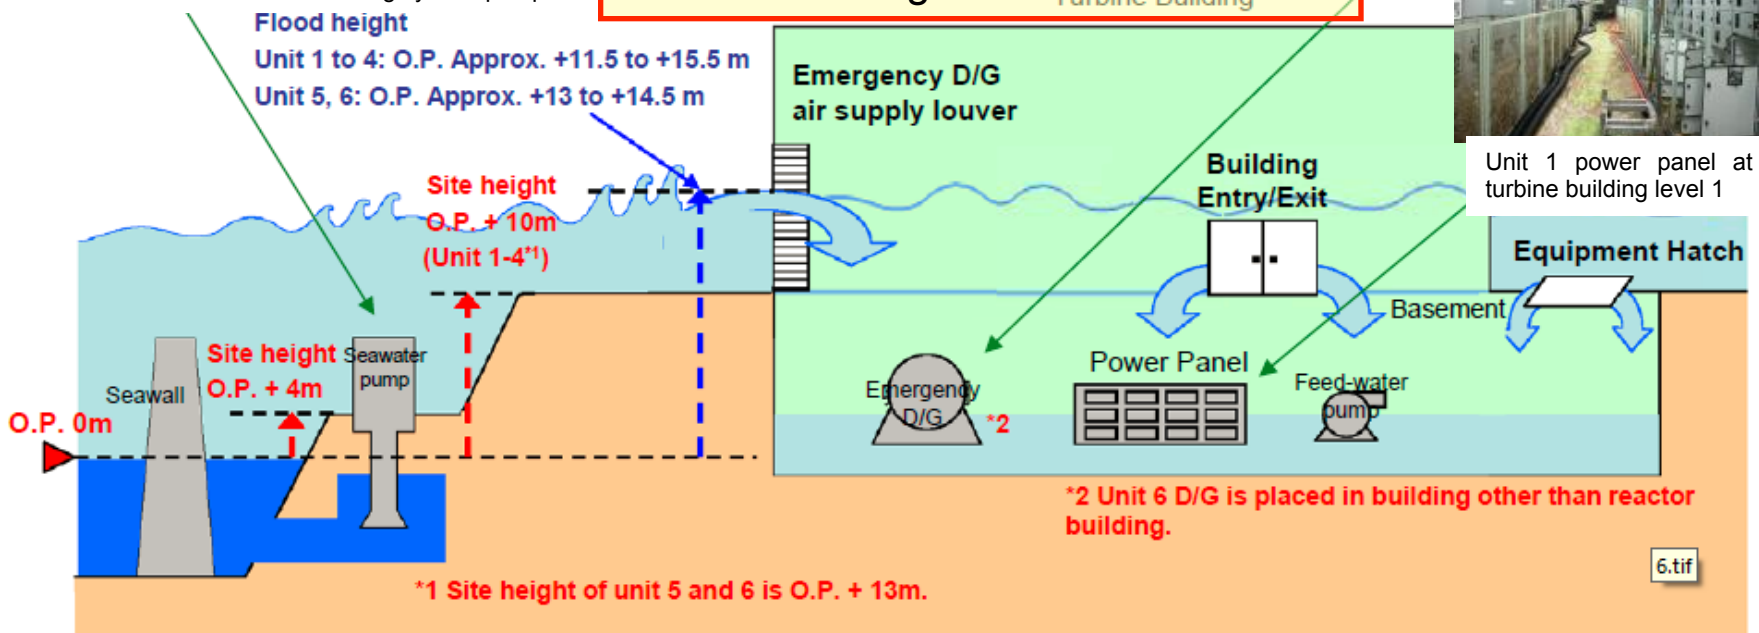
Unit 1 power panel at turbine building level 1

Confirmation result for the main flooding route by on-site confirmation surrounding the building

- (1) Building entry/exit
- (2) Equipment hatch
- (3) Emergency D/G air supply louver
- (4) Trench, duct (penetration of cables) etc.

⇒ Flooding of D/G, electric panel room etc. through these.

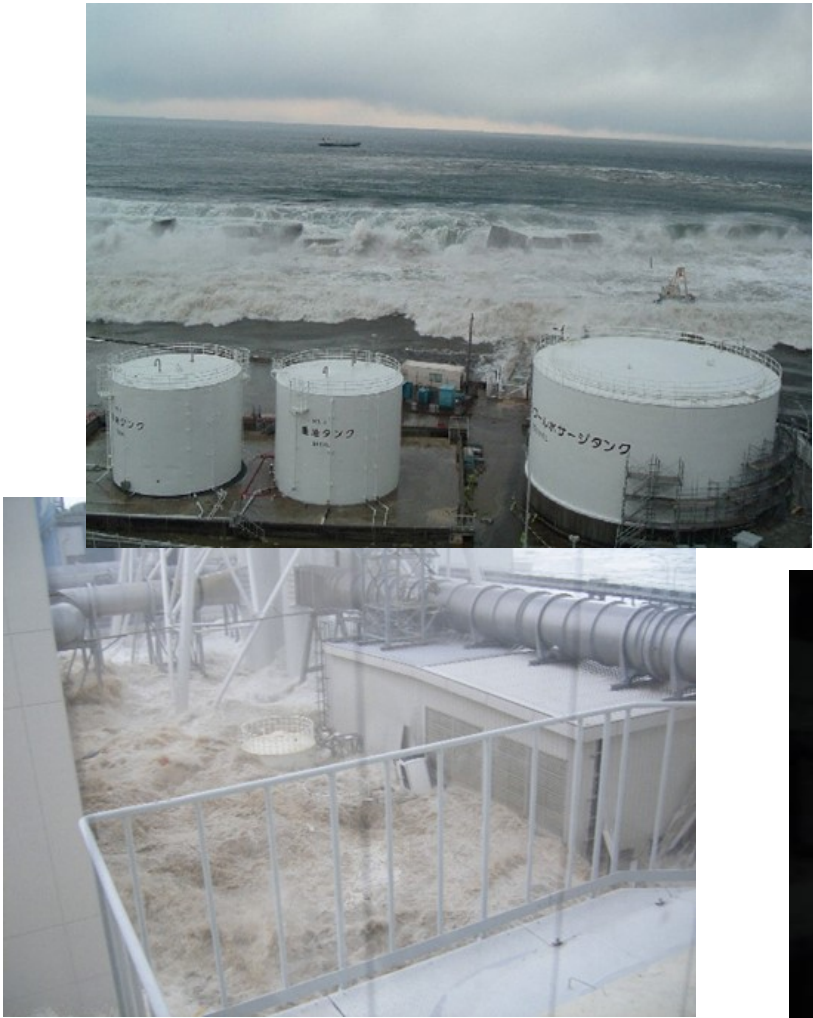
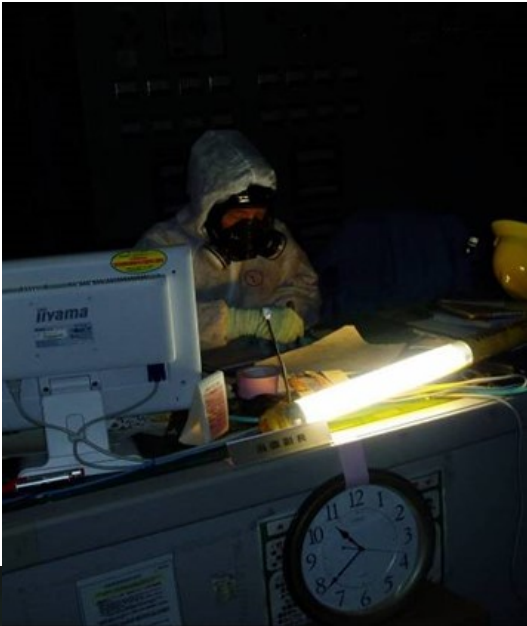
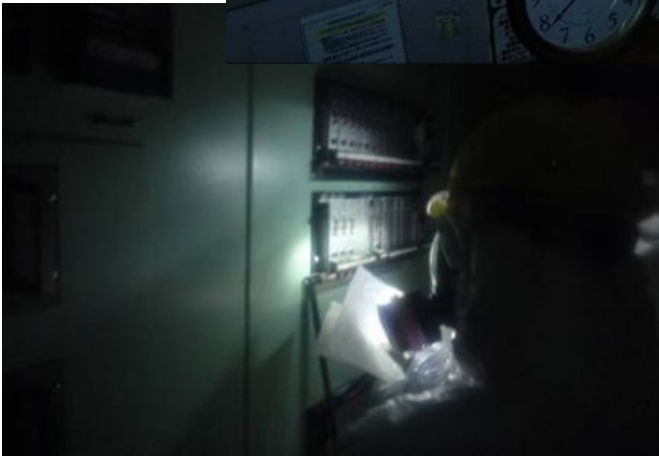
Tsunami that hit the power station

Operating Staff had to work at MCRs  
with very limited lightning

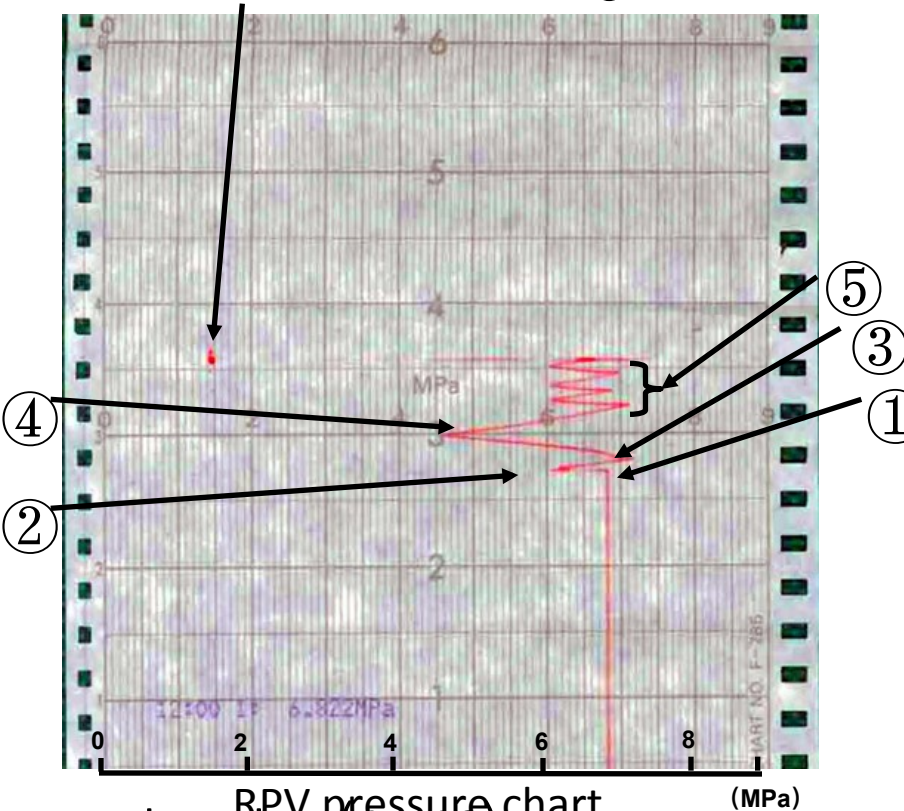
around 15:30:  
end of data recording

- ① Scram by the earthquake (14:46)
- ② Pressure increase due to MSIV closure
- ③ Depressurization due to IC operation (14:52)
- ④ Pressure increase due to stop of IC
- ⑤ pressure change related to IC operation

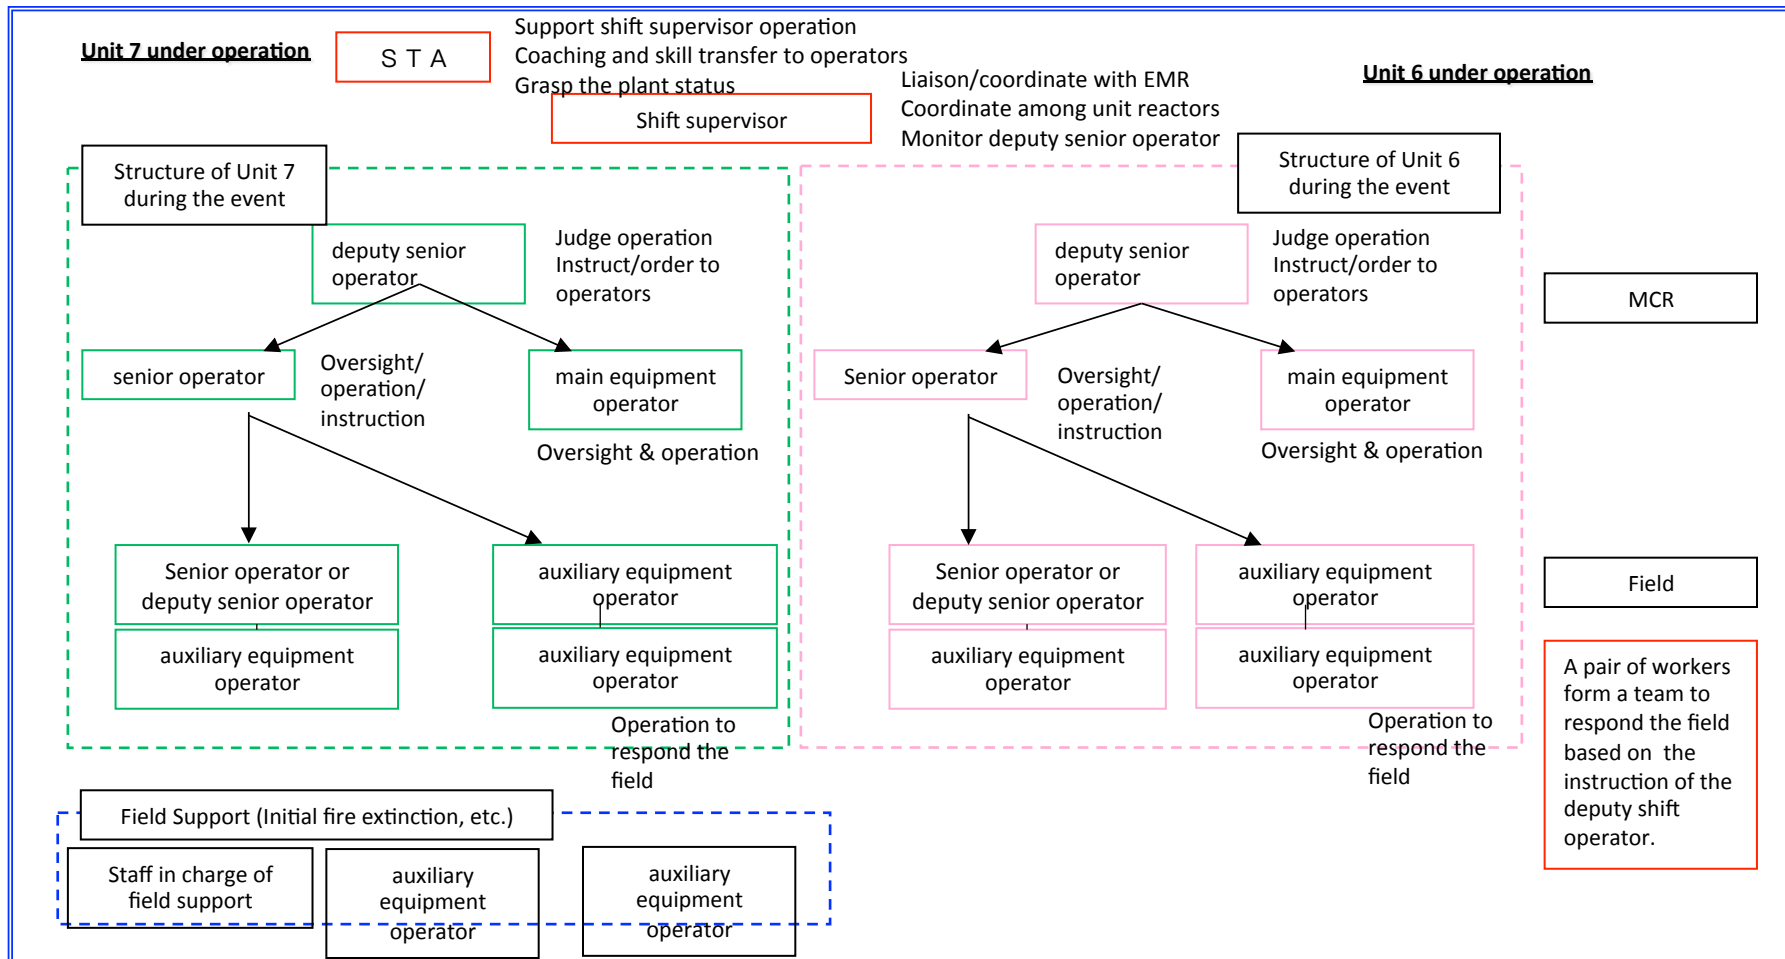
(when 2 plants are in operation: 18 crew + 1 STA)

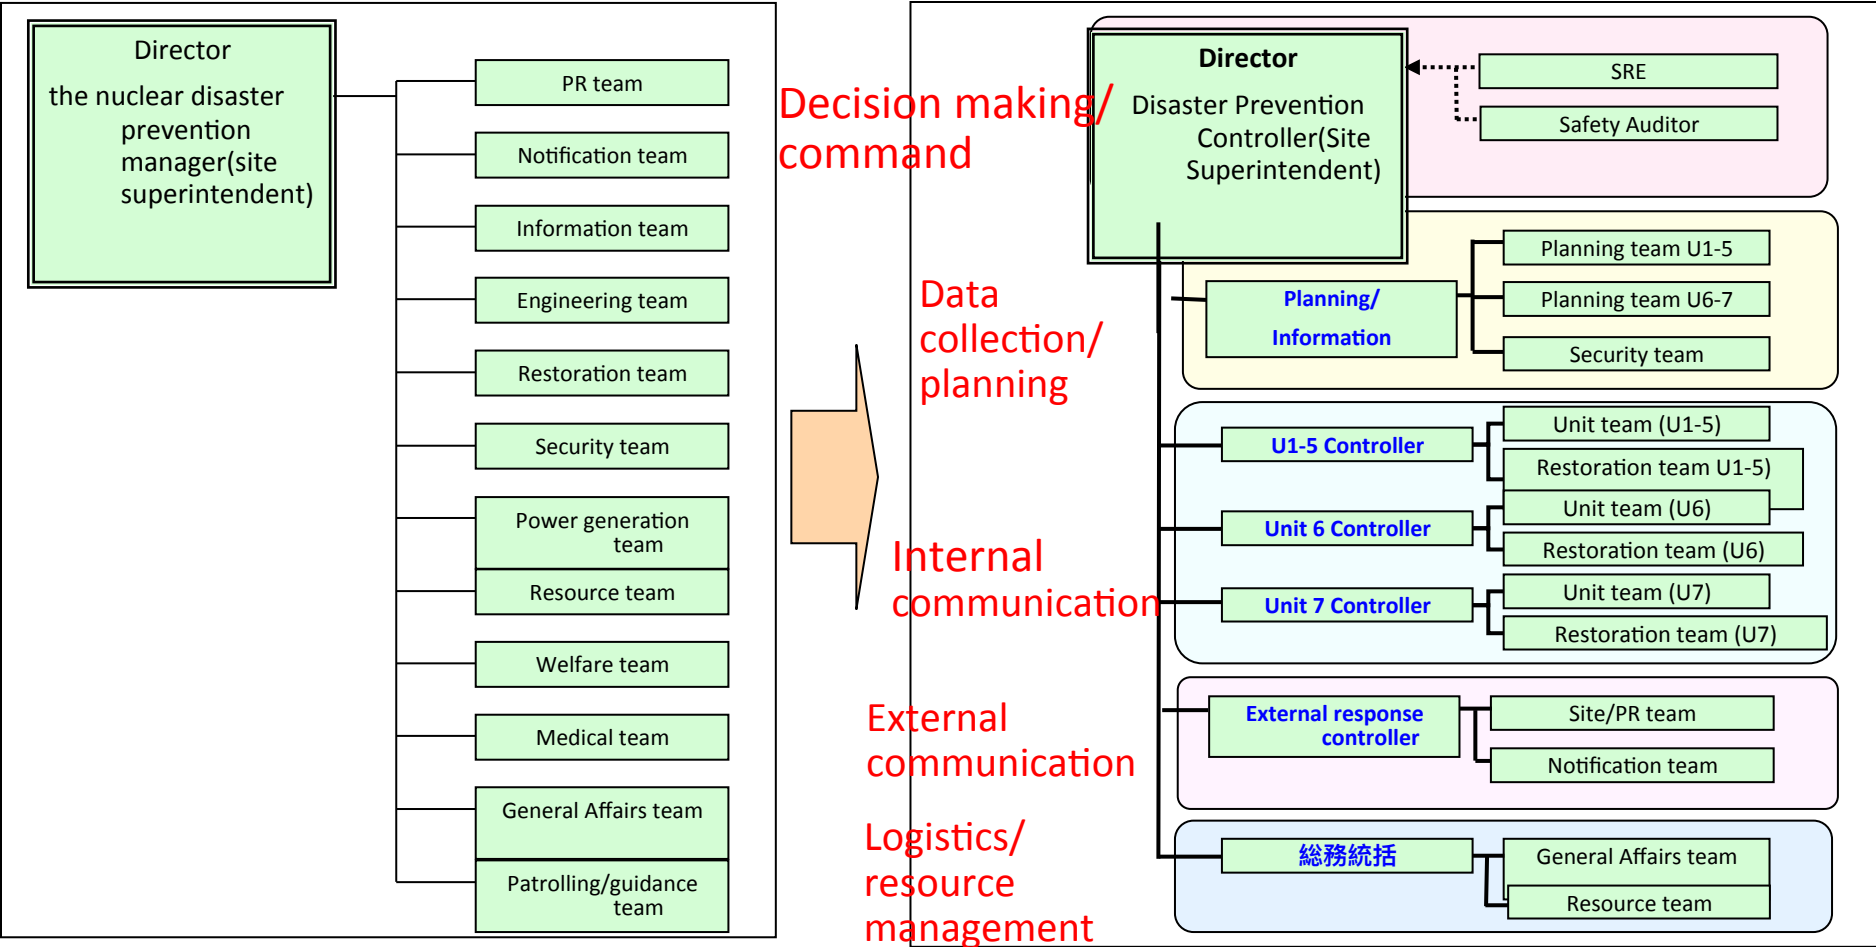
(Before) Build 12 functional teams in parallel under the Director.  
(After) Narrow the Director's span of control and stratify groups by function

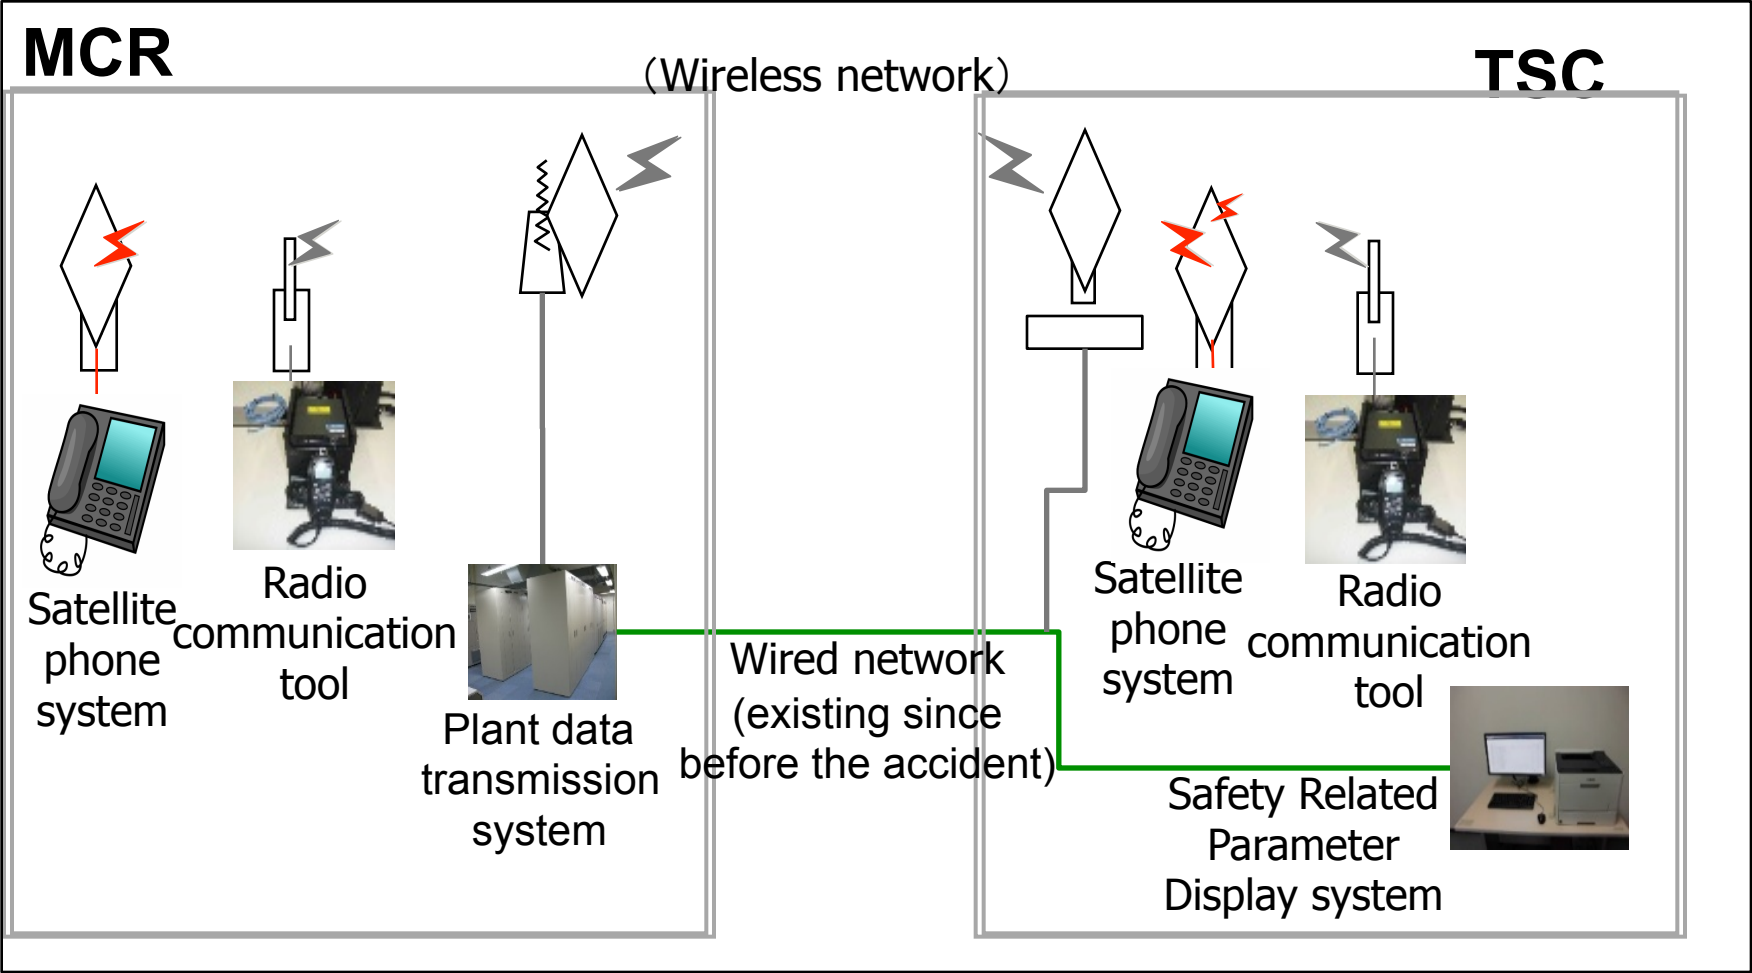
Enhanced diversity of communication tools between MCRs and TSC

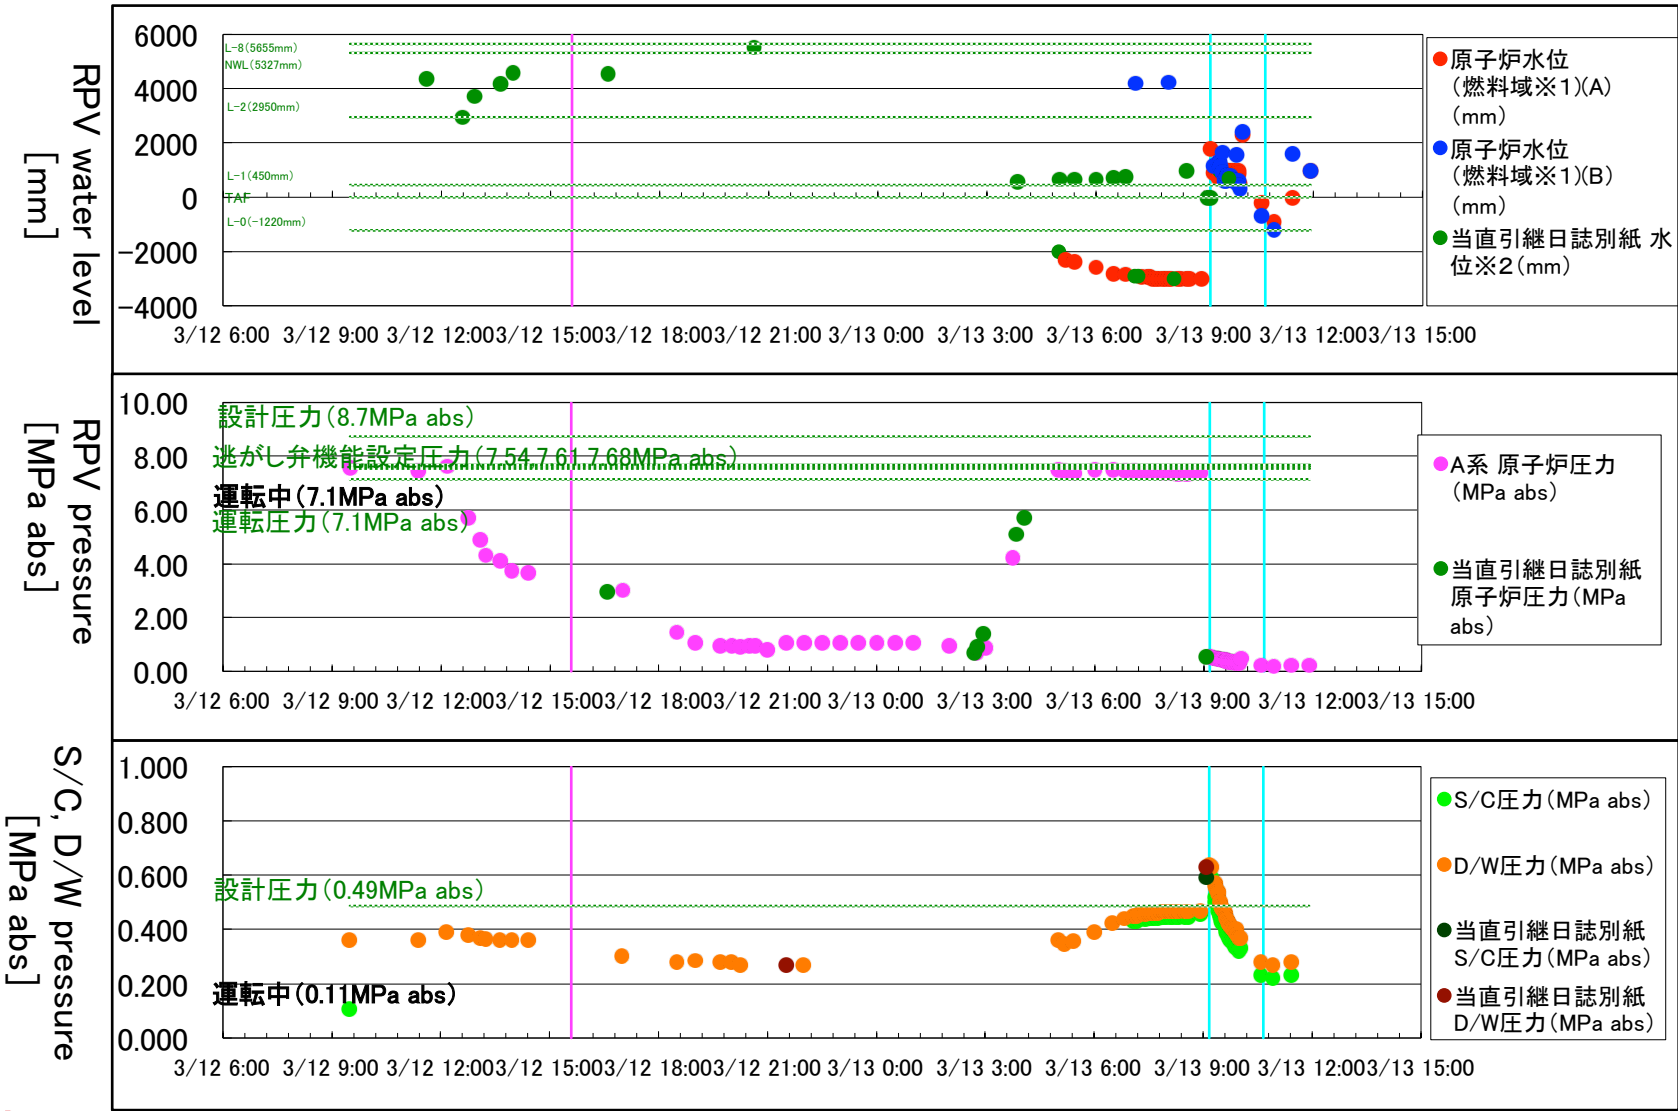
# HPCI data chart at Unit 3

1号機原子炉建屋爆発(15:36)

TAF到達<地震発生後約42時間>(9:10頃) 炉心損傷開始[水素発生開始]  
<地震発生後約44時間>(10:40頃)
