HOW INDUCED ACTIVATED ACCELERATOR PARTS HAVE AN IMPACT ON THE RADIATION SAFETY OF A PROTON THERAPY FACILITY

AUGUSTYNS V¹, AESSELOOS C², DRIESEN R², <u>BERGANS N³</u>

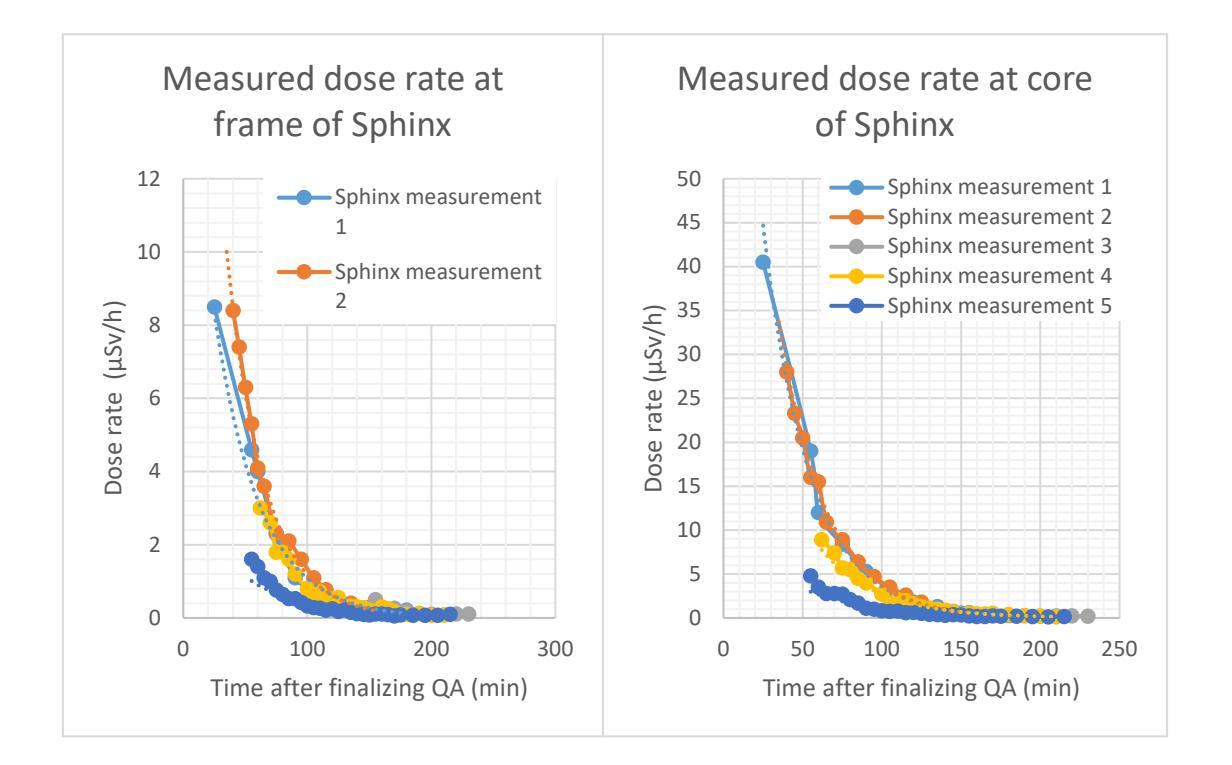
Irradiations on the Sphinx resulted in elevated dose rates inside the core of the Sphinx, but these dose rates are also significant at the positions where the Sphinx is held during manipulations. Based on the exponential extrapolation of these performed measurements a dose rate above 100 μ Sv/h can be

expected at the core of the Sphinx immediately after finalizing the QA measurements. The cumulated dose for staff related only to the daily manipulation of the Sphinx immediately after the morning QA during one year is estimated to be 2% of the Belgian public yearly dose limit.
