Corrosion behaviours of austenitic steel and ferritic steel in LBE with oxygen controlled conditions

China Institute of Atomic Energy

2019.10

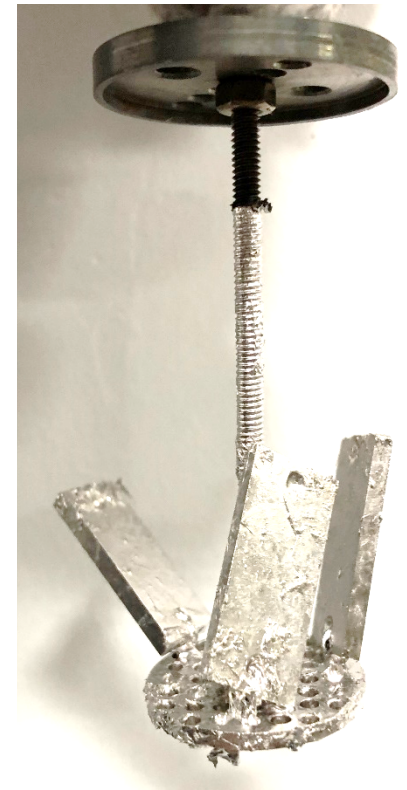
- Lead-bismuth alloy: Pb-Bi Eutectic (124°C melting point)
- Structural materials:
 - F-M steel: T91
 - Austenitic steels:
 - CN-1515: Cladding materials for CFR-600
 - 316Ti: 1st Generation cladding material for CEFR
- Sample size:
 - 20×10×2mm in three direction

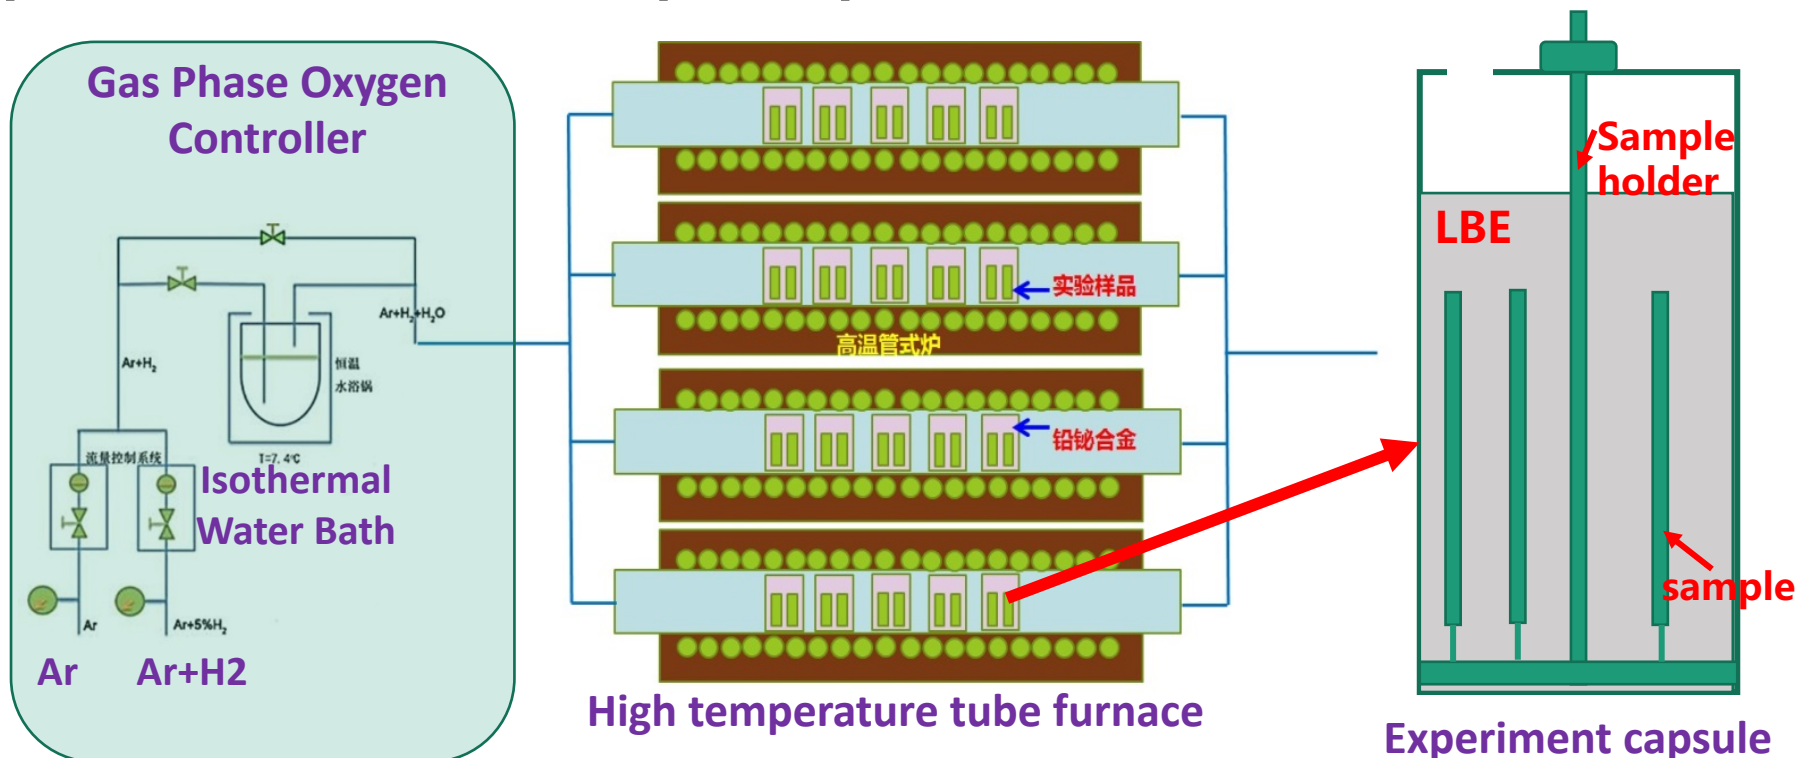
- Each capsule contains three specimens and LBE about 240g, and punched holes on the top of capsules.

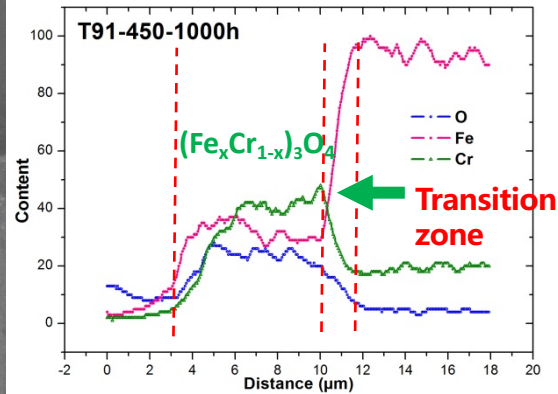
T91: Corrosion product composition analysis

- At 450°C , EDS line scanning shows a single layer of $(\text{Fe}_x\text{Cr}_{1-x})_3\text{O}_4$ magnetite is formed after 1000h LBE corrosion.

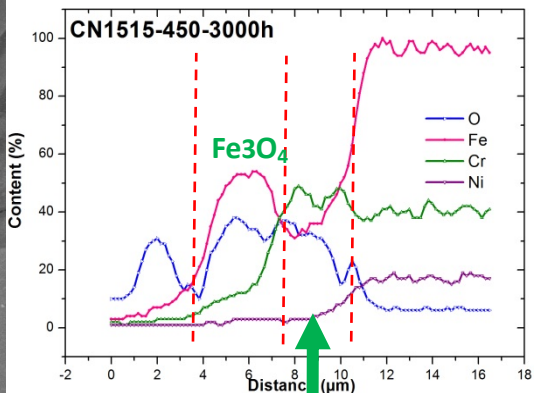
CN-1515: Corrosion product composition analysis

Ni dissolution aeron

(FeCr) $3O_4$

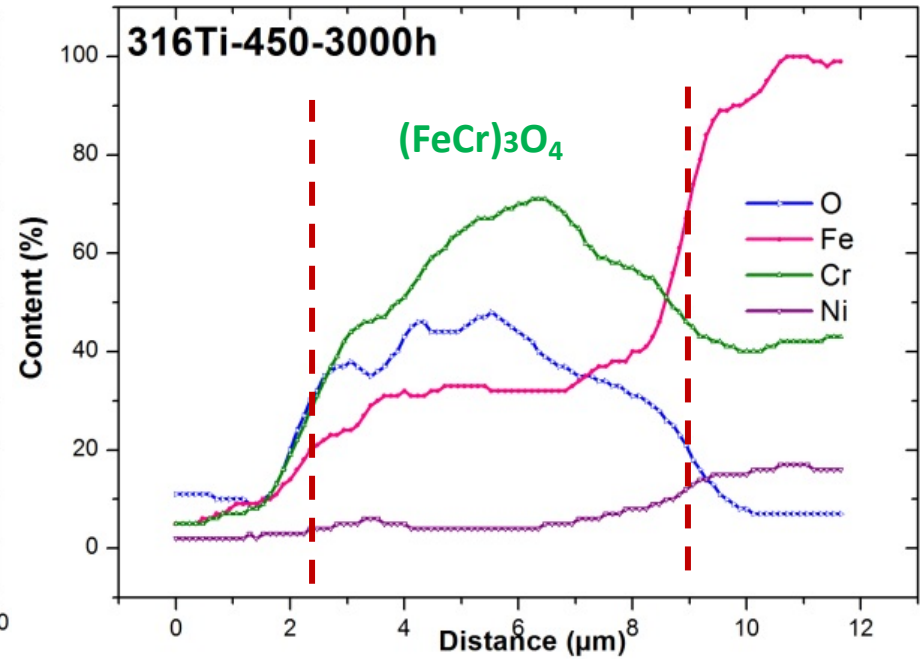
316Ti: Corrosion product composition analysis

- EDS analysis shows the observed oxidation film is single layer

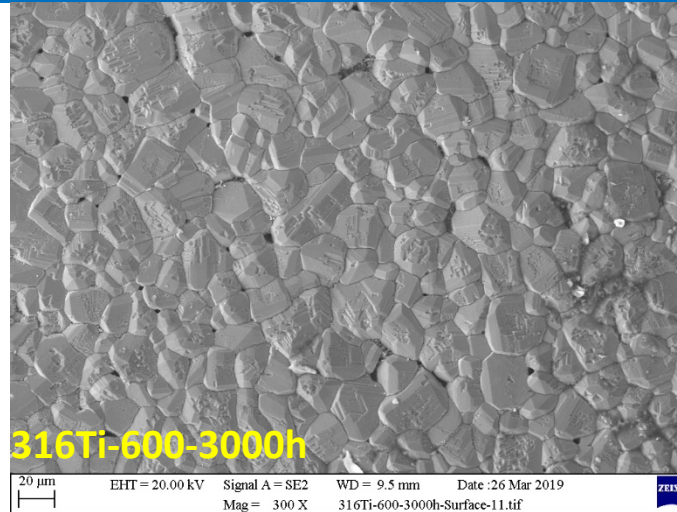
Severe mass transfer effect at high temperature

- At high temperature, LBE has a high solubility of Fe and Cr, and when reduce the experimental temperature, the over-saturated Fe and Cr precipitates on the surface of samples.

- At 450C°, an oxide film is formed on the surface of T91, CN-1515 and 316Ti, and the layer is not stable when it grows;
- At 500 and 550C°, a slight corrosion occurs on T91ferritic – martensitic steel ;
- For the austenitic steel (CN1515 and 316Ti), the Ni diffuse from corrosion layer to LBE, meanwhile, the Pb and Bi penetrate into materials matrix along the grain boundary;
- Because of Ni diffusion and dissolution, the original FCC structure is not stable, a FCC-BCC phase transformation occurs;
- At 600 C°, dissolution corrosion happened for all three materials;
- A severe mass transfer effect exists at high temperature as result of high solubility of Fe and Cr.
