# Status of the ITER Neutral Beam Test Facility and the first beam operations with the full-size prototype ion source

# Reliability of electrodeposited components for fusion application: A process evaluation of the first kind

## Reliability Of Electrodeposited Components For Fusion Application: A Process Evaluation Of The First Kind

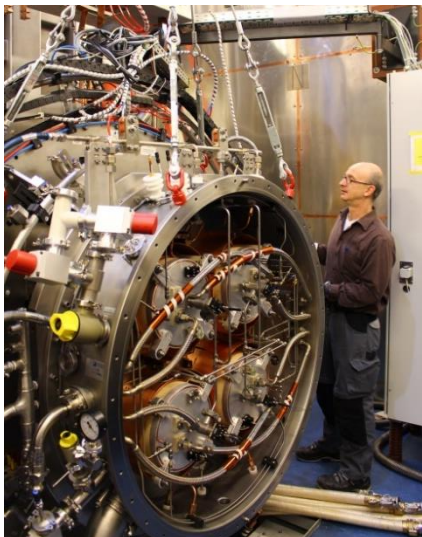
## Beams at ITER

### Heating beam (HNB)

### Diagnostic beam (DNB)

Heating    Current drive    Plasma rotation

Diagnosing He ash content (CXRS)

Parameter	HNB		DNB
	HH/HHe	DD/DT	HH/HHe/DD/DT
Phase	H	D	H
Species	16.5	16.5	2
Injected neutral beam power [MW]	870	1000	100
Beam energy [keV]	46	40	60
Accelerated current [A]	>90	>90	>90
Beam uniformity [%]	3÷7	3÷7	3÷7
Acceptable beamlet divergence [mrad]	1000	3600	5Hz; 3s ON /20s OFF

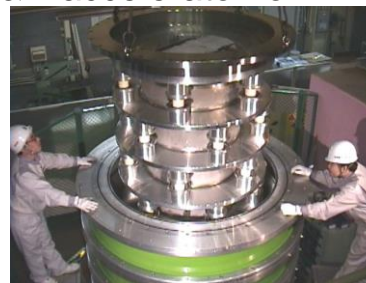
R&D of high energy & long pulse beam acceleration for ITER and JT-60SA  
970keV, 190A/m<sup>2</sup>, 60s; 500keV, 154A/m<sup>2</sup>, 118s  
FEC 2016 Kashiwagi, session TECH/3

R&D accelerator for ITER

JT-60SA beam source

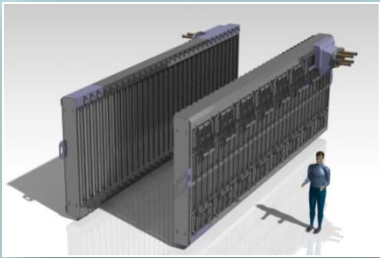
OPE-307

CRYOGENIC PUMPS

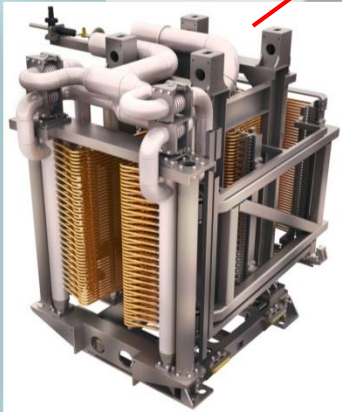
OMF-605

CALORIMETER

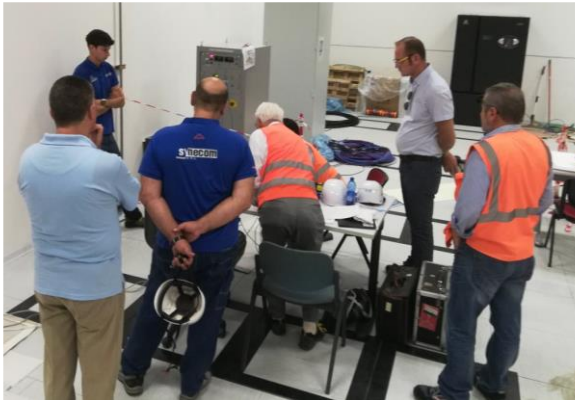
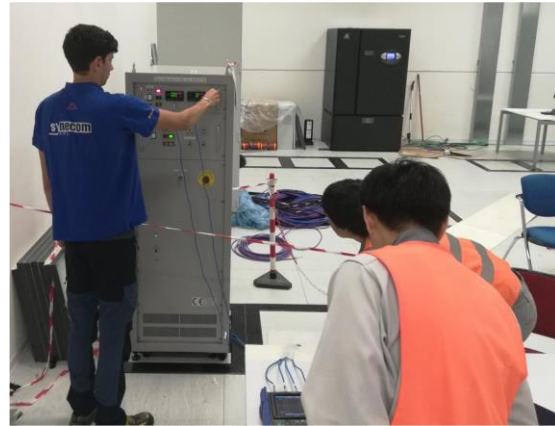
1<sup>st</sup> STEP 1200kV-1 HOUR

- The insulating tests were performed in successive steps, each time adding a new part of the system provided by a different DA
- The process was long and lasted about 1.5 years. The overall insulating test was successfully completed in Nov 2019

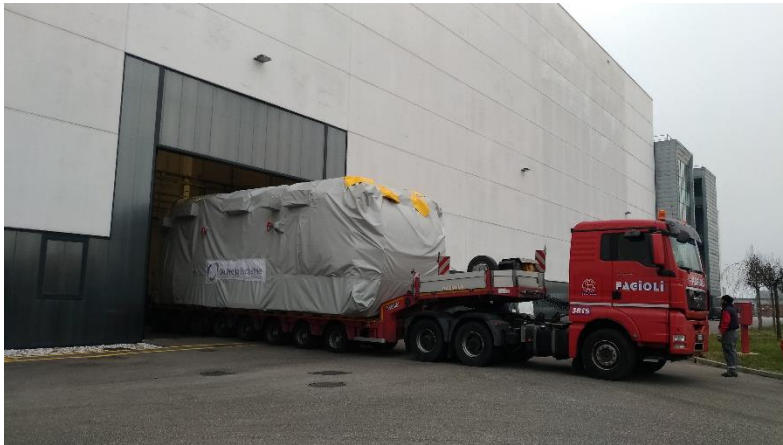
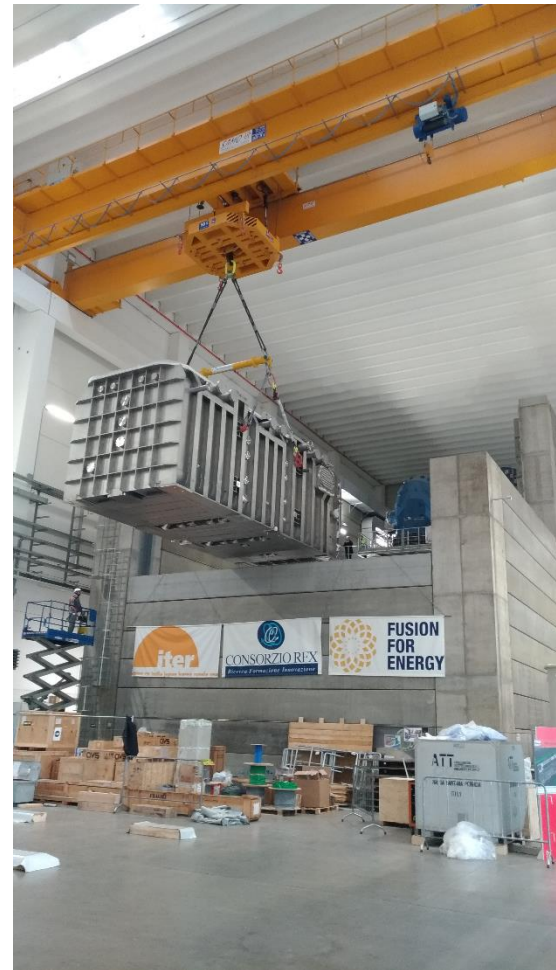
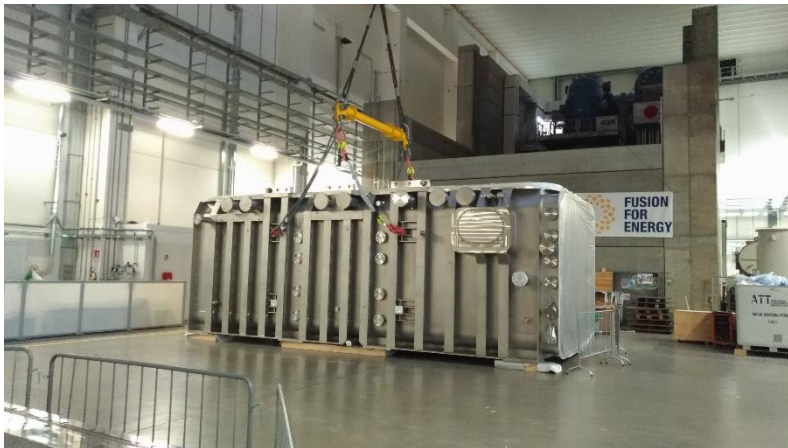
*Delivery on site and installation of the MITICA BLV*

- Installation and SAT completed in Q1 2020 just before the Site closure for some weeks due to the Covid-19

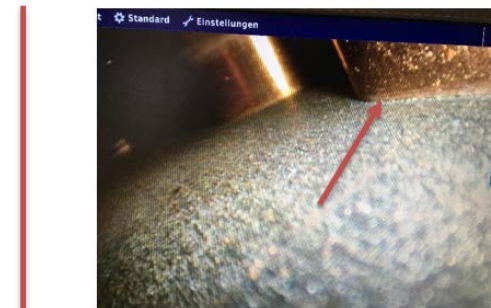
Example of 'a good ED bond'

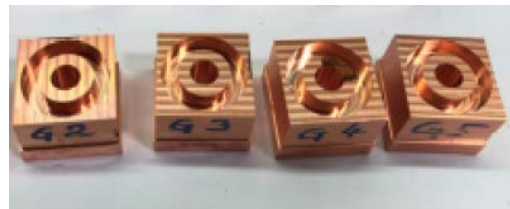
## Adhesion Strength: Modified Ollard Test

Based on the location of the failure for Modified Ollard test, it was inferred that:

- load of the plunger was actually resisted by the base material rather than the intended CuED layer
- the failure is mainly due to the stress concentration rather than the plunger loading.

→ The test configuration of the Modified Ollard test is not suitable and reliable for the present application.

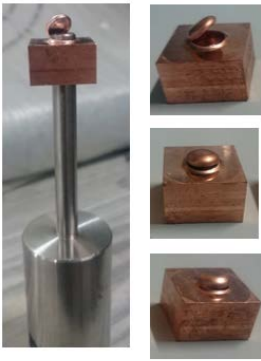
Push test samples after testing

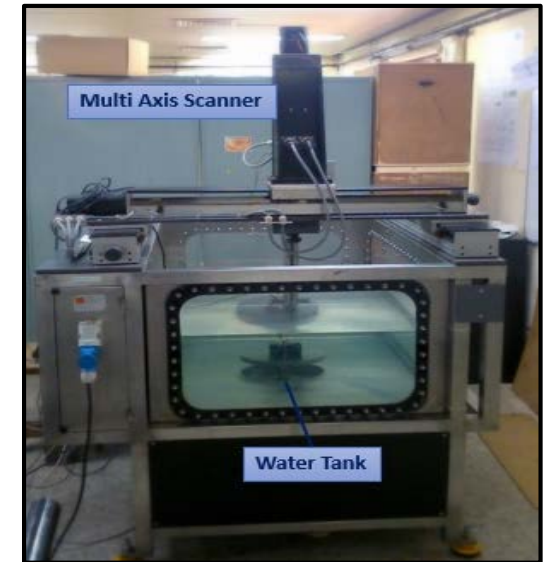
*Facility for performing Immersion UT examination at IPR*
