Status of the ITER Neutral Beam Test Facility and the first beam operations with the full-size prototype ion source

Reliability of electrodeposited components for fusion application: A process evaluation of the first kind

Reliability Of Electrodeposited Components For Fusion Application: A Process Evaluation Of The First Kind

Jaydeep Joshi
ITER-India, Institute for Plasma Research
Gandhinagar, India
jaydeep.joshi@iter-india.org

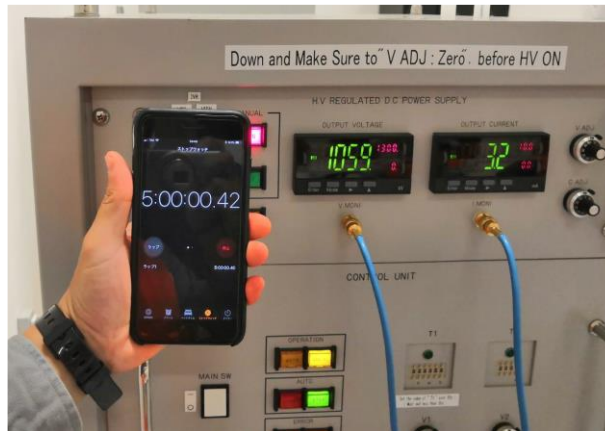
2nd STEP 1060kV-5 HOURS

- The insulating tests were performed in successive steps, each time adding a new part of the system provided by a different DA
- The process was long and lasted about 1.5 years. The overall insulating test was successfully completed in Nov 2019

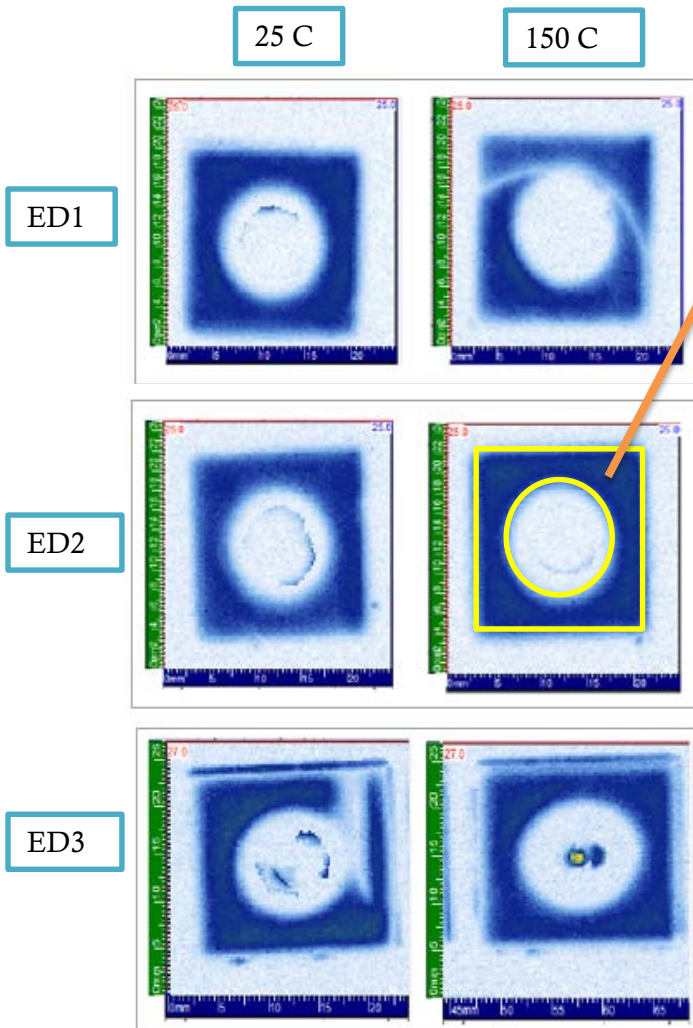
Area of interest between the yellow boundary (white shade circle is punctured area due to previously conducted adhesion test and this area to be ignored).

- C scan results confirm that there is no de-bonding presents in the samples, for both temperatures.
- The result also confirms that the reduction in the adhesion strength at high temperature is not associated with the de-bonding at the interlayer.

- In order to check the interlayer between the electrodeposition and base material, immersion ultrasonic examination with C-Scan technique has been performed.
