# ENTRAPMENT OF IMPURITIES INSIDE A COLD TRAP: A PURIFICATION PROCESS FOR REMOVAL OF CORROSION IMPURITIES FROM MOLTEN Pb-16Li

A. DEOGHAR, A. SARASWAT, H. TAILOR, S. VERMA, S. GUPTA, C. SASMAL, V. VASAVA, S. SAHU, A. PRAJAPATI, R. BHATTACHARYAY

Institute for Plasma Research, Gandhinagar, Gujarat, India

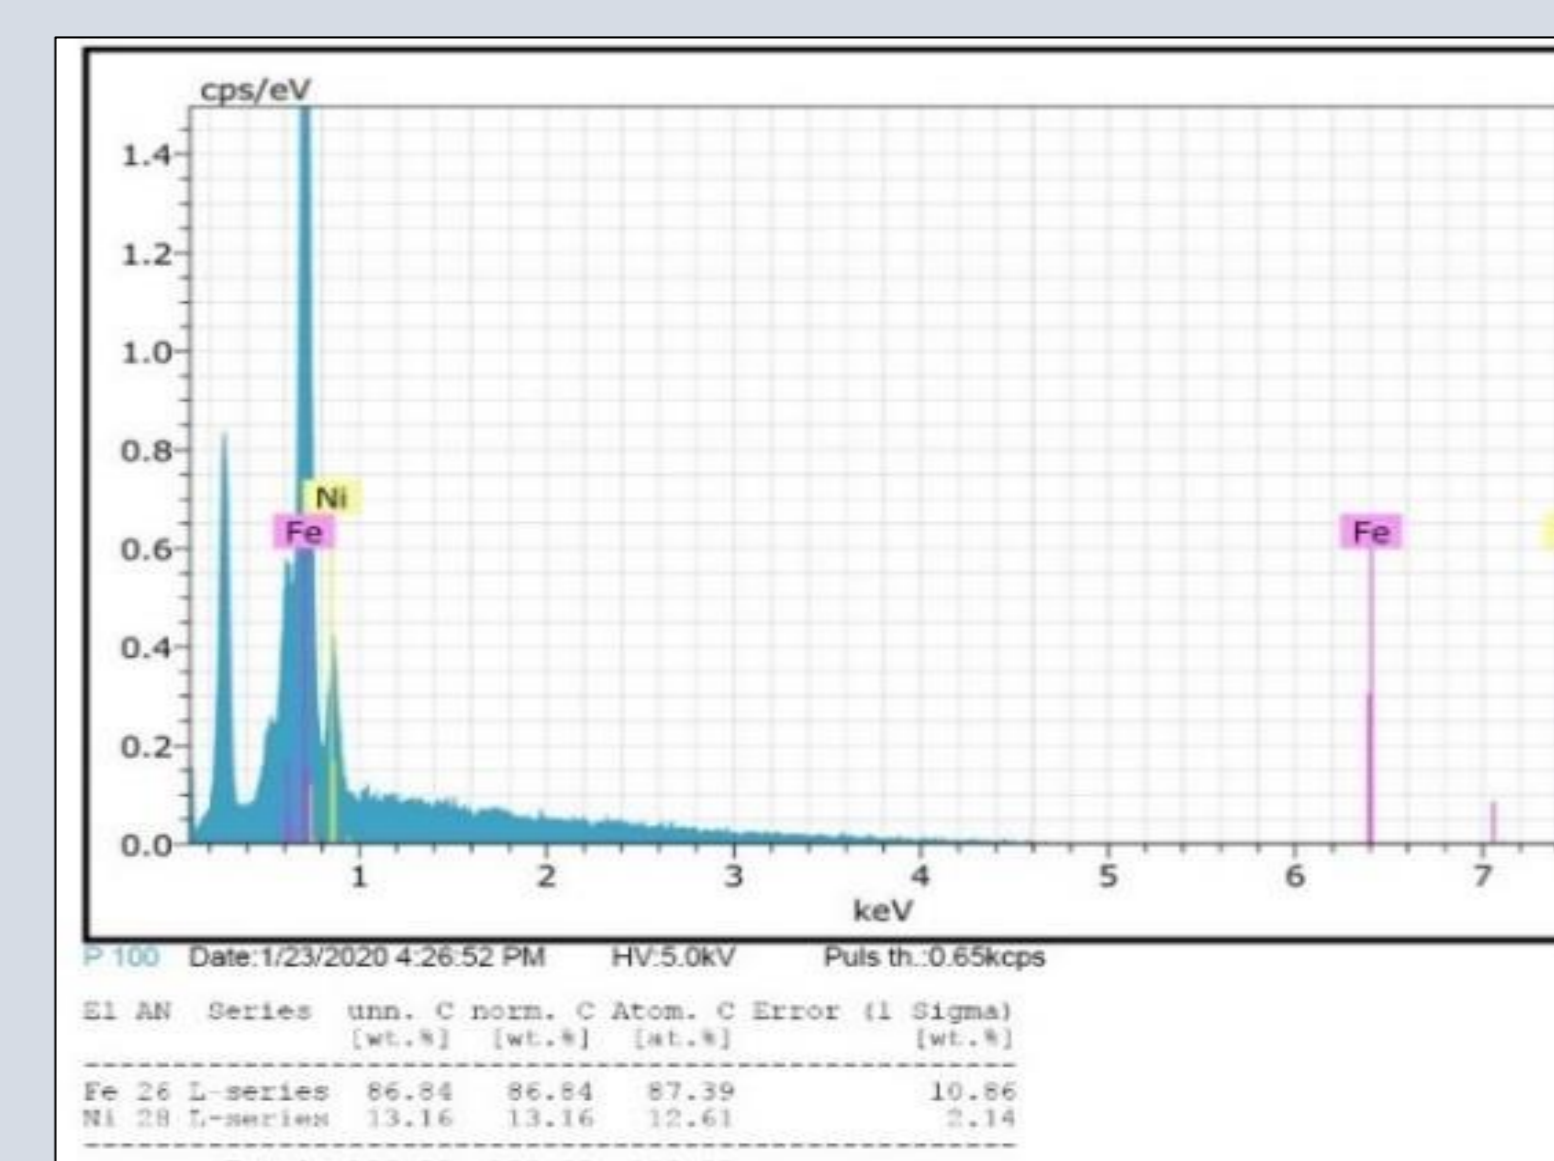
EDX analysis results of deposited crystal

- The corrosion impurities were found to be deposited in a needle shaped crystalline on the wire mesh.
- High concentrations of Iron (Fe) and Nickel (Ni) in the samples deposited on wire mesh of CT confirms the deposition of Fe and Ni impurities on CT mesh.
- The SEM-EDX and XRD analysis of the deposited needles suggest that the micron-size particles (50-191 μm) of iron nickel intermetallic (Ni<sub>3</sub>Fe and NiFe<sub>2</sub>O<sub>4</sub>) are embedded in Pb-16Li matrix.
- The reduction in the concentration of minor elemental impurity such as Copper (~190 ppm to ~50 ppm) was also observed during the CT operation.
