VENTILATION AIR SYSTEM ISSUE AT THE UNIVERSITY OF COSTA RICA'S CYCLOTRON FACILITY

Abstract

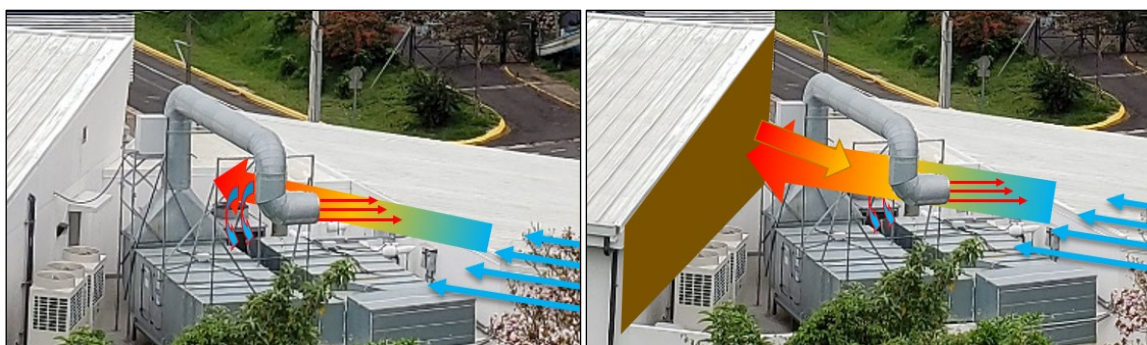
FIG. 2. Wind direction incidence over the inlet/outlet of the HVAC system that generates recirculation. Direct recirculation (left), indirect recirculation (right).

In the left-side image, the direct recirculation is given when the external air is flowing in a particular direction and tends to mix with the exhausted gases of the outlet pipe so the air flow from the outlet of the HVAC system to its inlet, therefore, cooling those gases and sending them to the production floor again.

In the right-side image, indirect recirculation way is showed, where the external air mix with the outlet but moving as a group and colliding against a building wall and losing its energy. In this case external air mix changes its direction to stay close or redirecting itself to the inlet pipe of the HVAC system. Then, eventually the external air mix could be incorporated into the production floor of the building.

For the analysis of the geometric configuration of the inlet and outlet of the installed HVAC system in the building, illustrations of *FIG. 2* were prepared to summarize the discussion of hypothetical ways in which the recirculation of radioactive material would take place.

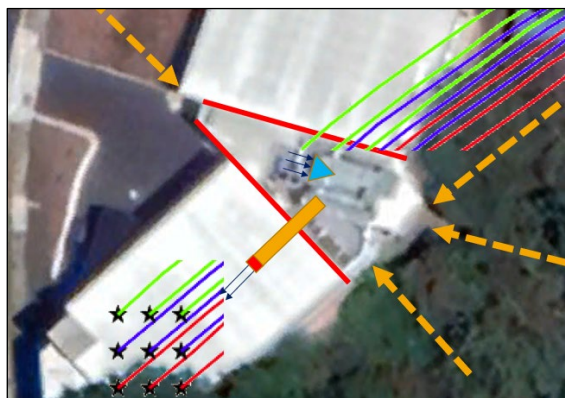
FIG. 5. Inlet (blue triangle) and exhaust pipe (orange-red rectangle) representations for change proposal with an over-position representation of the modelled wind direction, at the day and time where the recirculation incident took place.

Bearing in mind factors as intervention time, costs and some technical considerations, some configurations were discussed with engineers of the company in charge of the modification. The selected proposal for the exhaust pipe change consisted in a horizontal rotation of the pipe to direct its outlet downwind and extended its length, supported over the roof of the building, to avoid recirculation due to changes in wind direction. The proposed modification can be seen in *FIG. 5*.
