Damages on tungsten plasma facing components after experimental campaigns in WEST

Third IAEA Technical Meeting on Divertor Concept – 4th November 2019

M. Firdaouss, E. Tsitrone, M. Diez, A. Grosjean and the WEST team

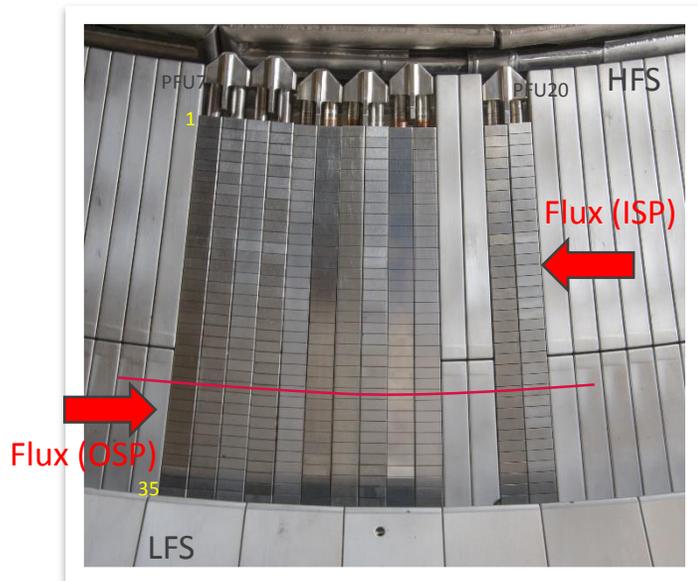
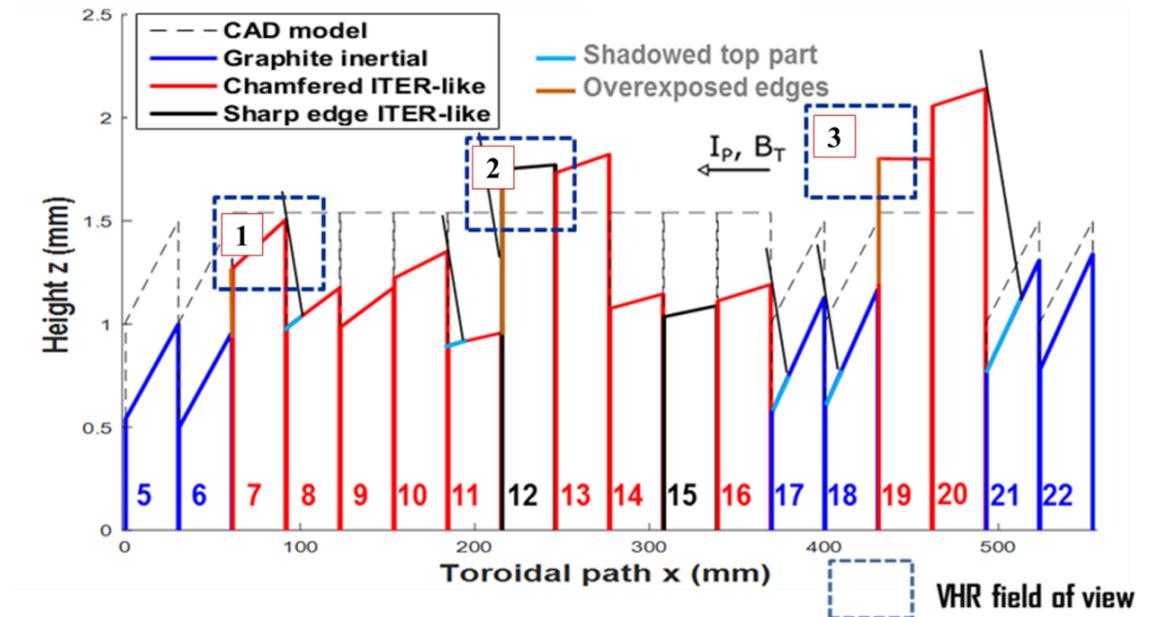
Three PFU misalignment > ITER specification (0.3mm) at OSP:

- ▶ PFU 7 : 0.31 mm
- ▶ PFU 12 : 0.79 mm
- ▶ PFU 19 : 0.63 mm

PFU 12 at risk

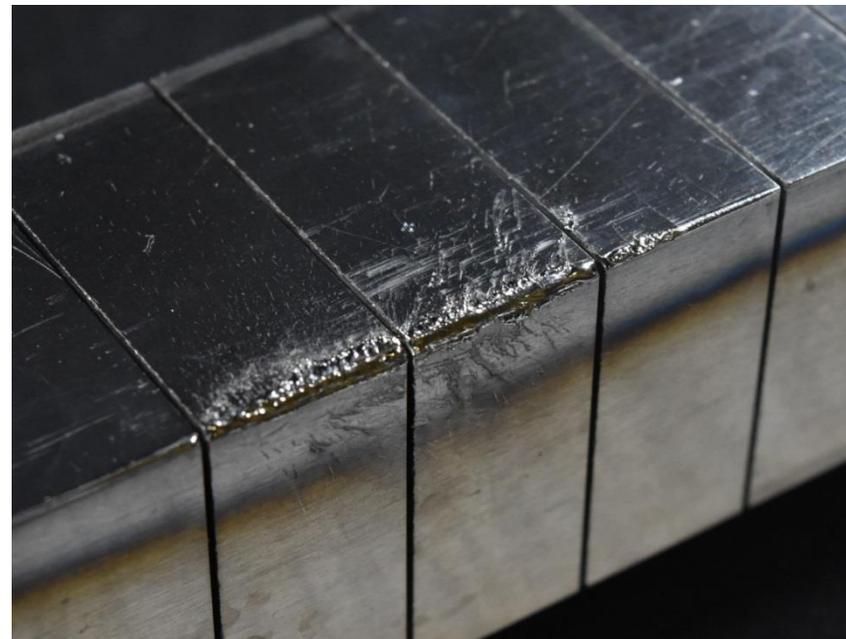
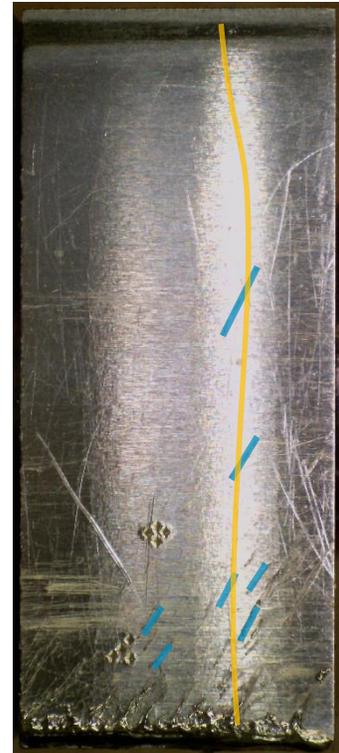
Ex-situ inspection between C3 and C4

- ▶ Damaged area identified after C3a using the robotic Articulated Inspection Arm during experimental campaign
- ▶ Localization on the **trailing sharp edge**
- ▶ Combination of single / few **powerful events** ($>200\text{MW/m}^2$ parallel during 10ms) with 0.8 mm misalignment
- ▶ **No evolution** during following operation C3b

Melted W across monoblock and **long crack**

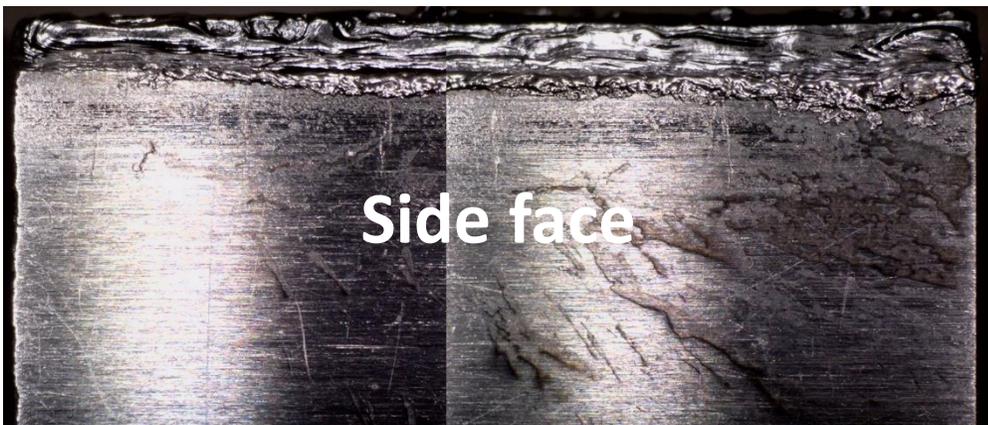
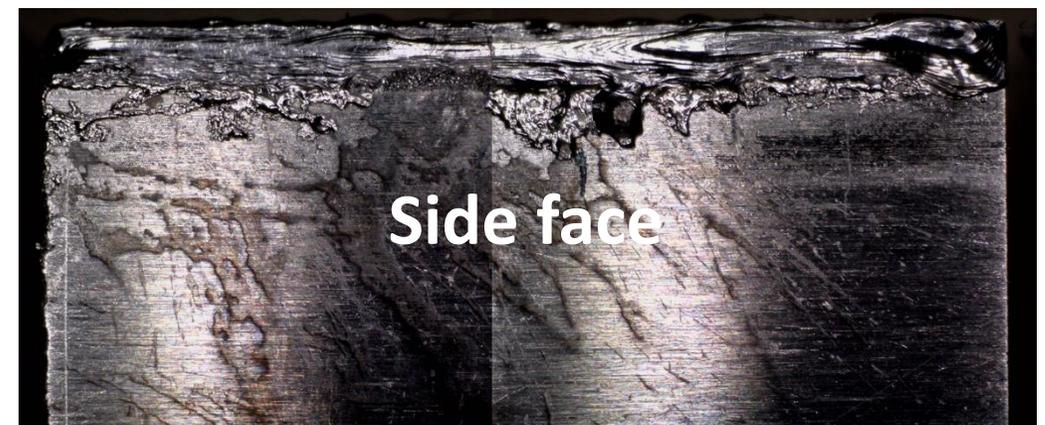
Crack network development

- ▶ Long cracks in yellow on monoblocks far from the melted area (and melted material in blue)
- ▶ Specific to this area, meaning that it is caused by a localized single / few transient event

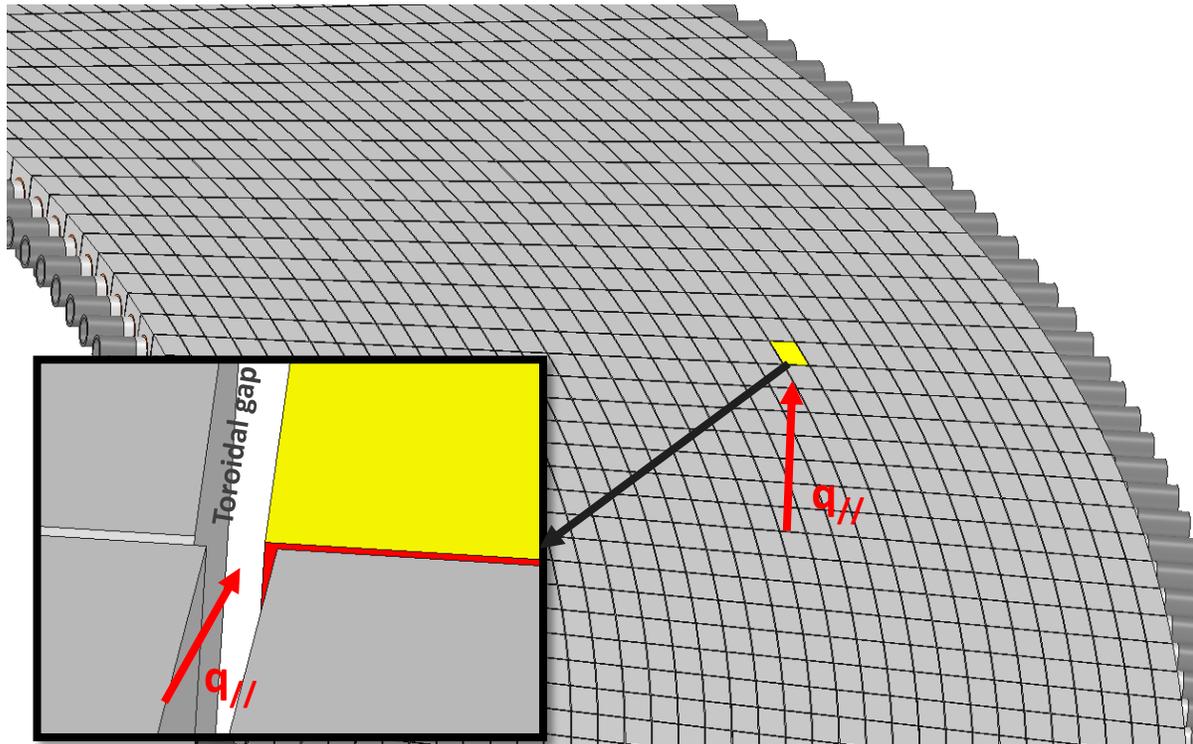
Heat flux on a toroidal face due the particles flowing in a toroidal gap

VHR Infrared image of OHS during a disruption (digital level) on PFU13 (aligned with PFU12)

- ▶ OHS has a deep triangular shape, depending of geometry and plasma equilibrium
- ▶ OHS observed for perfectly aligned PFU on the corner or on the face
- ▶ Simulations have shown that the thermal response of W monoblock to OHS can be an issue for ITER, during ELMs and transient (*Surface heat loads on the ITER divertor vertical targets*, J. P. Gunn et al., 2017, Nucl. Fusion)

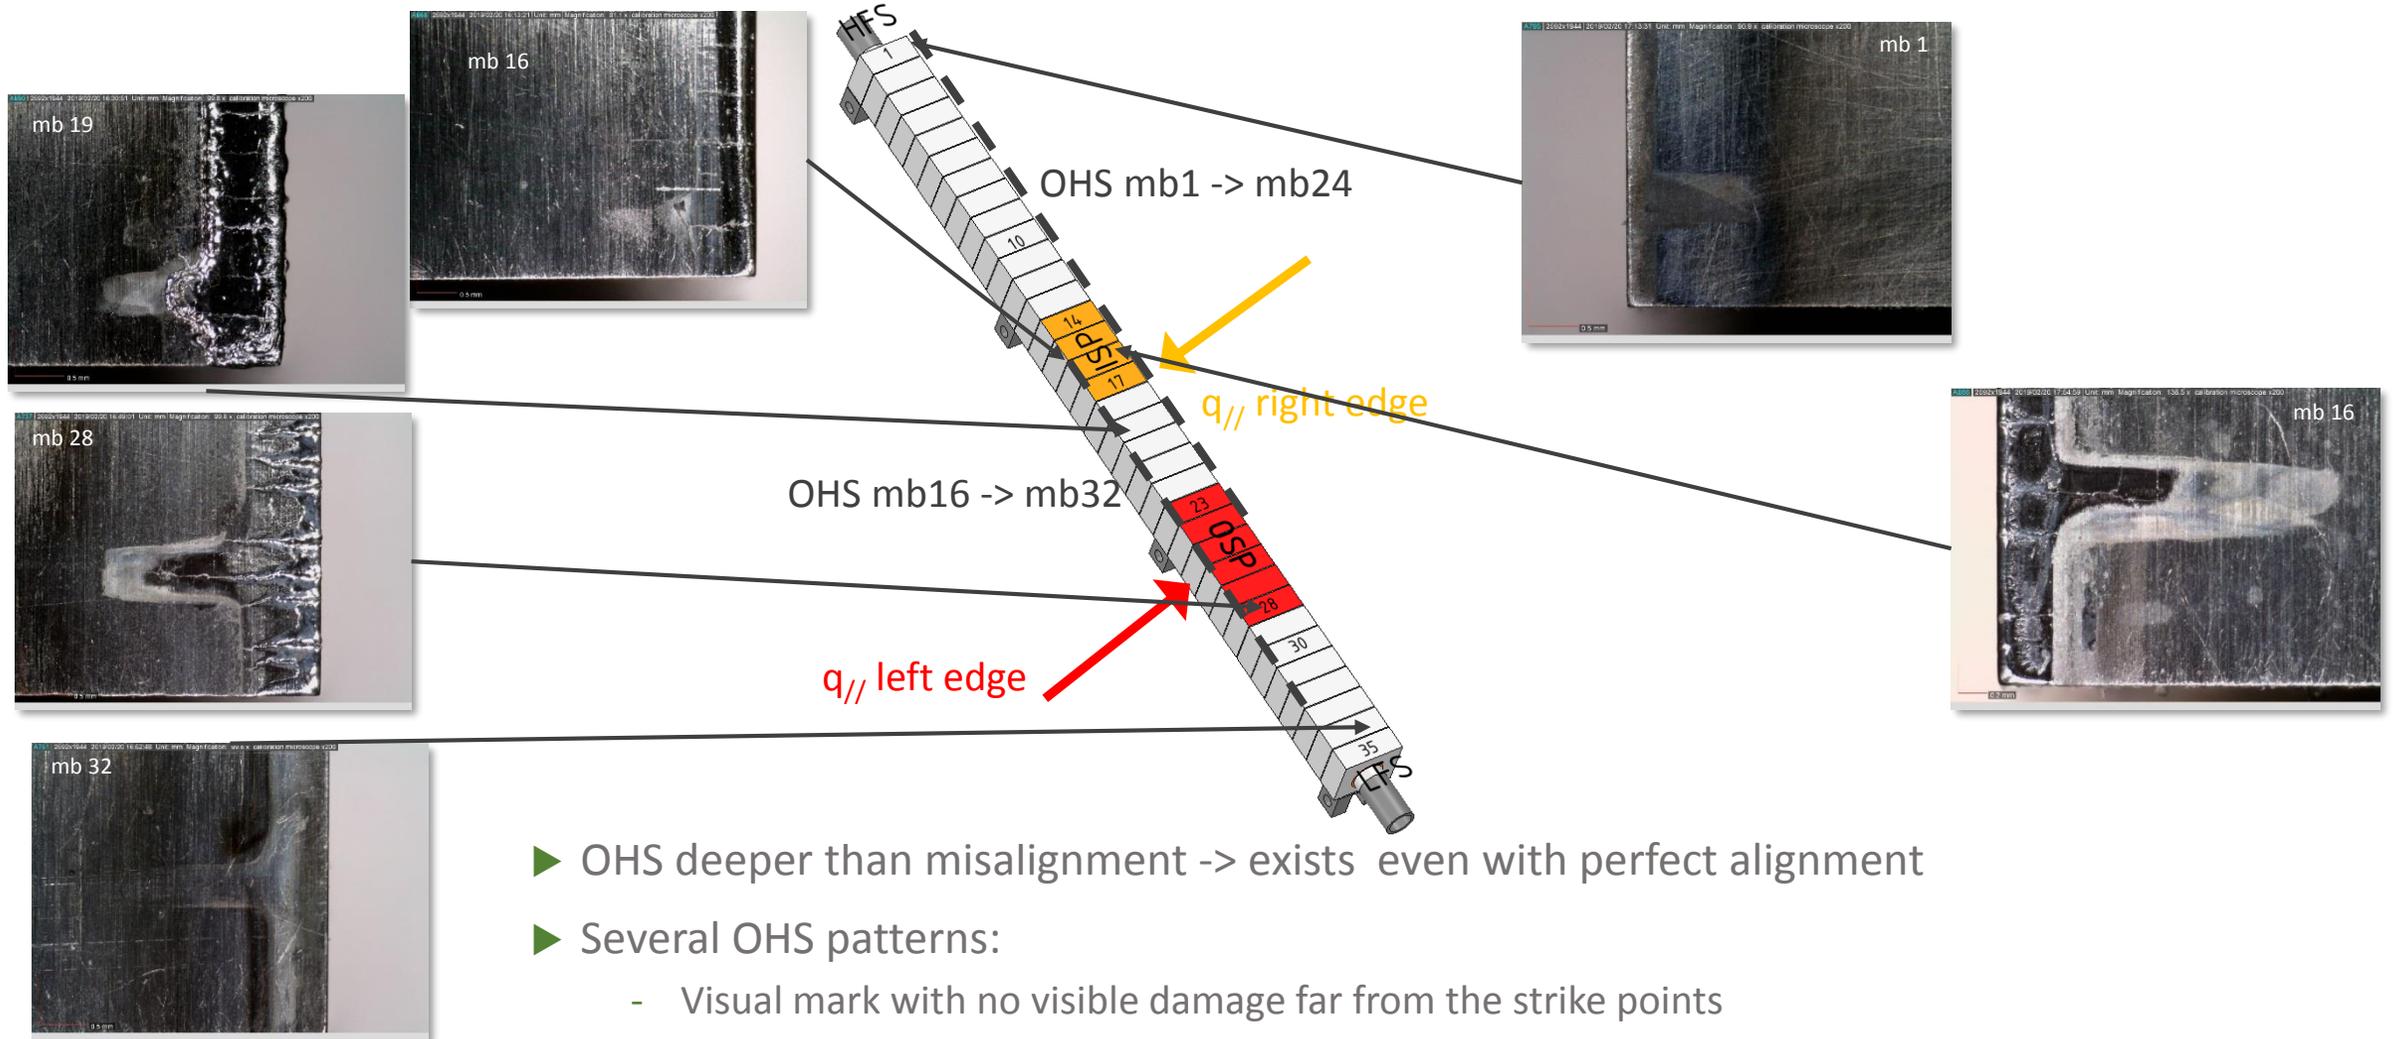
OHS visible all along the plasma exposed edge, cracks near the strike points

- ▶ OHS deeper than misalignment -> exists even with perfect alignment
- ▶ Several OHS patterns:
 - Visual mark with no visible damage far from the strike points
 - Additional melting on non exposed edge (mb 19)
 - Melting and cracks up to the tip of the OHS at both strike points
