Italian National Agency for New Technologies,  
Energy and Sustainable Economic Development

# RADIATION TESTS ON COMPONENTS FOR THE ITER PROJECT AT THE CALLIOPE FACILITY

J. SCIFO<sup>1</sup>

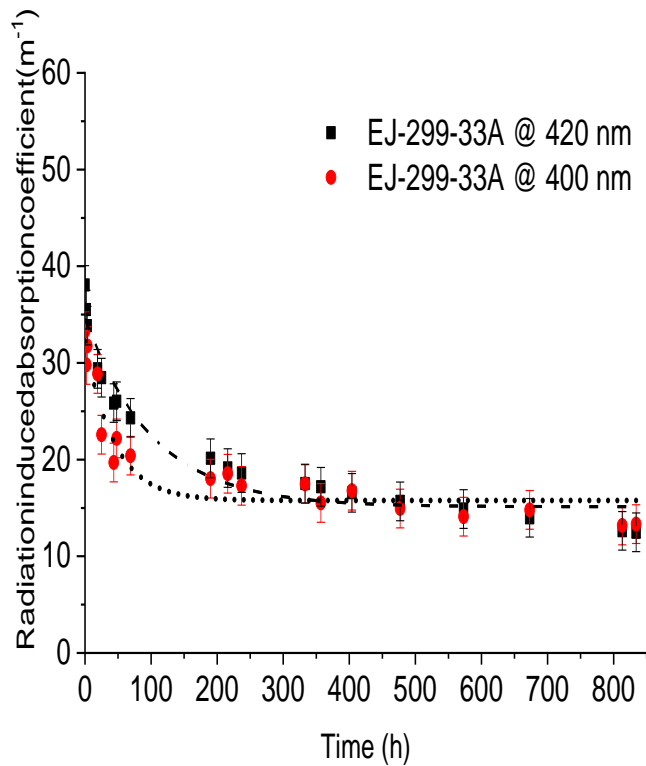
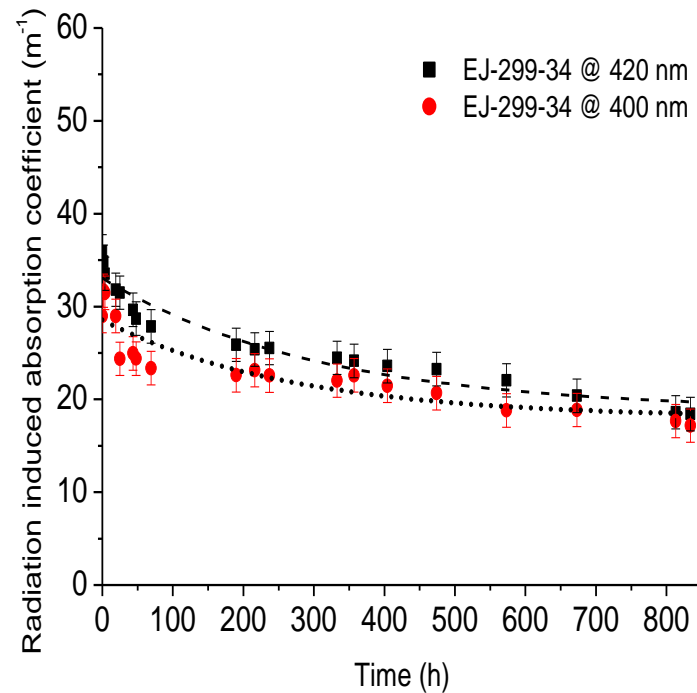
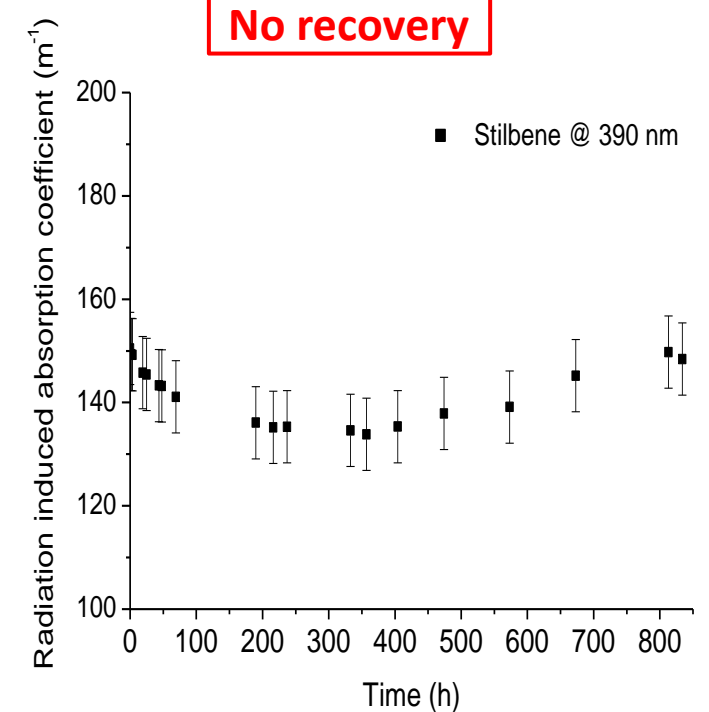
# Gamma Radiation Damage Test: scintillators (3)

Radiation induced damage recovery after 24 kGy absorbed dose

35 days in the dark, at RT

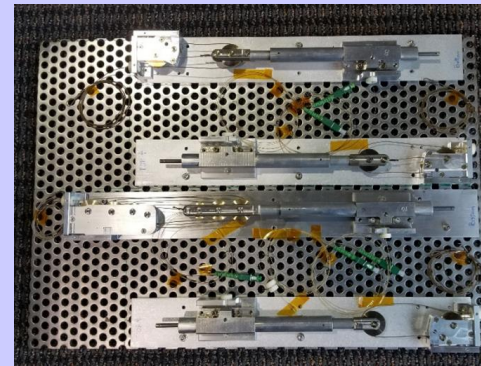
Before Irradiation

- No significant damage or degradation have been detected.
- Some darkening appeared on the metallic surfaces, but the sensors have passed the accuracy verification.
- **Maximum deviation lower than 1% of the Full Scale (FS)**
- **Minimum modulation value of 8.7% higher than 6%**
