Characterization of transient heat flux induced damages of tungsten PFCs during plasma disruption in EAST

Institute of Plasma Physics, Chinese Academy of Sciences

3-6 Sept 2024, IO Headquarters

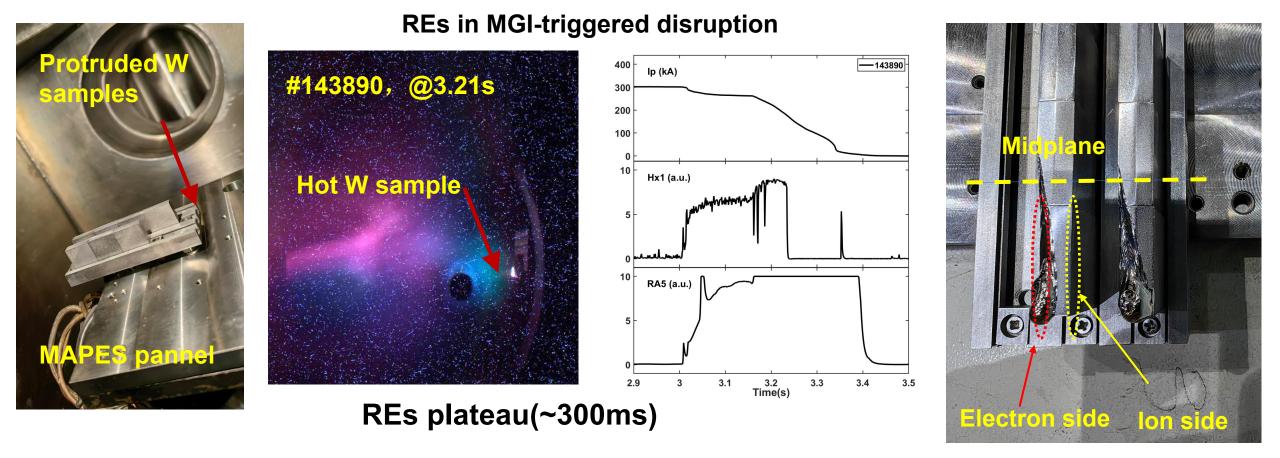
Actively-induced melting experiments

Actively-induced melting by REs during MGI-triggered disruption was successfully performed using MAPES during 2024 EAST spring experimental campaign
