**30<sup>th</sup> IAEA Fusion Energy Conference**

# **Recovery of ITER Sector Modules from Critical Issues**

**Chang Hyun NOH, A. Bonito Oliva, N. Koizumi, and E. Rodilla Hoyo**

15 Oct. 2025

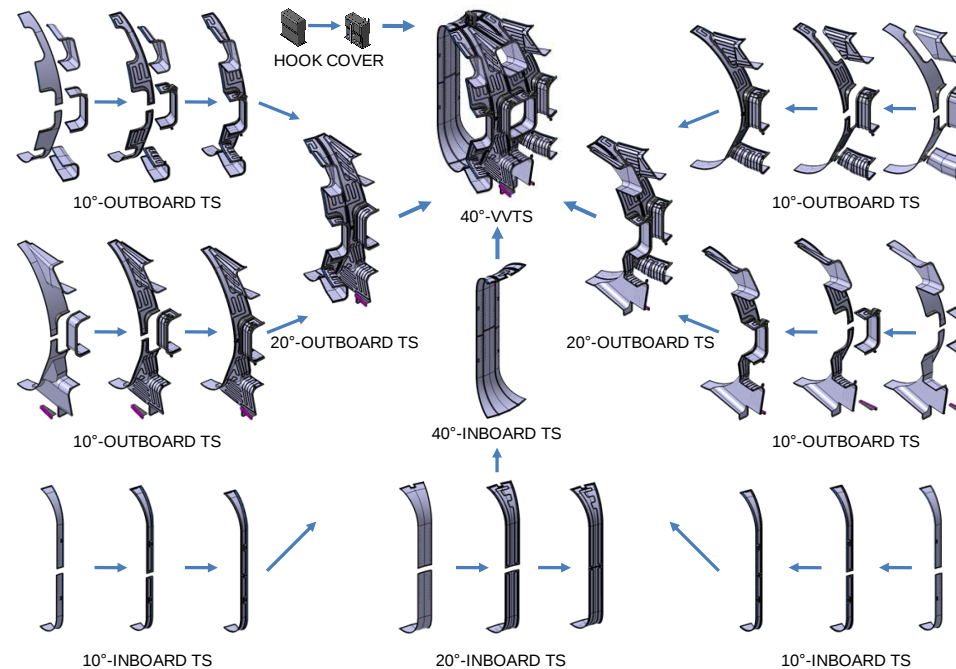
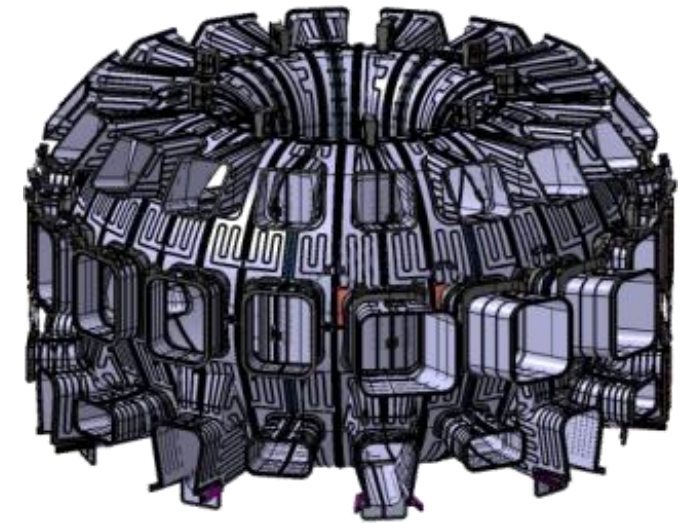
VVTS 40 deg. sector and its fabrication flow

- ✓ Composed of approximately 200 panels and each panels are assembled together by bolting.
- ✓ Cooling circuit (DN80, stainless steel pipes, 80K 1.8 gaseous helium flow) attached on the panel by stitch welding.

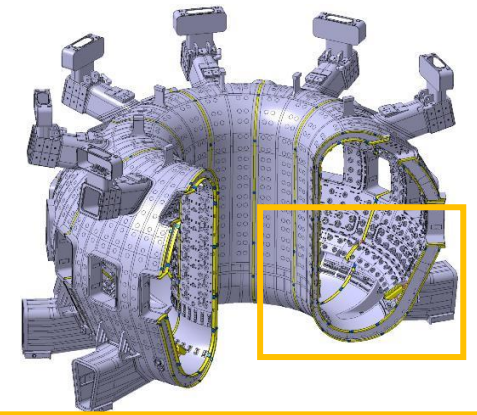
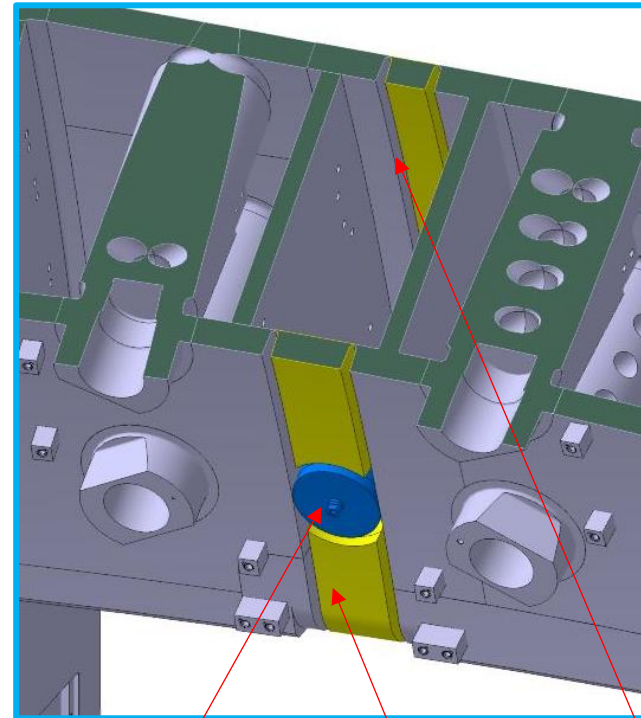
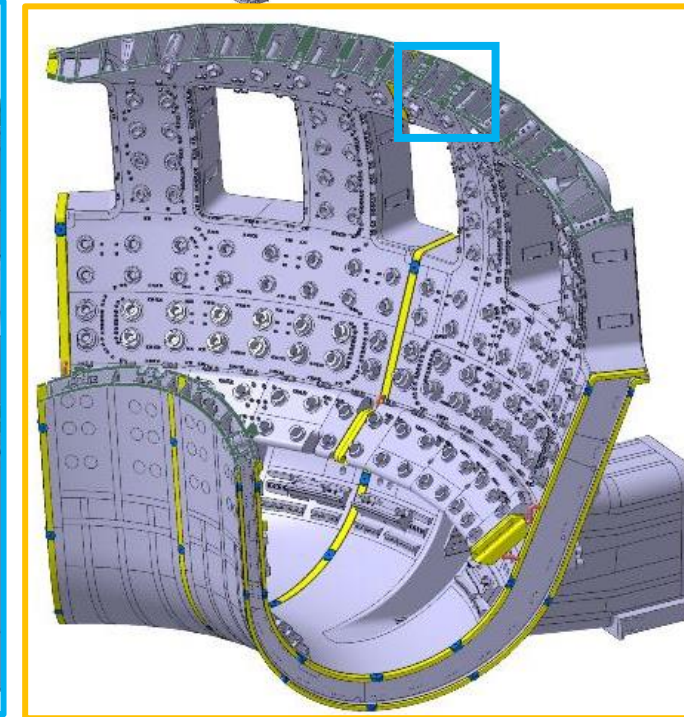
Biscuit      Inner Shell Field Joint / Splice plate      Outer Shell Field Joint / Splice plate

- ✓ Welding of the **9 Vacuum Vessels**
- ✓ Austenitic Steel 316L(N)-IG, **60 [mm] thick**
- ✓ Total **welding length**  $\approx 1$  [km]
- ✓ Total **welding mass**  $\approx 10$  [t]
- ✓ **Splice Plate** (SP) are to accommodate manufacturing and assembly tolerances with widths around 100 [mm] and 160 [mm] for outer shell and inner shell respectively (customization for each assembly)
- ✓ **Biscuits** are intermediate circular plated whose function is to access to the backside of splice plates (let the root access, avoid cross welding & allow NDE)

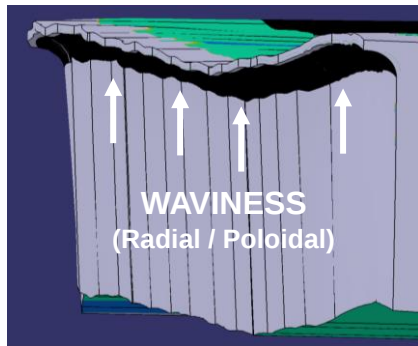
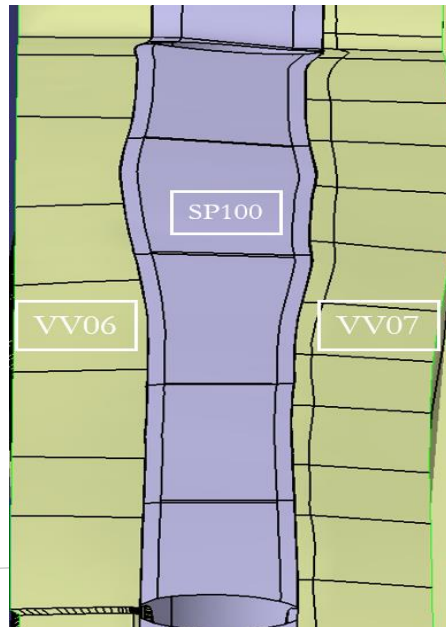
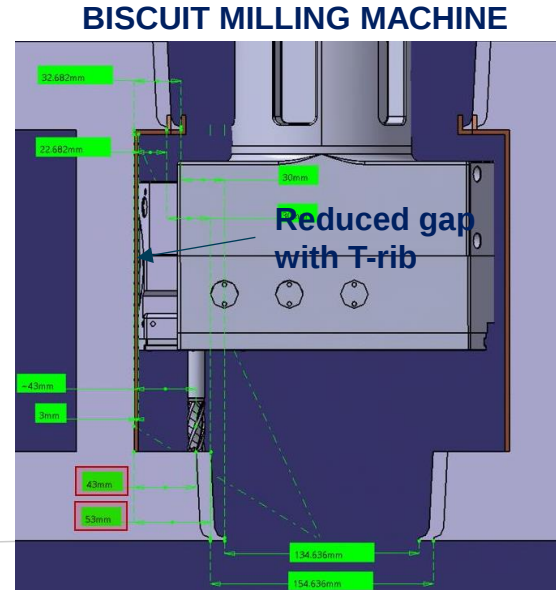
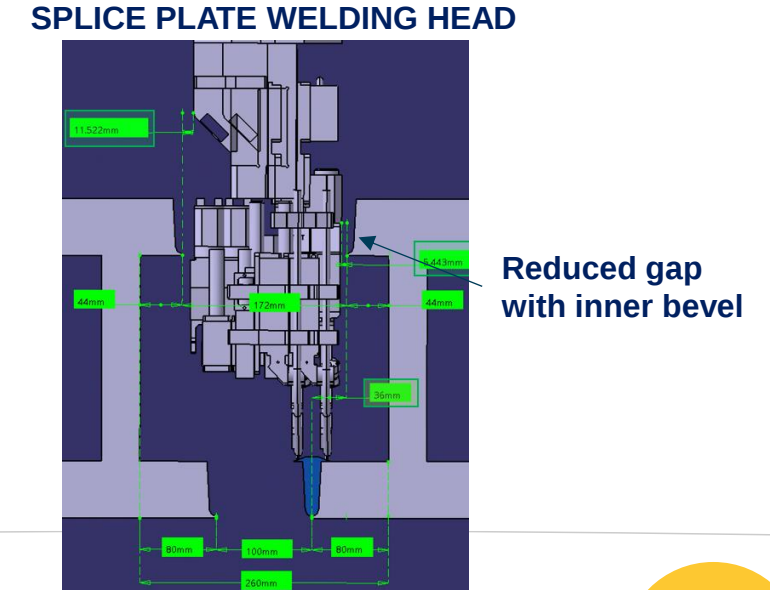
- ✓ Difficulties in adapting the welding machine to trajectory changes
- ✓ Difficulties in splice plate customization and alignment
- ✓ Potential variability in welding parameters depending on position: Irregular bevel profile due to deviations in nose thickness
- ✓ Potential clashes with welding machining and NDE tooling

→ To Repair VV Sector bevel as built dimensions to meet the dimensional requirements for field joint welding and Non-Destructive examination.

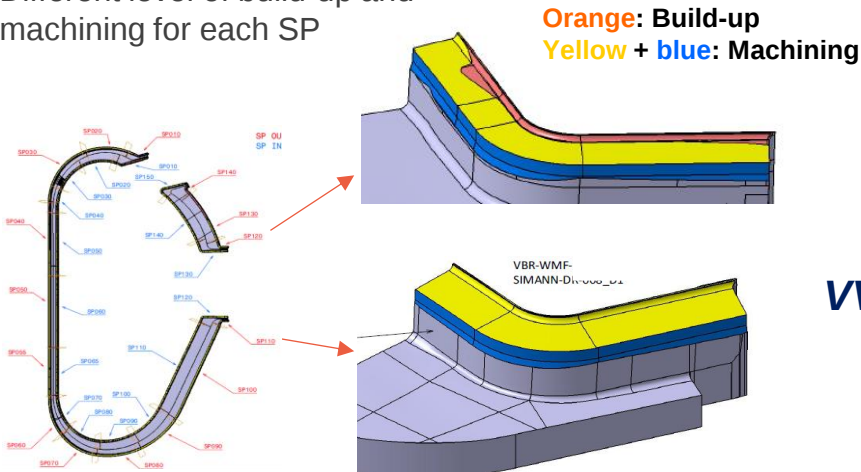
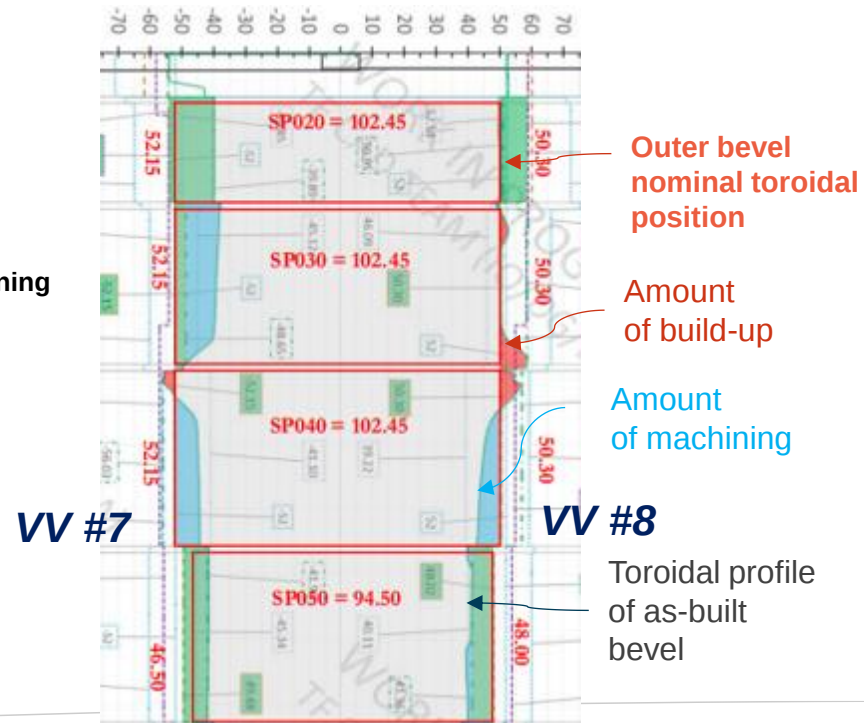
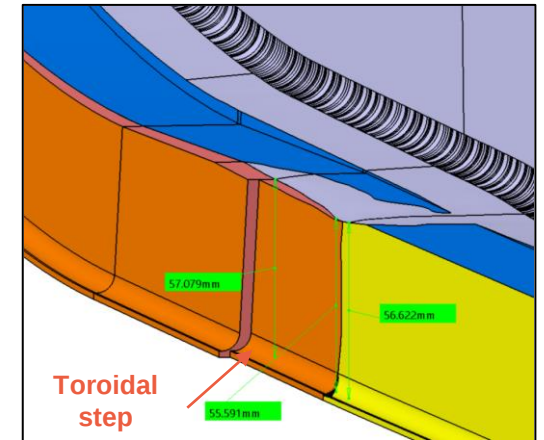
Different level of build-up and machining for each SP

### Different toroidal position for bevel nose for each SP

Example (FJ #15, S7-S8):

- ✓ Build-up: to recover material in toroidal dir. (mostly outer bevel)
- ✓ Machining: to remove excess of material in toroidal dir. (mostly inner shell) and to get final bevel shape
- ✓ Customized solution for each Splice Plate adapted to each field joint.
- ✓ Development of metrology process for identification, monitoring and validation of areas to be repaired
