# Recovery of ITER Sector Modules from Critical Issues

Chang Hyun NOH, A. Bonito Oliva, N. Koizumi and E. Rodilla Hoyo  
ITER Organization  
changhyun.noh@iter.org

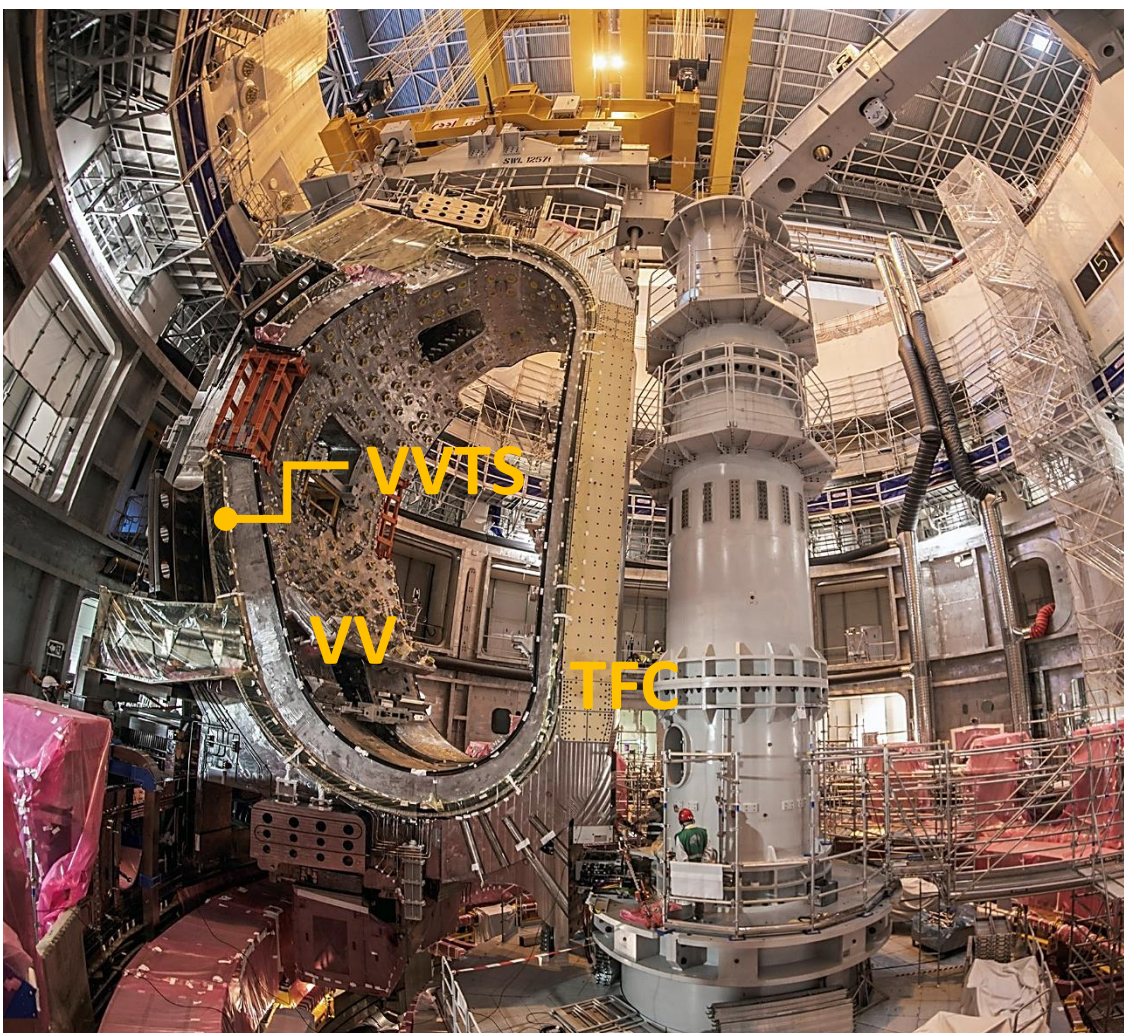
- In May 2022, the assembly of the first Sector Module (SM) was completed, and it was successfully transferred to the pit. However, it was decided to return the first SM to the SSAT and dismantle for repair due to critical non-conformance in the VVTS, confirmed in Sep. 2022. It also was decided to carry out VV bevel repair outside the pit originally planned repair in the pit.

ITER Sector Module in the pit
