Long pulse discharges with duration 30 s – 1 min routinely performed in Phase I

Phase II with the full ITER-grade divertor aiming at 1000s plasmas to start in summer 2021

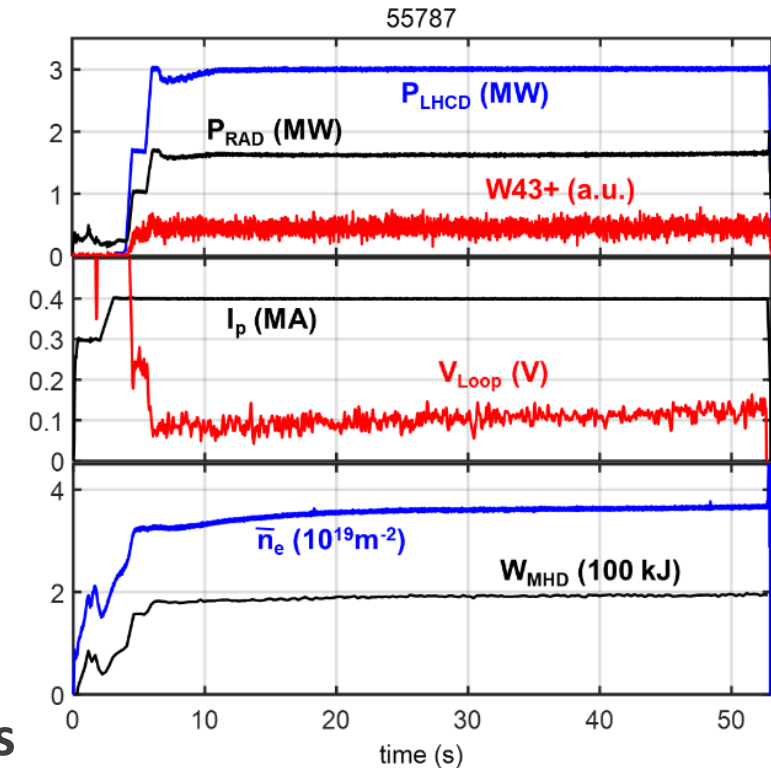
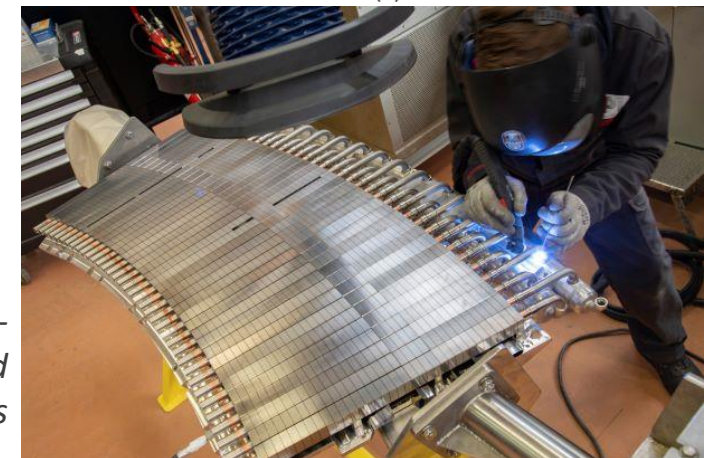
Welding of a 30 degree-sector of divertor composed of 38 ITER-grade PFUs

- ▶ 456 PFUs manufactured and reception tests competed → assembly ongoing
- ▶ Main thrusts for phase 2:
 - ✓ Combined high heat flux/high particle fluences studies
 - ✓ Towards **steady-state H-mode operation in full W device**
