Corrosion of SS316H in Static and Flowing U-Bearing Fluoride Salt

Ph.D. Student: Jaewoo Park

Advisor: Jinsuo Zhang

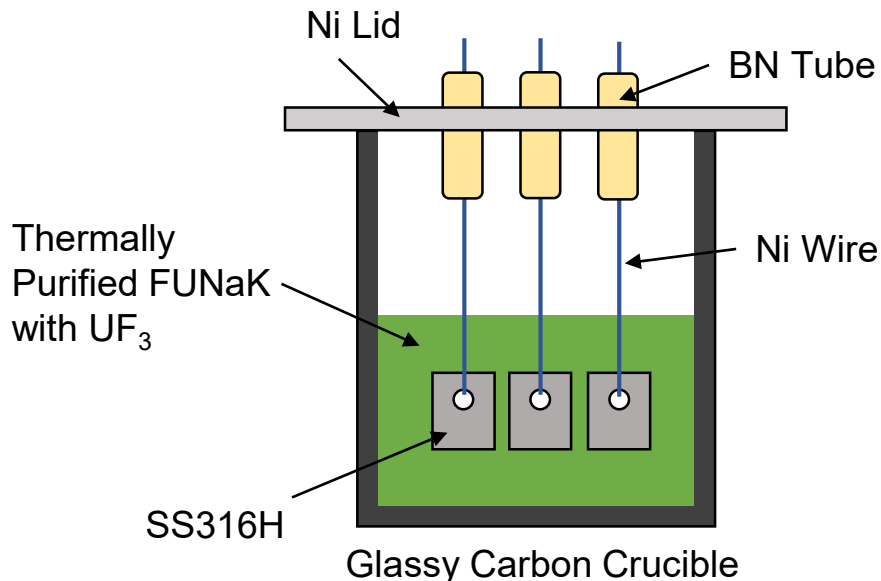
With thermally purified salt

- Mainly two different batches of FUNaK were prepared: thermally purified and chemically purified (HF+CA) salts.
- For the chemically purified FUNaK, two different batches with and without UF_3 were prepared to study the impact of UF_3 on corrosion.
- Experiment Conditions: 800 °C for 120 hours. The same ratio of salt mass to specimen's surface area was used between tests with thermally and chemically purified salts.

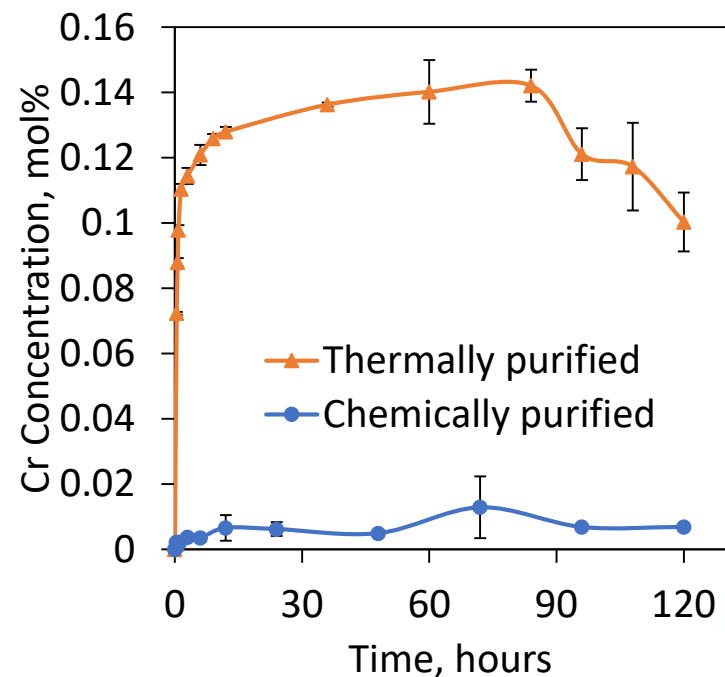
Concentration changes of Fe and Cr in thermally and chemically purified salts during tests

- The dissolution of corrosion products was reduced by chemically purifying salt.
- For the thermally purified salt, the dissolution of Fe and Cr increased rapidly as the test started.
- The Fe concentration then decreased while the Cr concentration gradually increased due to the reaction between FeF_2 and Cr and the formation of carbides on the glassy carbon crucible.

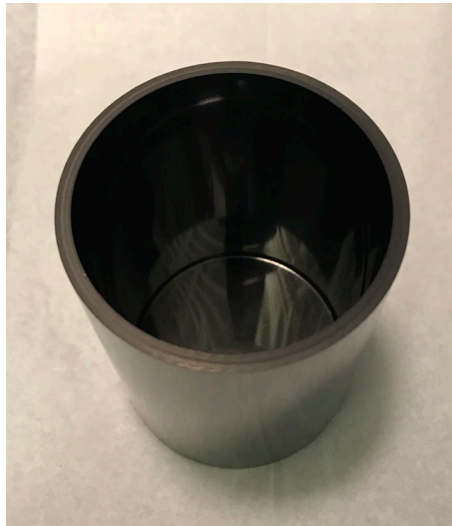
Pre-test crucible

- Unlike the test using chemically purified salt, silver-colored layers were observed on the glassy carbon crucible after the test using thermally purified salt.
- The thickness of the layers was around $1.315 \pm 0.707 \mu\text{m}$.
- The post-test crucible from the 2 m/s test broke without significant force when it was being taken out of the furnace. This might be caused by the difference in thermal expansion between glassy carbon and materials of the layers.
