**SWITCHING FROM A CESIUM-137 BLOOD
IRRADIATOR TO AN X-RAY IRRADIATOR**
*Experience at a Community-based
Hospital in the Northeastern U.S.*

M. HERNANDEZ
Morristown Medical Center – Atlantic Health System
Morristown, New Jersey, U.S.A.
Email: marissa.hernandez@atlantichhealth.org

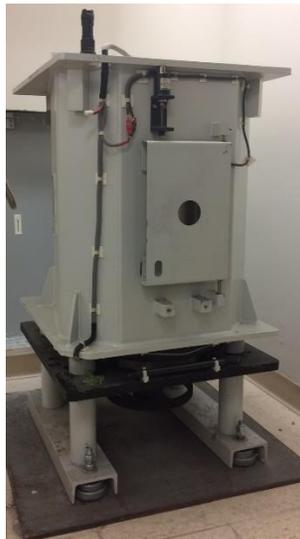
FIG. 1. Caesium irradiator with the cover removed

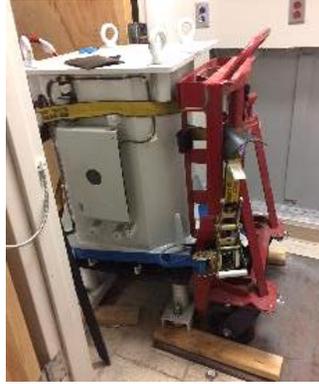
FIG. 2. Disposal Preparation of the caesium irradiator

7:00-11:00 a.m.	Removal company staff prepared the caesium blood irradiator, located in the Blood Bank
7:30 a.m.	Crane arrival
8:00 a.m.	Arrival of trailer/cask and INL personnel
11:00 a.m.	Removal company staff wheeled out the irradiator from the Blood Bank, out to the parking lot area next to the trailer.
11:00 a.m.-3:00 p.m.	INL prepared the irradiator for transport – including leak tests and radiation surveys.
3:00 p.m.	Trailer transporting the cask containing the irradiator, left MMC.

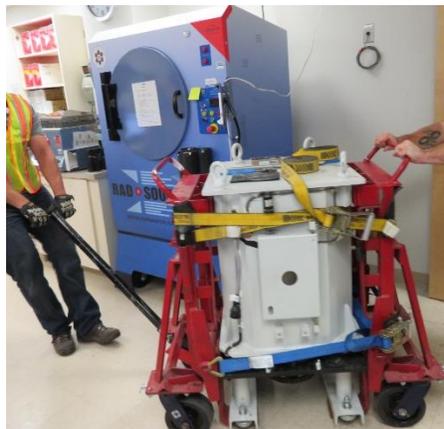
FIG. 3. Caesium irradiator being transported out of the Blood Bank

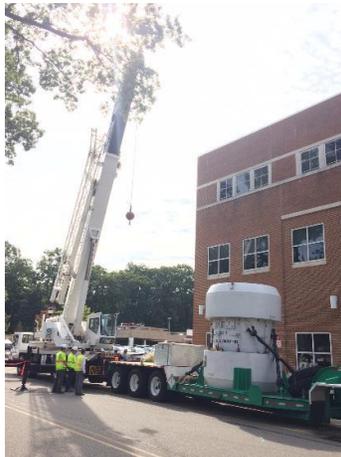
FIG. 4. The Crane and the Cask in the parking lot behind the hospital

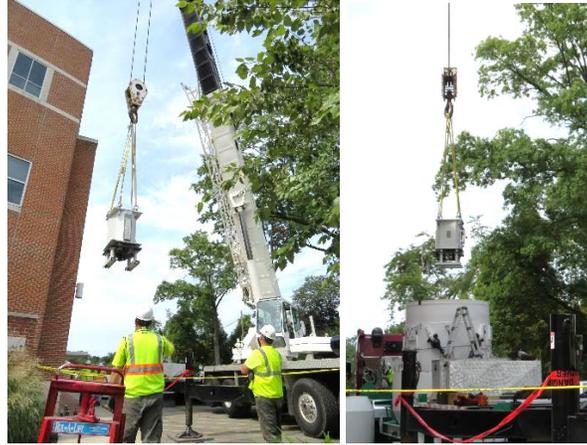
FIG. 5. Caesium blood irradiator being hoisted into the cask

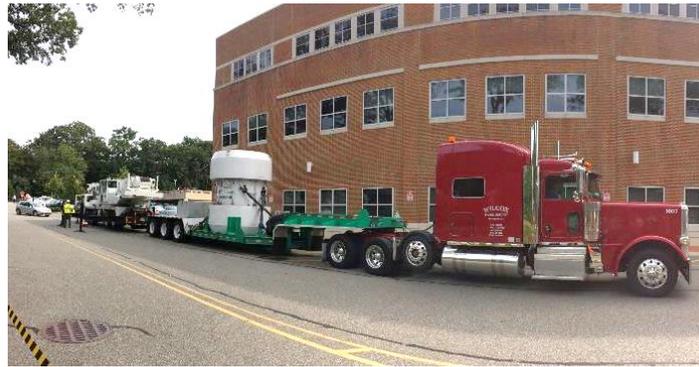
FIG. 6. Trailer hauling the cask containing the irradiator, as it leaves the facility
